CATOCTIN FURNACE DOUBLE LOG HOUSE

A HISTORIC STRUCTURE REPORT

THE CATOCTIN FURNACE HISTORICAL SOCIETY

PRESERVATION ASSOCIATES

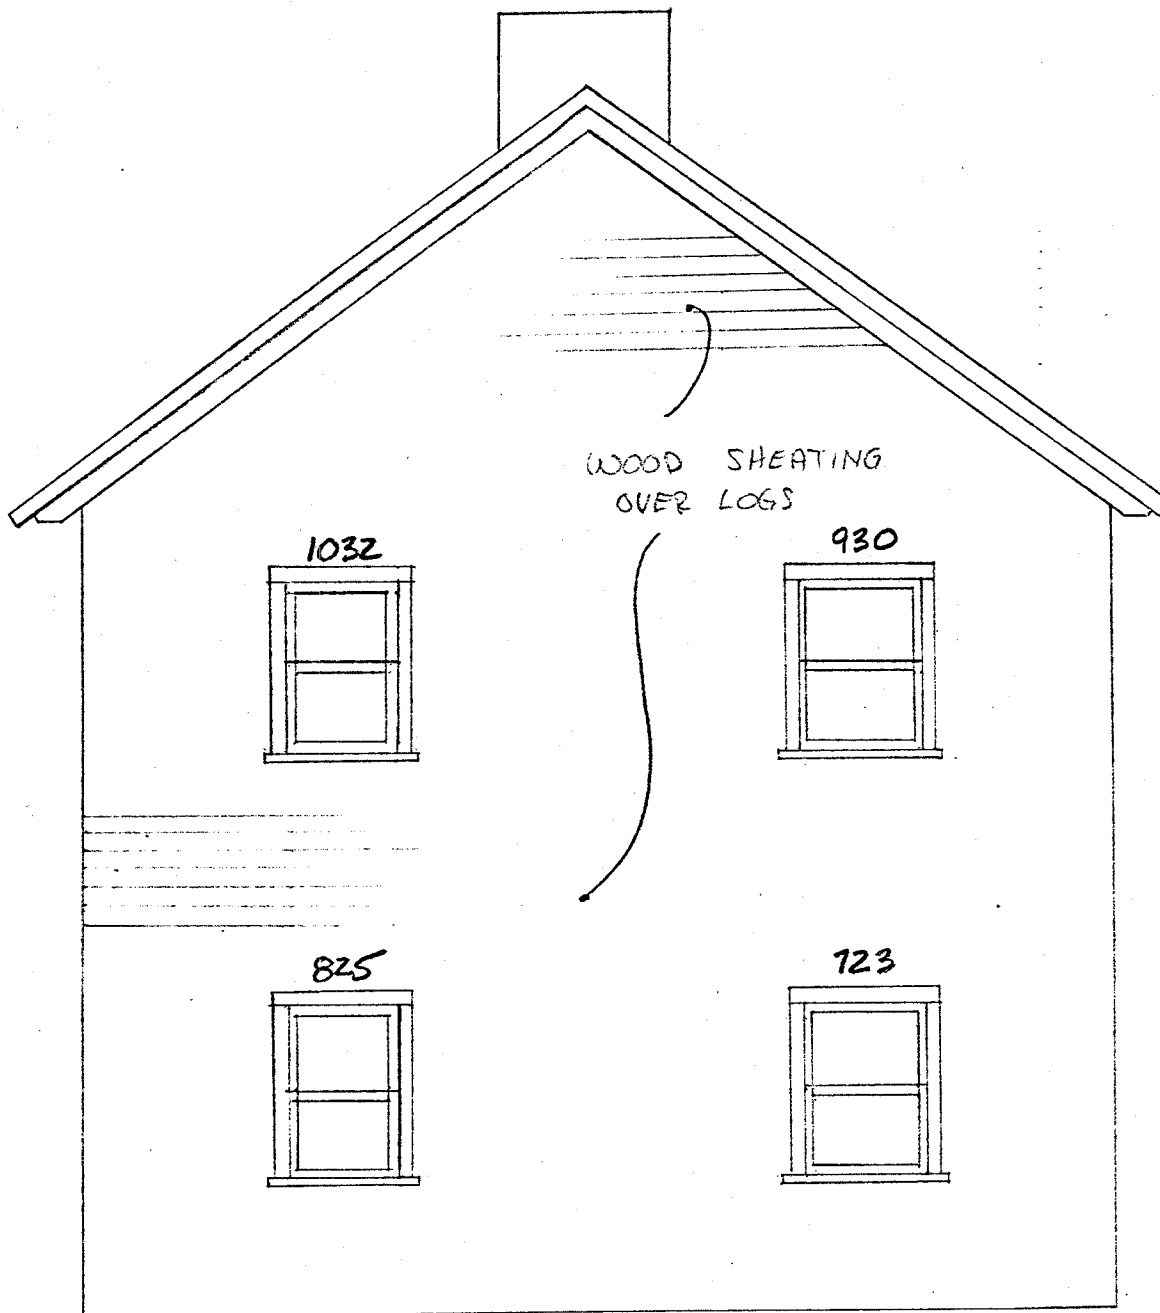
WEST ELEVATION

LOGS NOTICED
AND TENONED
AND PEGGED
INTO ADDITION POST

ALL LOGS EXPOSED AND
WHITEWASHED

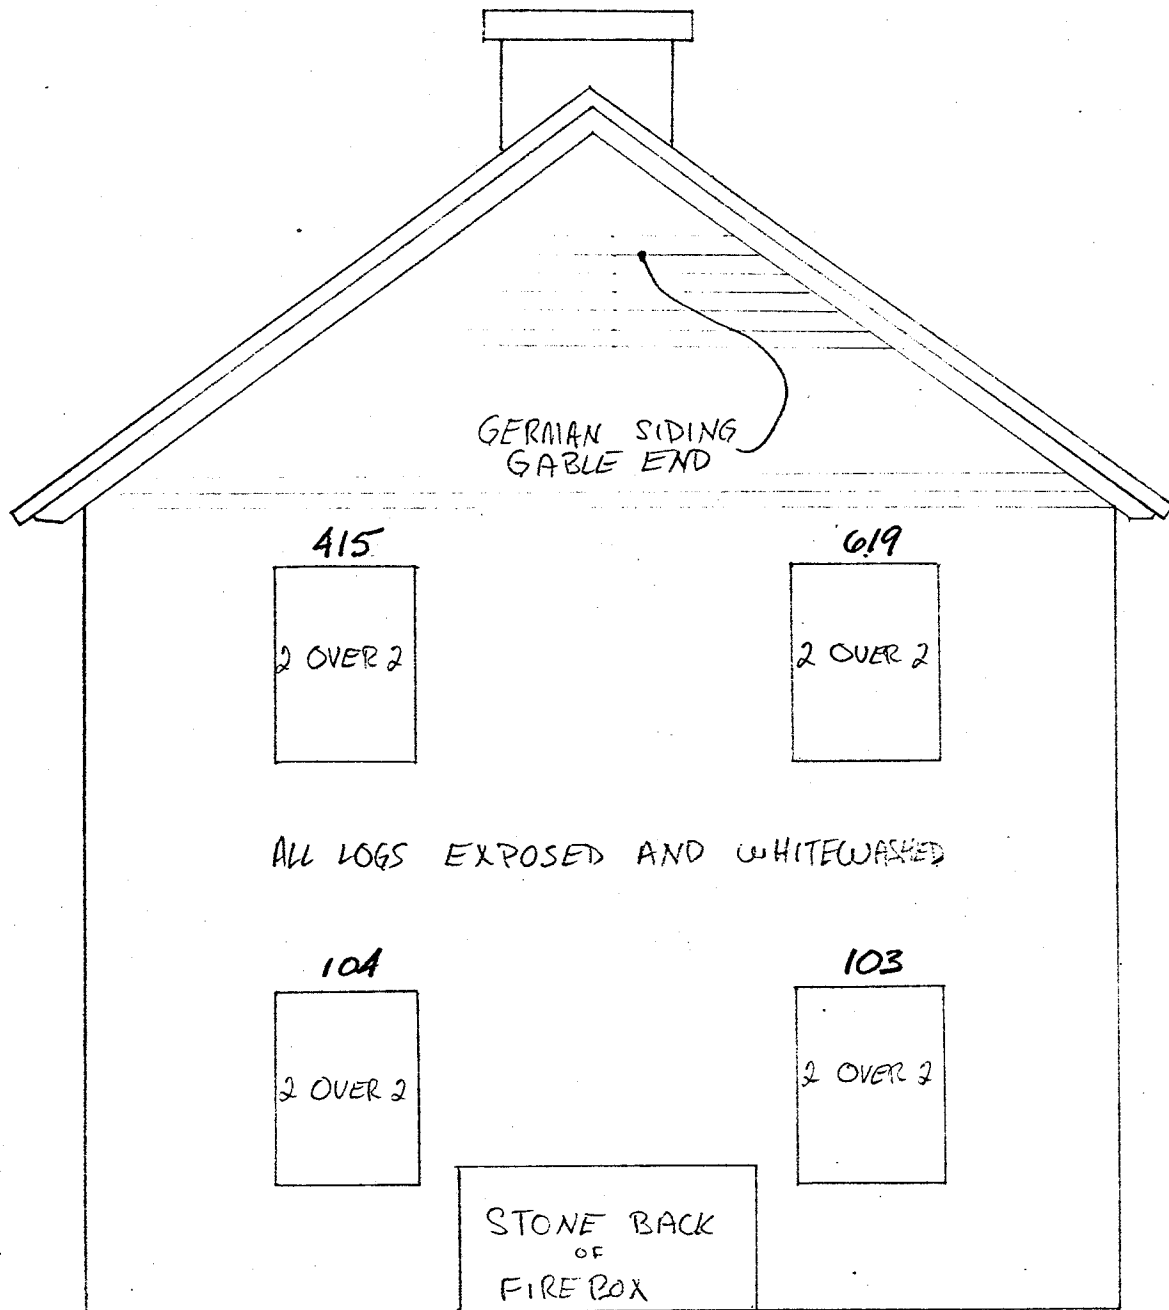
SOUTH ELEVATION

LOGS EXPOSED AND WHITEWASHED

DOOR
MISSING
