# CATOCTIN FURNACE

A Design Program for the  
Investigation, Repair and Stabilization of the  
Retaining Walls and Furnace Stack at  
Catoctin Iron Works  
Cunningham Falls State Park

The Construction History of the Stone  
Retaining Walls and Furnace Stack

Project #P-016-741-401

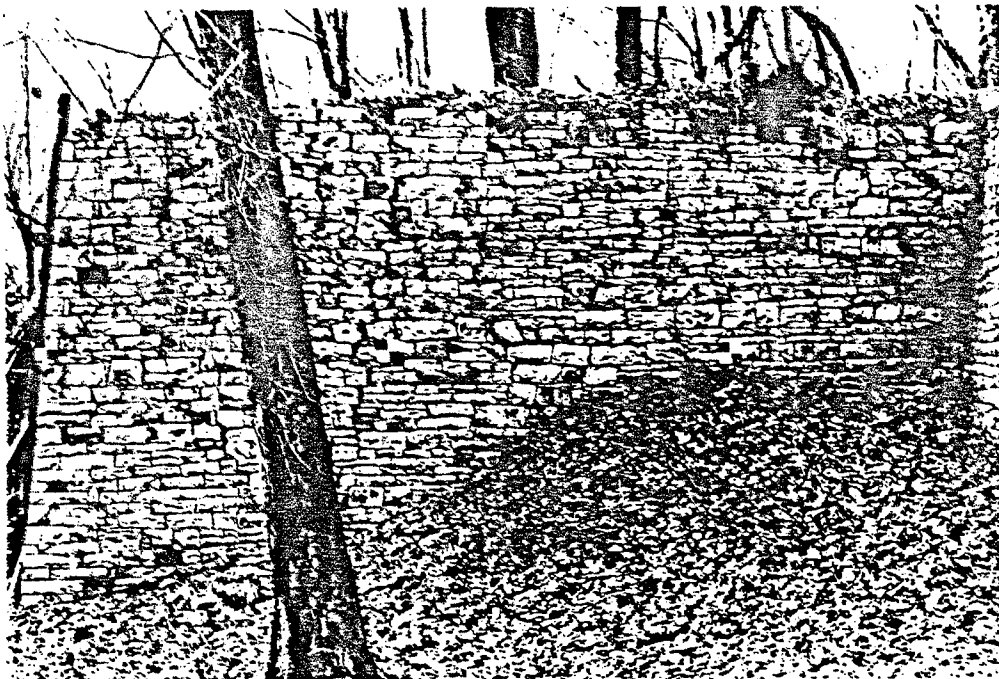
Plate 7

North face of engine house retaining wall.

This section of the retaining wall, noted on the accompanying drawings in grid sections D-E, 3,2,1 extends west from the north end of the engine house wall. (Refer plate 7).

Like the rest of the wall, its surface is of cut rectangular blocks with a hammered rock-faced surface finish. The exposed or north face of this wall is fairly uninterrupted except for the general deterioration already noted. A mound of earth heaped against the west end of this section of the wall has been identified in the 1974 Catoctin Furnace Stabilization Study as a pile of limestone. Three joist pockets are located near the east end of this wall. These apparently were associated with the operation of the "Deborah" furnace. They appear to be original to the construction of the wall. A tree stump protrudes from the top of the wall near its west end and there is a vertical crack near its east end.

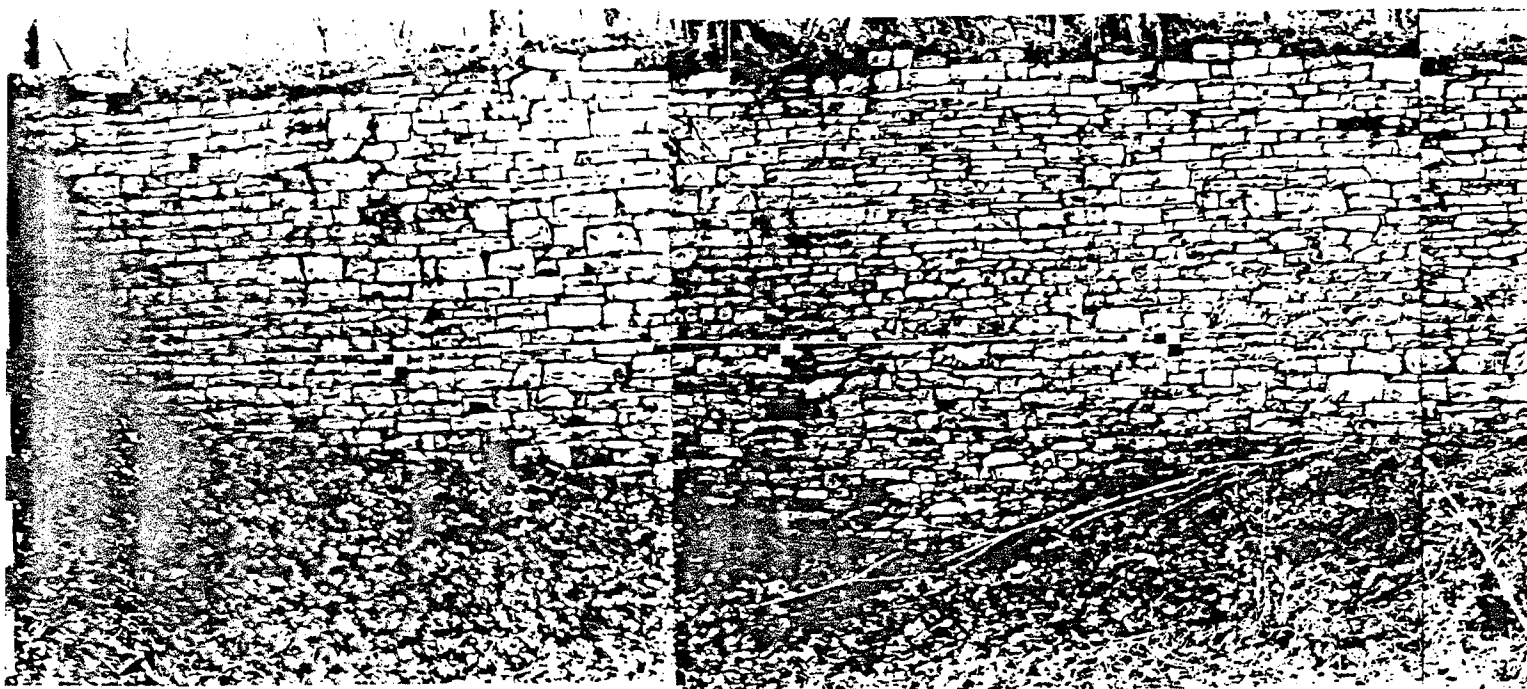
Plate 8, 9, 10, and 11

South end quadrant of long retaining wall, mid south quadrant of long retaining wall, mid north quadrant of long retaining wall, north end quadrant of long retaining wall.

This is the longest uninterrupted section of the wall. It runs in a north-south axis for approximately 135 feet. (Refer plates 8, 9, 10, & 11). Its construction of rock-faced sandstone cut into rectangular blocks is that already discussed for the entire wall except for the "Isabella" stack and the wall to its north. The wall has deteriorated due to weathering, lack of maintenance, and overgrowth of vegetation. In 1974, a wooden brace was planted against the east face of the wall, 72 feet north of the beginning of this span, between grid lines H and I. Approximately two feet north of the brace is a vertical crack in the wall. This area of the wall has moved and bows outward or

to the east substantially at this point. (See drawing #3 of appendix D). Several tree stumps protrude from the top of the wall indicating that after the furnace was abandoned, trees rooted and grew to maturity directly on top of the wall. These trees have been a major contributor to the deterioration of this part of the wall. In the vicinity of grid line "K" efflorescence and water seepage is clearly visible on the surface of the lower half of the wall. A number of stones have fallen away from the top of the wall in this area adjacent to two of the tree stumps. From this point northward, the wall has also moved and now leans backward or west into the slope. There are a few open areas in the wall suggesting the presence of joist pockets, but their locations are erratic, forming no pattern. These holes apparently are where small stones have fallen out of the wall. A few small mounds on the ground along this section of the wall were identified in the 1974 report by National Heritage Corporation to be slag heaps. Old photographs of the furnace complex indicate that a stock house, stood on the embankment directly above this section of the wall. It probably served the "Deborah" furnace, and possibly also held raw materials for furnace stacks #1 and #2. These old photographs also show that a structure was built against the face of this wall long most of its length. It appears to have been a catwalk.

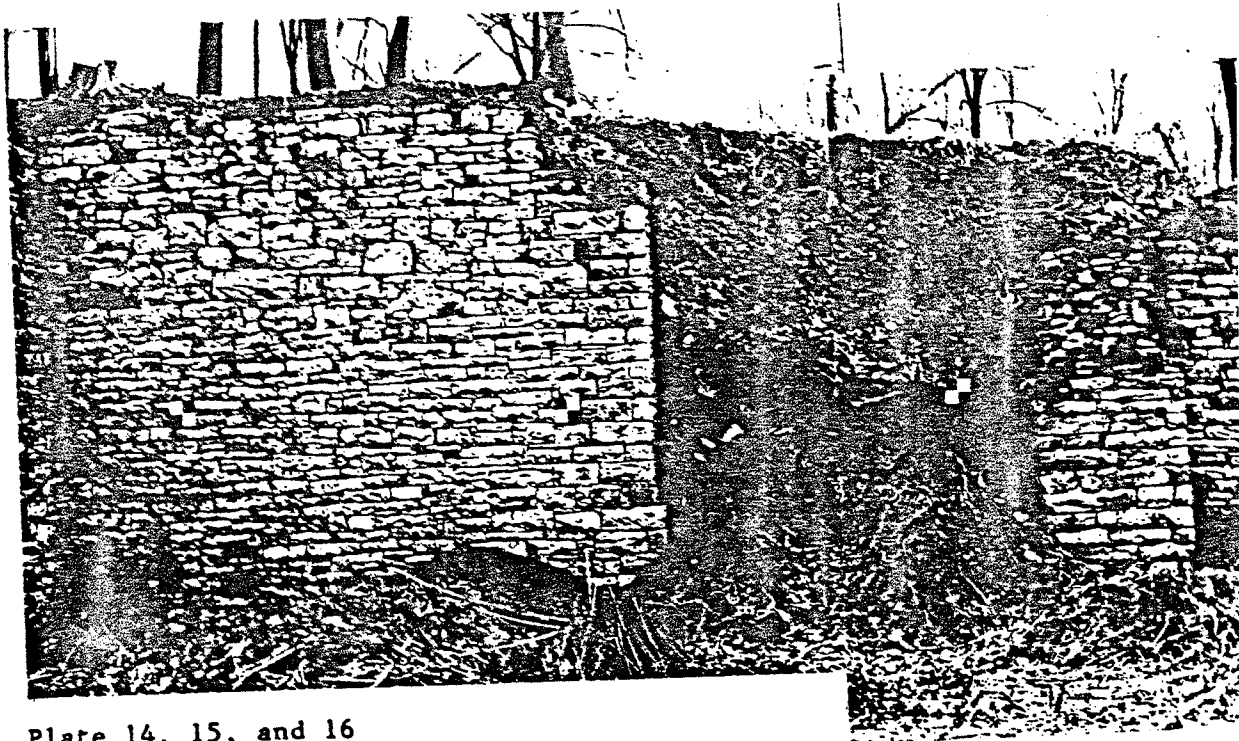
Plate 14, 15, and 16

West end of north retaining wall, collapsed section of north retaining wall, 18th Century bellows house wall.

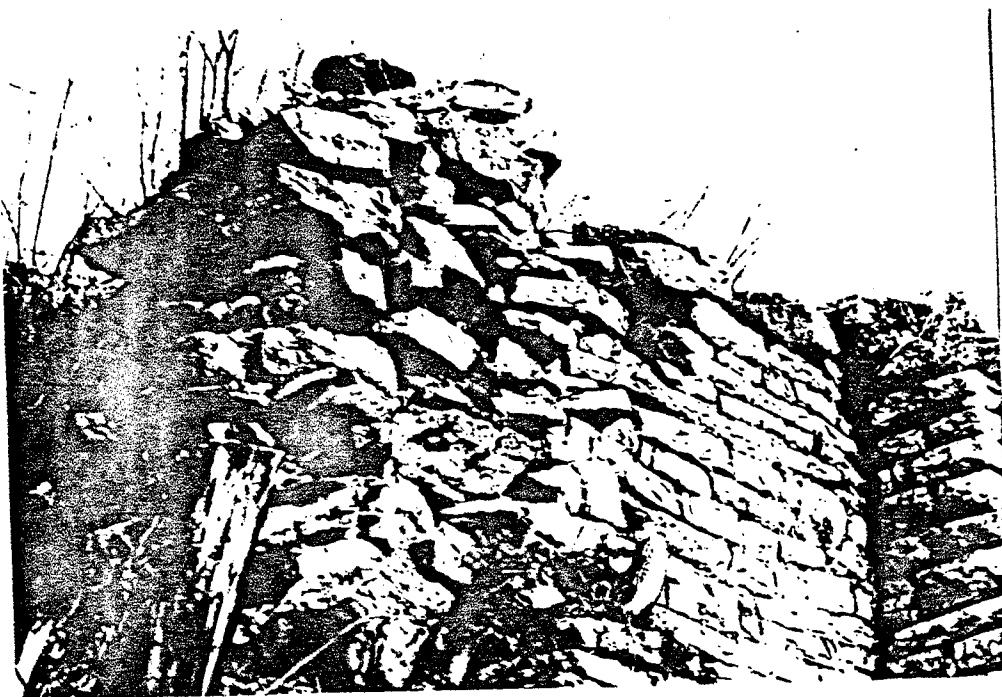
Plate 17

As was typical of stone construction in the 18th and 19th centuries, the rocks were cushioned by a soft bedding of clay or naturally oxidized silacious material combined with lime. (Refer plates 2 & 17). The purpose of the bedding (the interior mortar) was not, as usually construed, to bind the stones together, but rather to hold them apart. The mortar acts as a shock absorber to cushion the stones during movement of the wall caused by thermal changes and freeze-thaw action.<sup>3</sup> Soft mortars such as this were used predominately until the late 19th century when hard cement mortars were introduced. The principle behind the use of hard mortars is opposite that of soft mortars. A hard cement-mortared wall depends upon rigidity for its structural stability while a soft mortared wall depends upon flexibility.<sup>4</sup>

Inner wall construction, 18th Century bellows house wall.

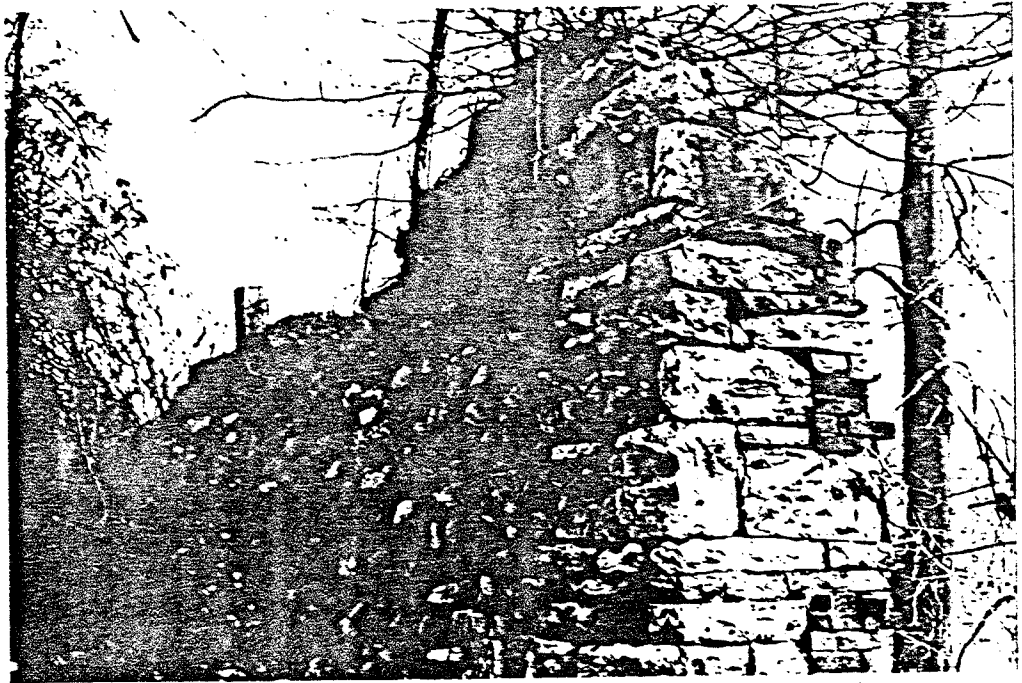
Plate 1

The wall is essentially wedge shaped in section tapering from a foundation width of approximately five feet to about two feet wide at the top. The inner surface against the earth fill is slightly more vertical than the outer surface. The wall's construction is typical for the 18th and 19th centuries consisting of a rubble interior with a dressed stone face. Long pieces of rock extend through the wall. Called tie rocks, they help to bind the wall together. One end of a tie rock might be exposed to the face and extend inward into the wall. Overlapping it is another tie rock with one end exposed to the opposite surface of the wall. These overlapping tie rocks bonded or knitted together the coursed face stones and the rubble stones of the interior and earth-faced side of the wall. (Refer plates 1,2,3,20 and appendix B, Illustrated Wall Section).

Southwest corner of engine house retaining wall.

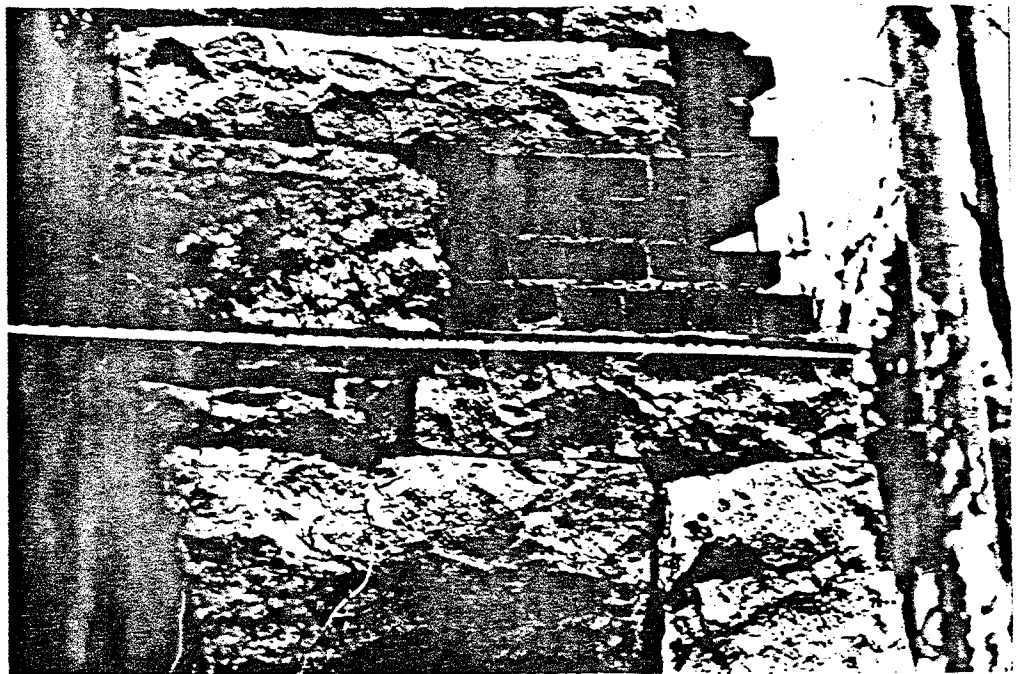
Plate 2

wall is a finished or returned edge indicating that the wall ended here as constructed. (Refer Plates 2 & 3). At the upper corner of the south end of the wall, stones have loosened and fallen away. A wooden bracing system has been constructed against the wall in an effort to help support it. The bracing was done in 1974. (Refer plates 3 & 4). Two diagonal cracks near the north end of the engine house wall occur along vertical joints of the stove to form a V-shaped weak area in the wall.

South end of engine house retaining wall.

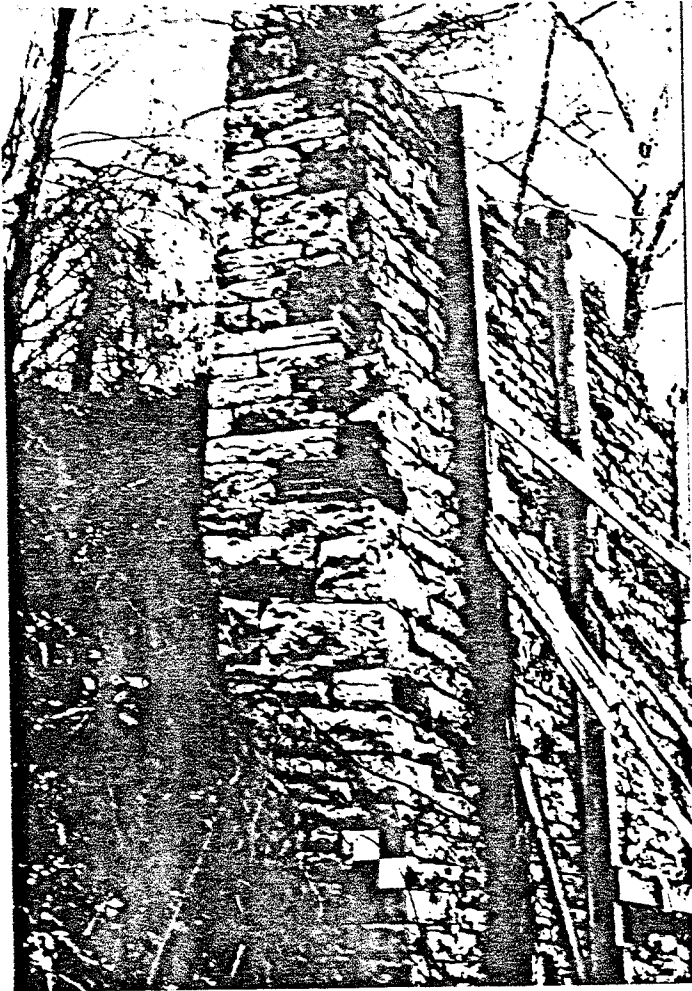
Plate 3

Southeast corner of engine house retaining wall.

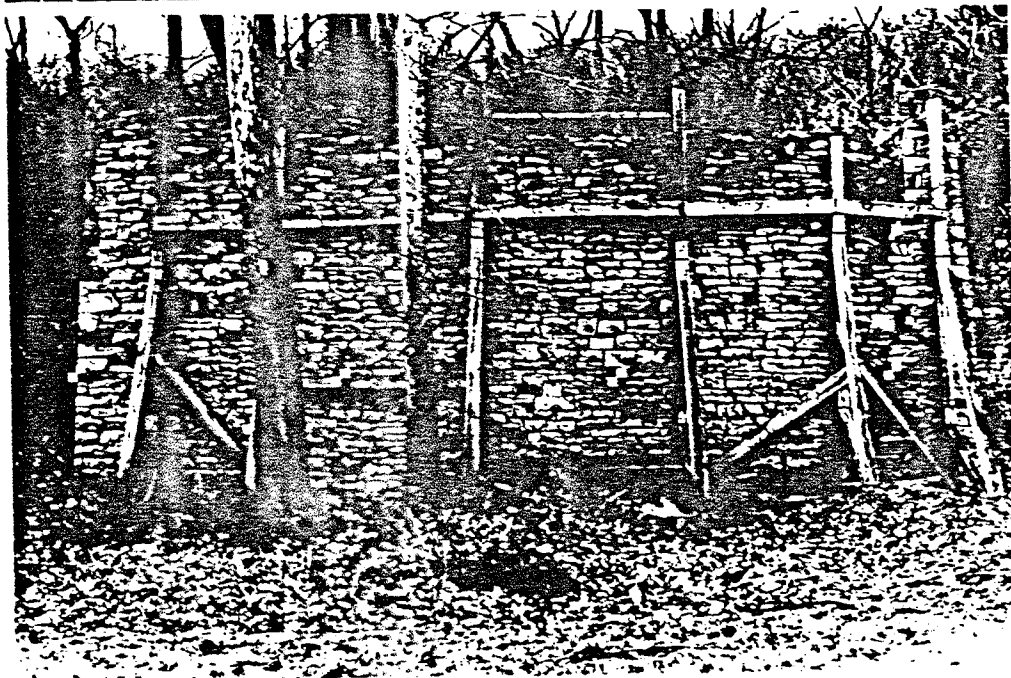
Plate 4

East face of engine house retaining wall.

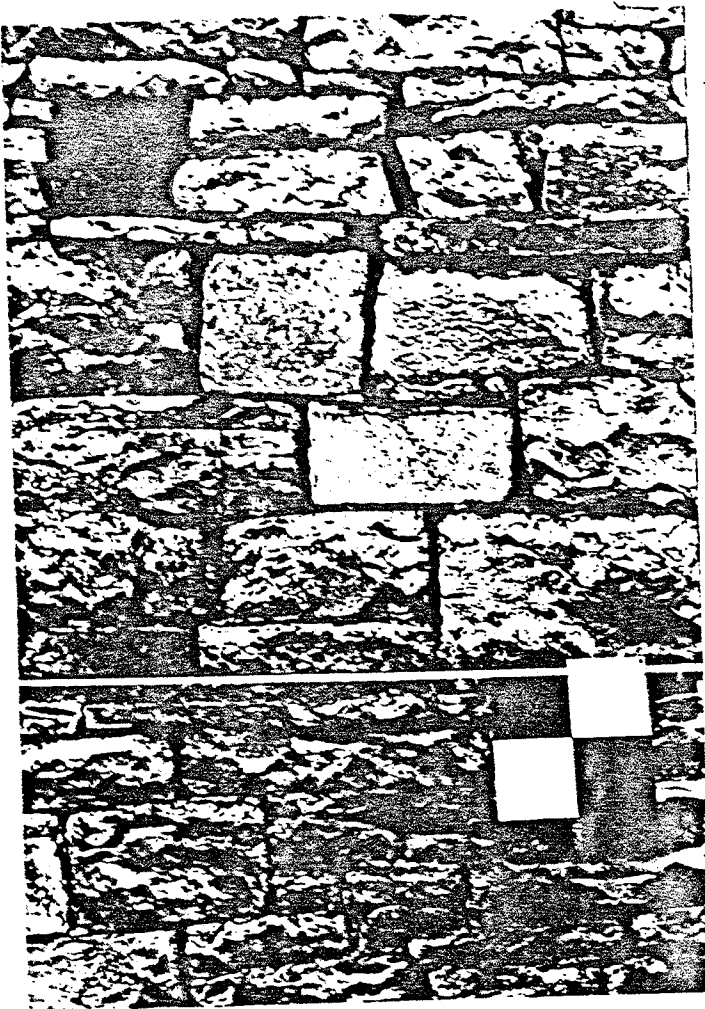
Plate 5

The fallacy of the dry-laid theory regarding the retaining wall at Catoctin Furnace probably results from the fact that the original pointing has failed, fallen away and has allowed mortar to wash out, giving the wall the appearance of being dry laid. Fortunately for researchers examining the site in 1984 for this report, small areas of lime pointing remain intact as shown in plates 5, 6, 12, & 13.

Several of the few remaining areas of intact pointing of the Catoctin retaining wall where the mortar was in good condition clearly revealed that the wall was not only fully bedded in mortar, but that the pointing made use of mortar with a high lime content and the inverted "V" technique. (Refer plates 5, 6, 12, & 13).

Pointing sample, engine  
house retaining wall.

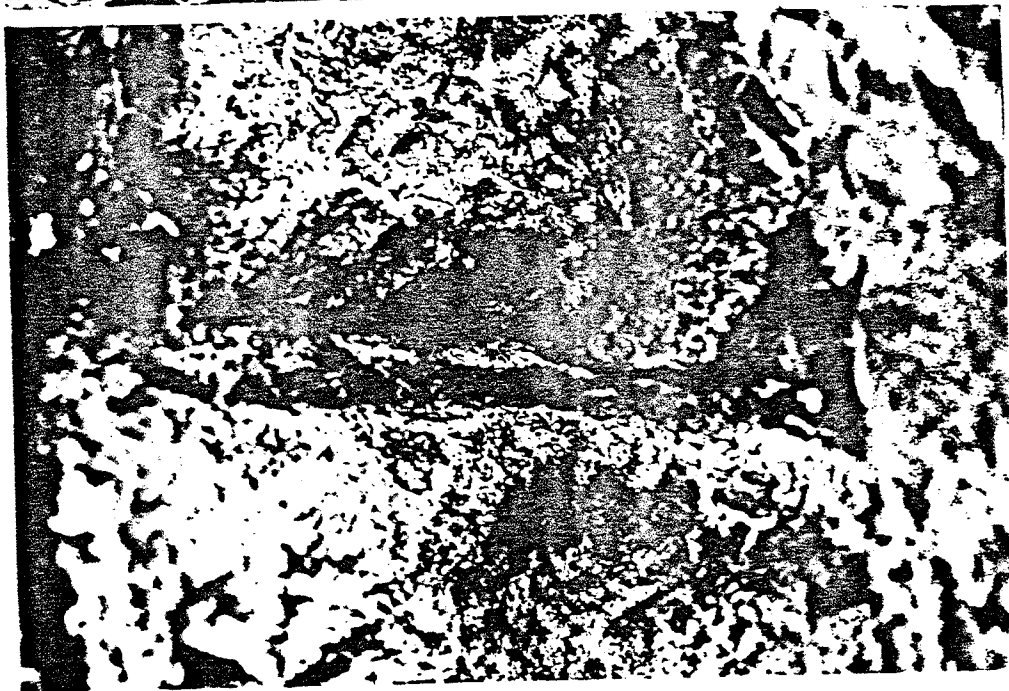
Plate 6

Pointing sample, engine house retaining wall.

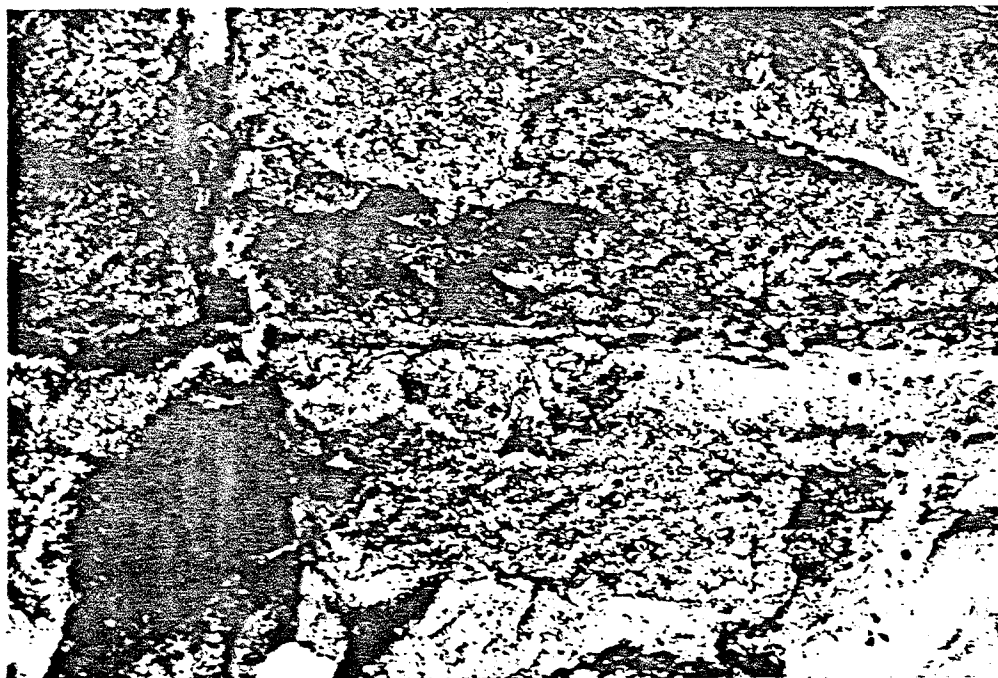
Plate 12

Pointing sample of long retaining wall.

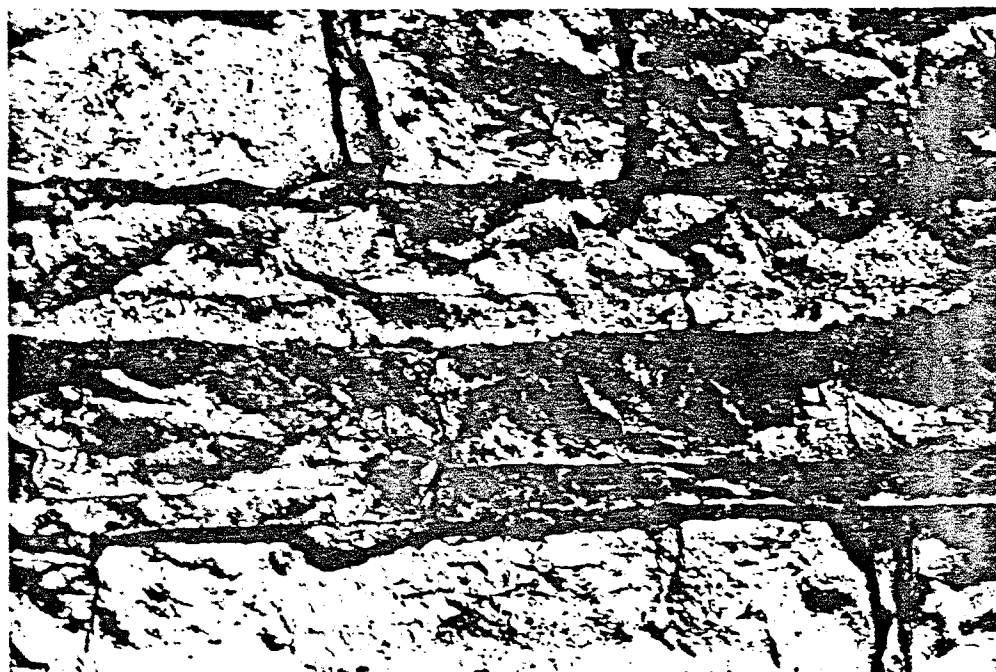
Plate 13

Pointing sample of south face of north retaining wall.

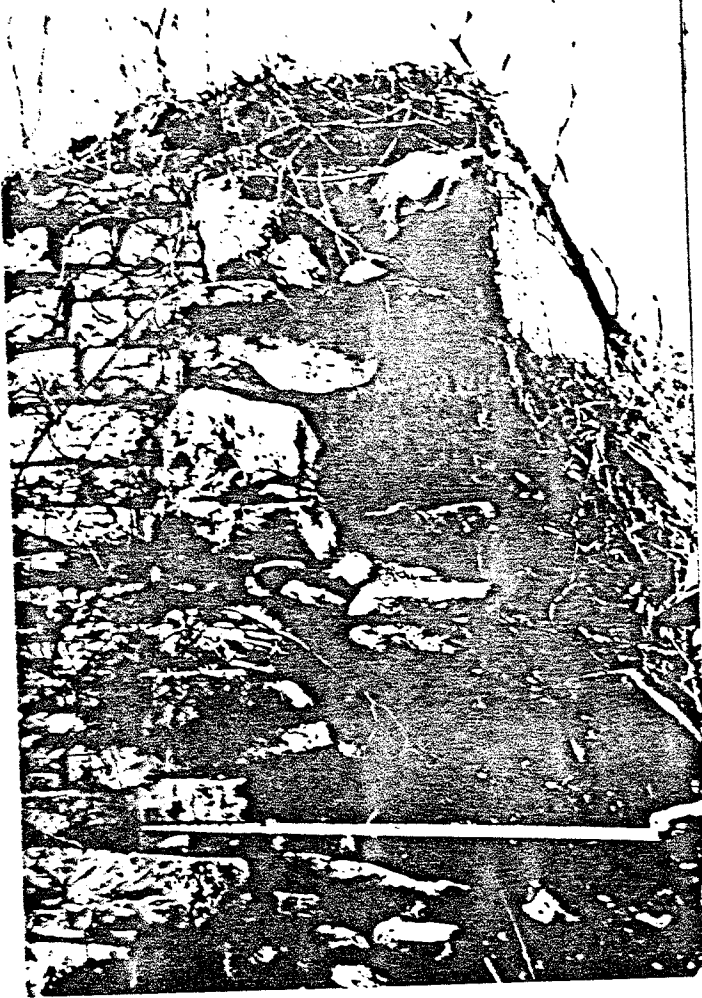
Plate 19

Earth side face of 18th  
Century bellows house  
wall.

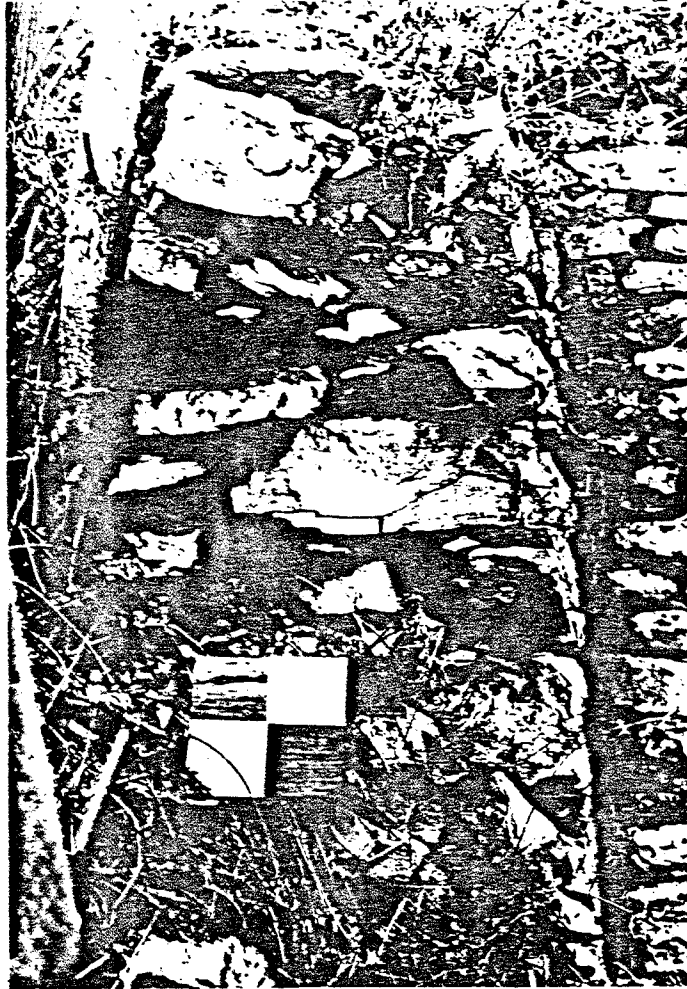
Plate 20

Inner wall construction, 18th Century  
furnace retaining wall.

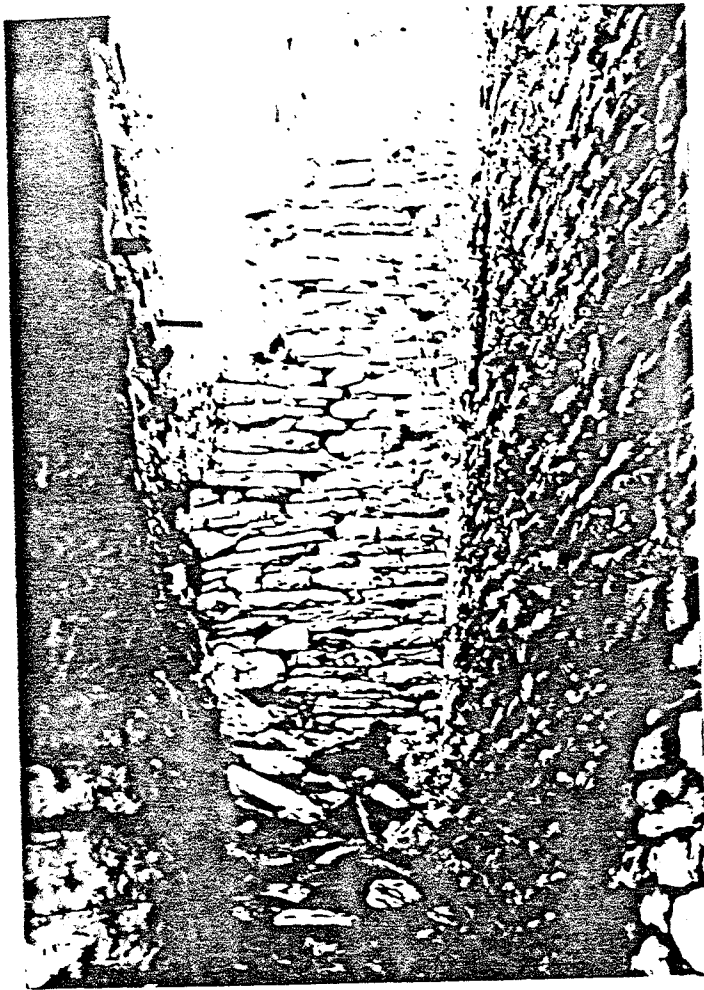
21. Northern most retaining wall (to right) and collapsed west wall, furnace stack to left.

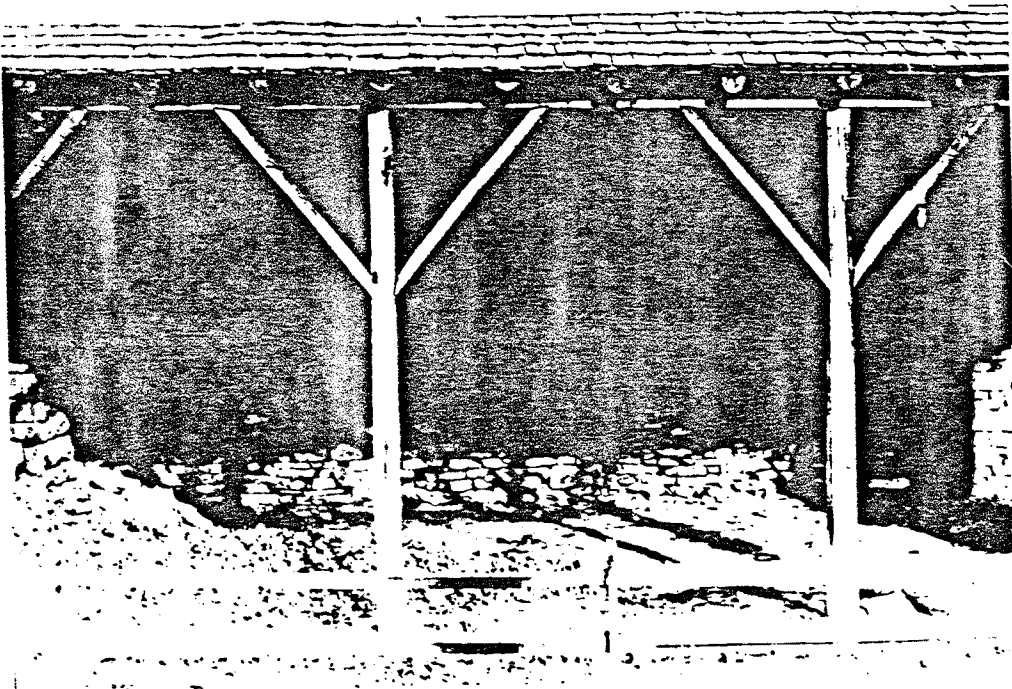
22. Reconstructed casting house and south face of the north retaining wall.

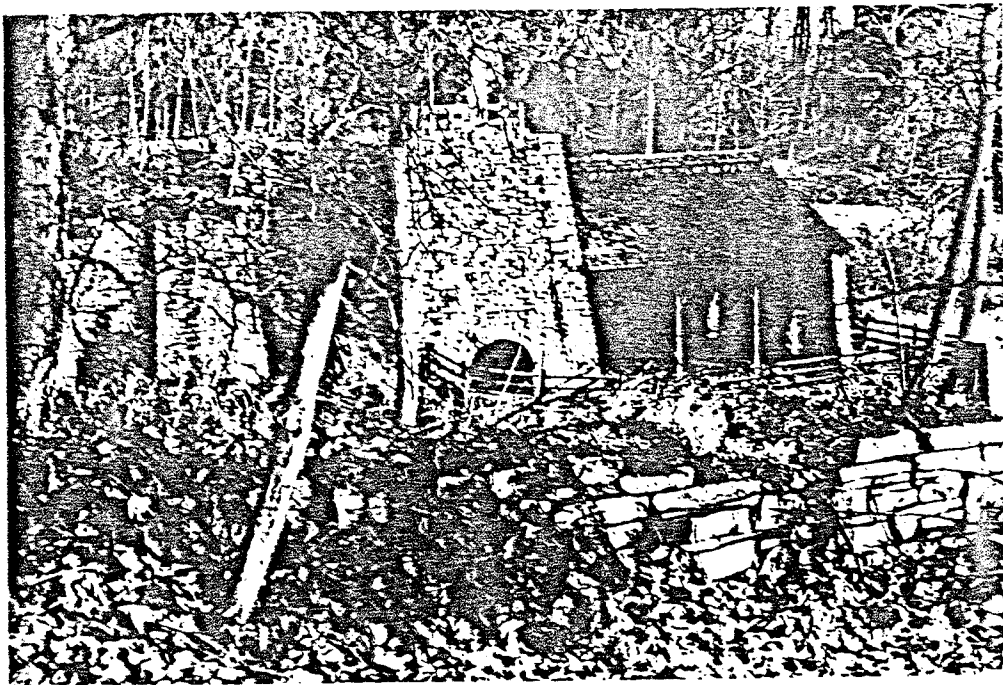
23. Northeast view of furnace, casting house and portions of the retaining wall.

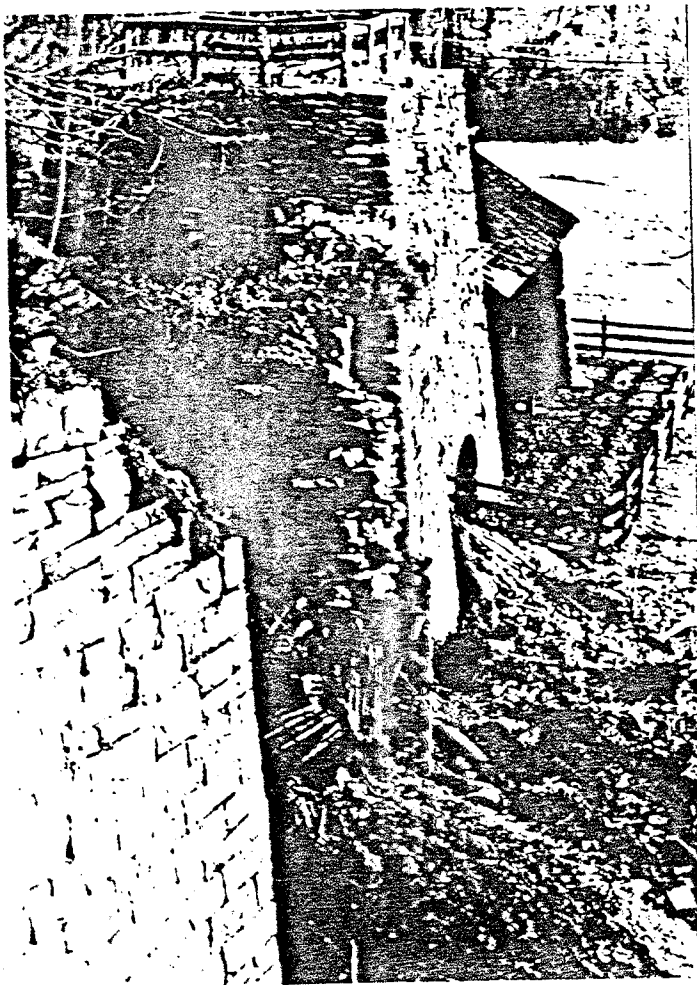
24. Northeast view of furnace, casting house and a portion of the wall.
