# Historic Structures/Cultural Landscape Report: The Carty-Miller House

12606 Catoctin Furnace Rd, Thurmont, MD

**The Catoctin Furnace Historical Society**

August 2023

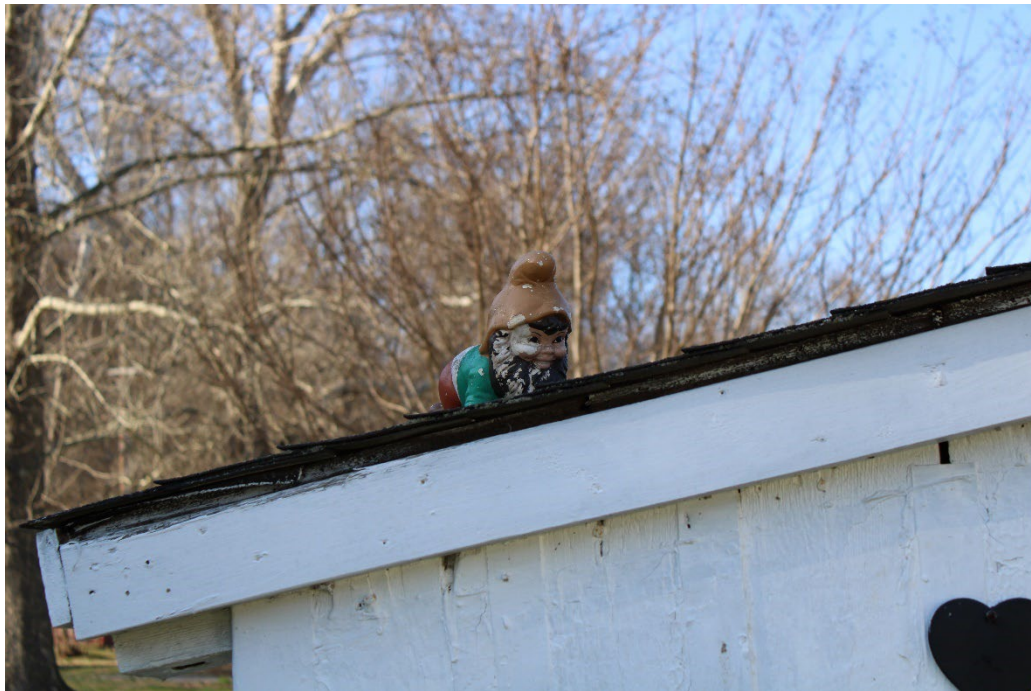
*Figure 13: The gnome on the garage roof; its chipped paint can be clearly seen.*

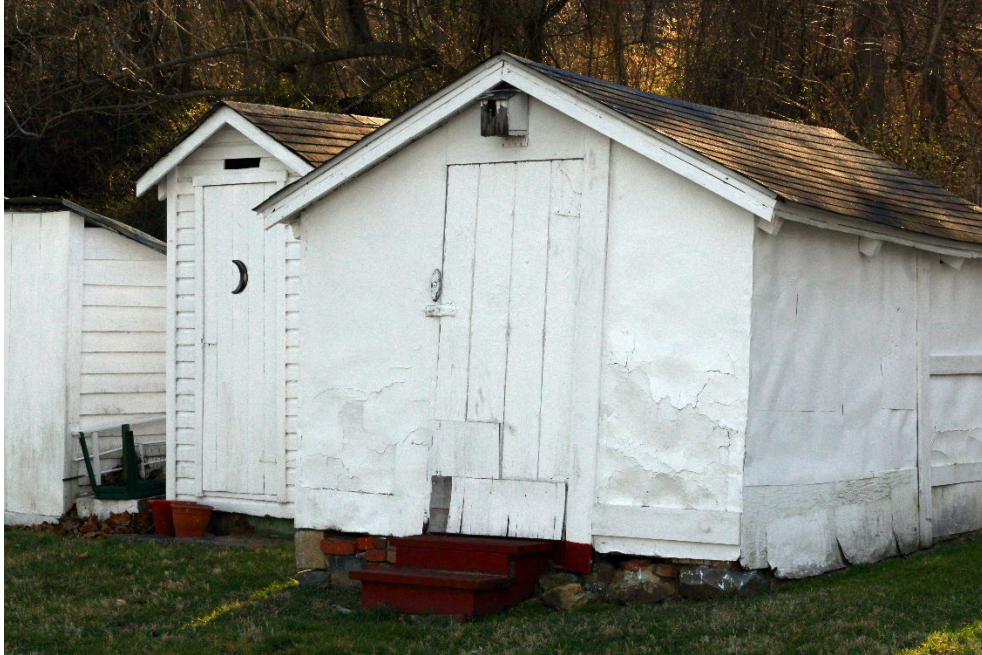
*Figure 32: Close-up of the hog pen (front) and the outhouse to the left of it, as well as the chicken coop slightly in view all the way to the left. The roof of each outbuilding can be distinguished, as can the damage to the hog pen and outhouse. The bluebird house mounted above the hog pen door can also be seen with its chipped white paint.*

recommended to organize a plan for regular lawn maintenance, and to repaint and repair the outbuildings as necessary.

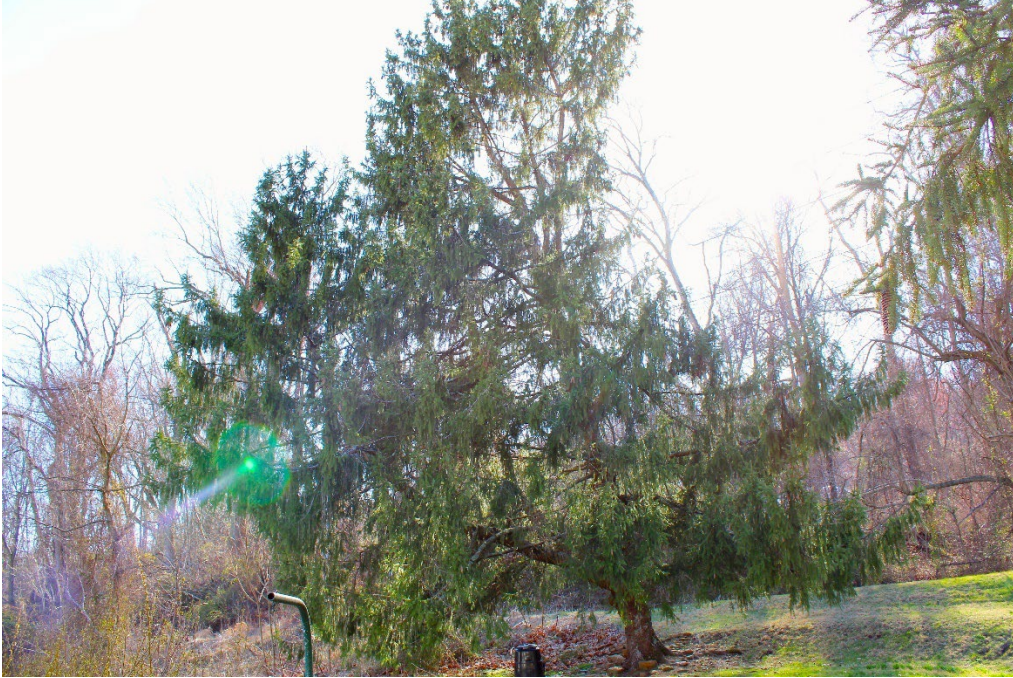
rooted into the ground, it is possible that the placement of the tree on such a steep slope could be hazardous if it were to fall, as it would almost certainly fall into the properties of 12606 and 12604 as can be estimated by the manner in which it is leaning. The plants around the yard, as well as the grass, are also currently in serious need of maintenance, as is the case with the outbuildings, particularly the outhouse and hog pen.

*Figure 34: The larger of the two pine trees, looking southwest. The tree's dramatic lean toward the properties is clearly visible. Also in view are the green metal pole near the clothesline pole at the bottom, and a branch of the smaller pine tree at the far right.*

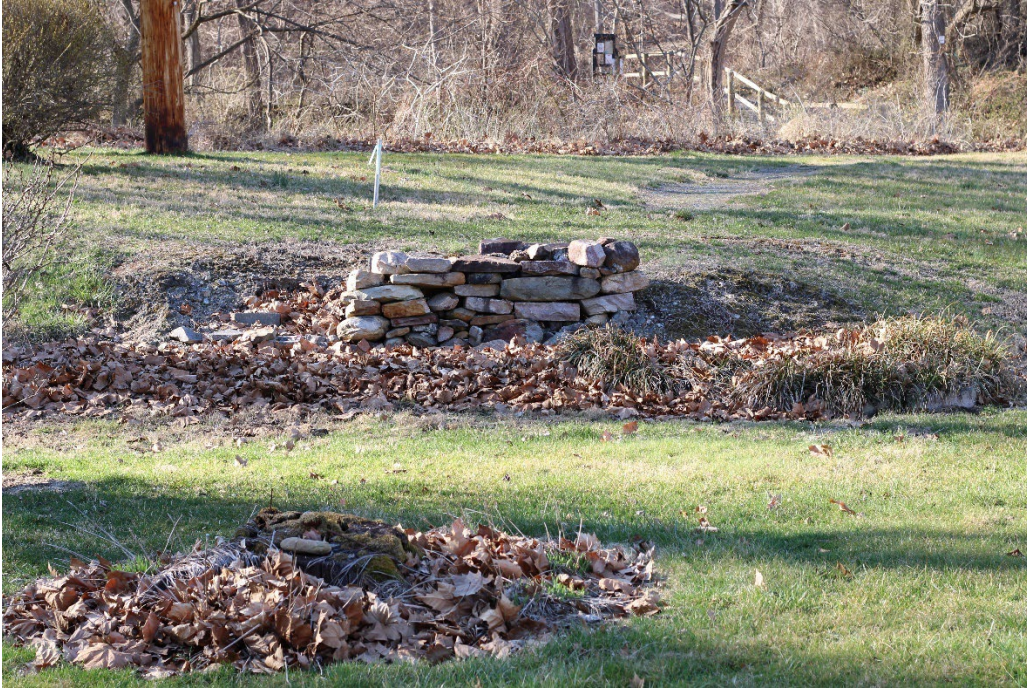
*Figure 36: The stone pile composing the paper burn pit, with its surrounding garden, which is mostly in poor condition. Closer in frame is the stump of a black walnut tree, and to the right is the “Mill Alley” right-of-way.*

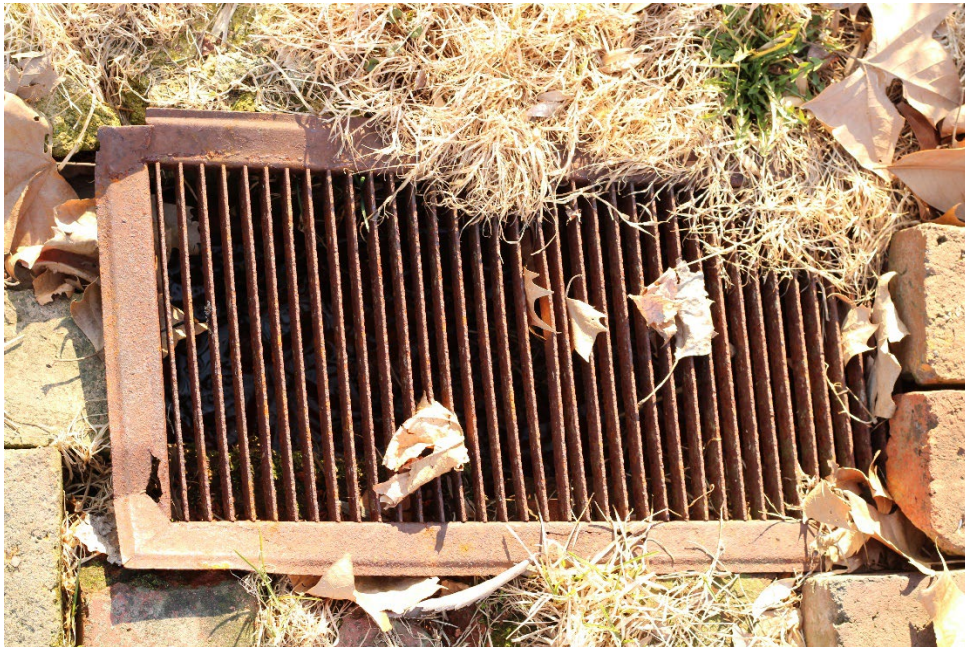
*Figure 37: Close-up view of the grate by the paper burn pit. Rainwater can be seen puddling below it.*

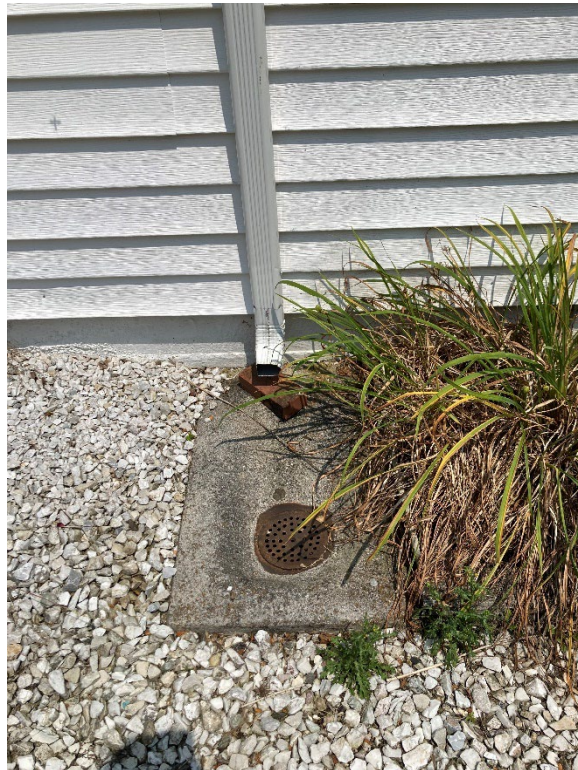
*Figure 51: The drain on the west elevation of the dwelling which directs water from the gutters into the underground pipe system connected to the underground stream. (June 28, 2023).*
