Historic Structures/Cultural Landscape Report: The Hoke House

12602 Catoctin Furnace Rd, Thurmont, MD

December 2024

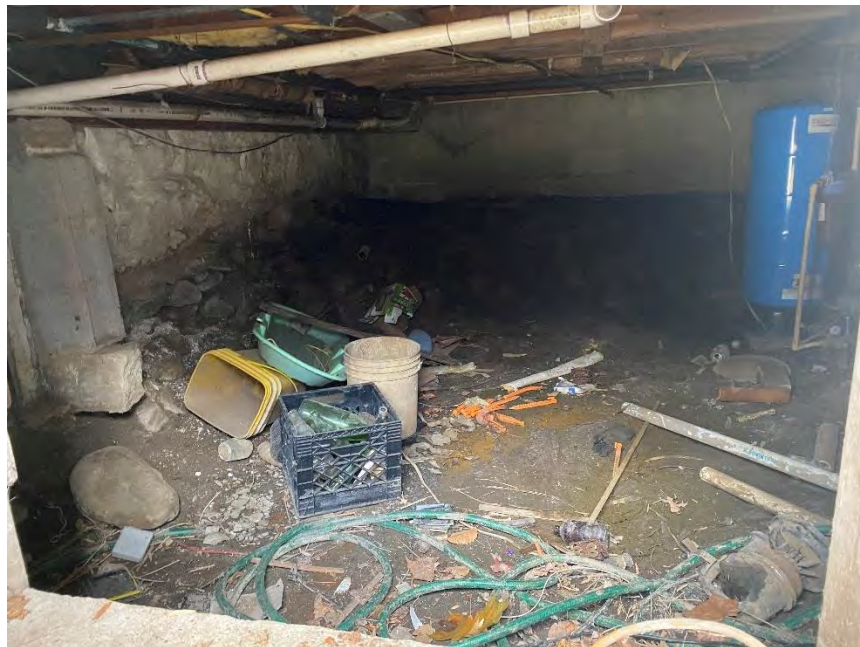
Figure 41: Shallow cellar area beneath the south addition, with a view of the CMU foundation wall and the north original stone foundation left of it. The dwelling's water tank is visible to the right. The moisture seeping out of the earthen floor of the cellar can also be seen, demonstrating the excess groundwater in the area.
