Historic Structures/Cultural Landscape Report: The Hoke House

12602 Catoctin Furnace Rd, Thurmont, MD

Tyler Wilson

December 2024

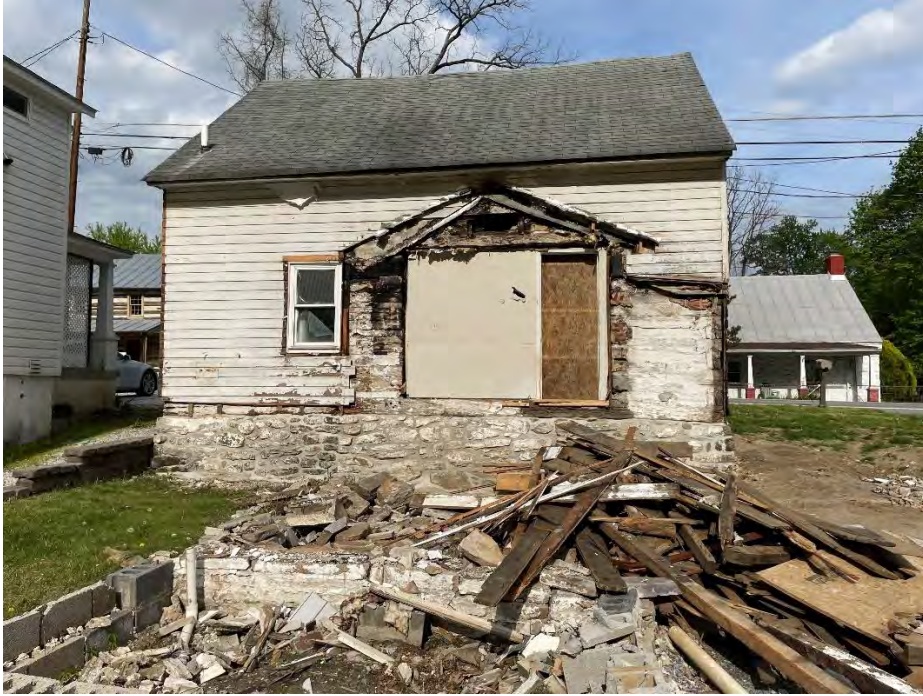
The entire west addition was removed during the 2024 excavation process. The only remnants of the additions as of July 2024 are an outline on the original dwelling's exterior where the addition connected to it, the doorway leading into the living room, and some of the brick and stone components of its foundation (*Figure 14*).

Figure 14: Post-excavation photograph of the Hoke dwelling west elevation, revealing sections of the original stone foundation and log siding. The outlines of the west addition and outdoor tool closet can both be seen on the dwelling, as well as the doorway that once connected the west addition with the main structure. The restroom window, as well as remains of the west addition's stone and brick foundation, are also extant. (25 April 2024).

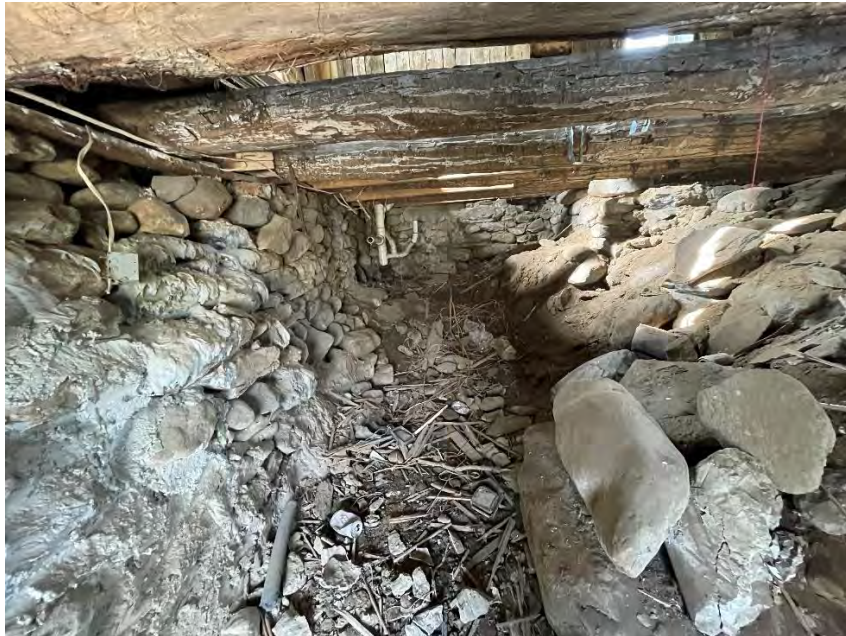
Beneath the original dwelling structure is a mostly underground crawl space area encased by the stone foundation with an earthen floor, with a clearance of four and one half feet between the ground and the first-story floor joists (*Figure 24-25*). Before the 2024 excavation and

Figure 25: Crawl space beneath the original dwelling post-excavation. The original log floor joists and stone foundation walls are all in full view. The stone wall blocking access to the eastern portion of the crawl space can also be seen to the right, rising from the ground to the floor joists. (25 April 2024).

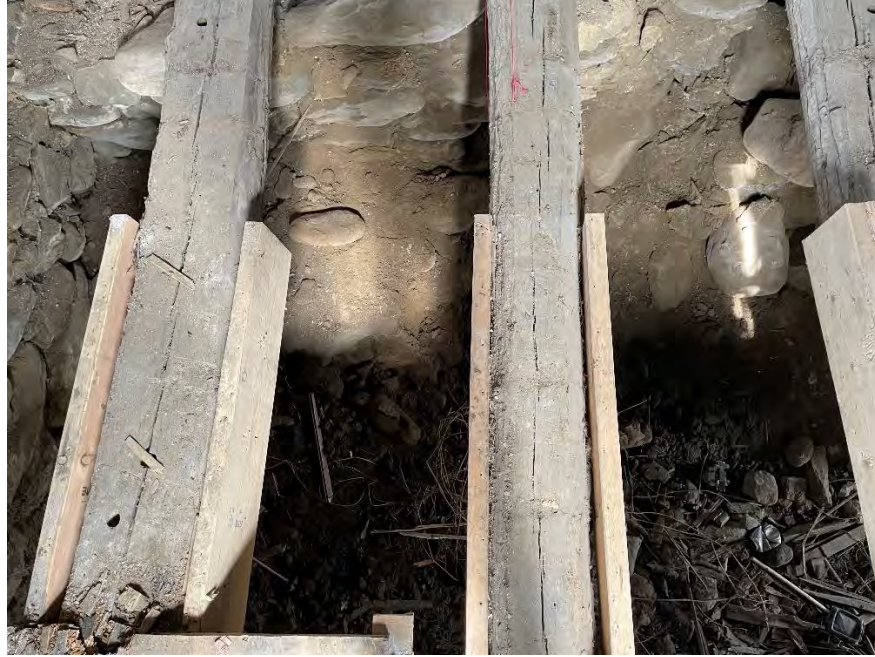
Figure 28: Nonoriginal wood support blocks attached to the original log floor joists on the west elevation of the main dwelling structure. (25 April 2024).

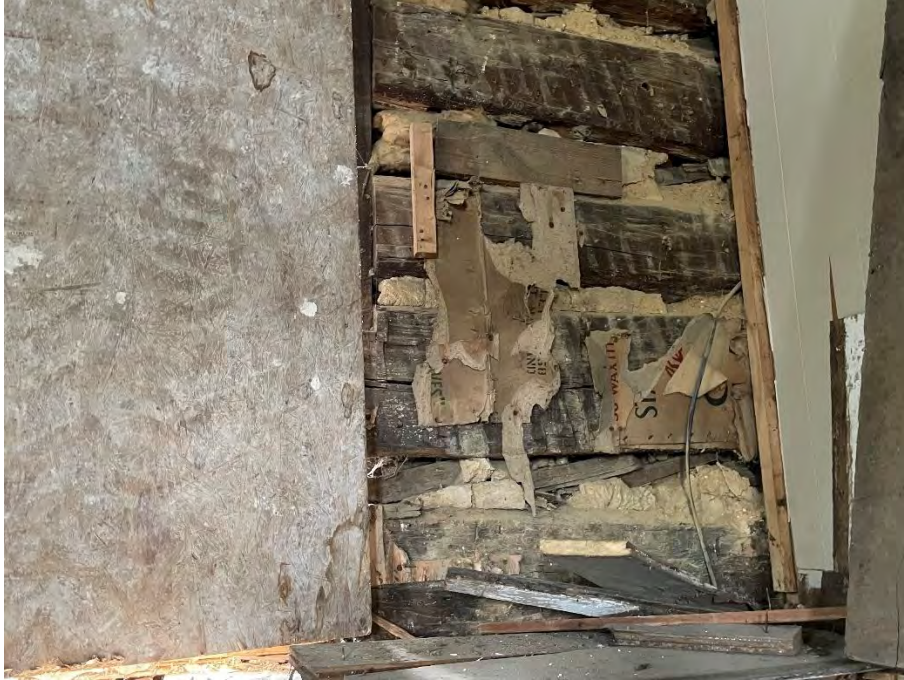
Figure 30: Interior remnants of poster paper used as insulation attached to the original log wall in the southwest corner of the dwelling structure. The chinking (sealant material used to fill gaps between logs in log buildings) between the logs is also visible. (25 April 2024).

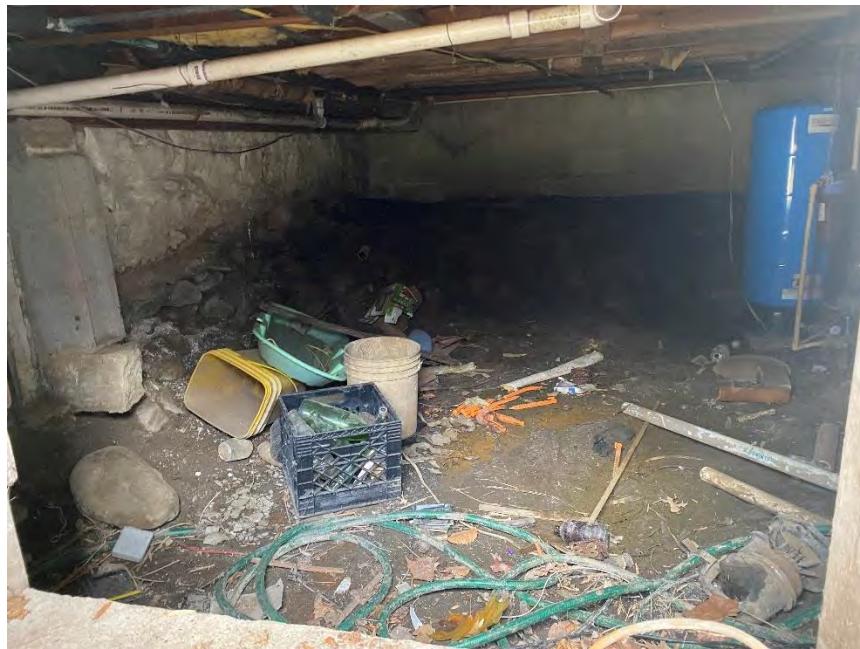
Figure 41: Shallow cellar area beneath the south addition, with a view of the CMU foundation wall and the north original stone foundation left of it. The dwelling's water tank is visible to the right. The moisture seeping out of the earthen floor of the cellar can also be seen, demonstrating the excess groundwater in the area.

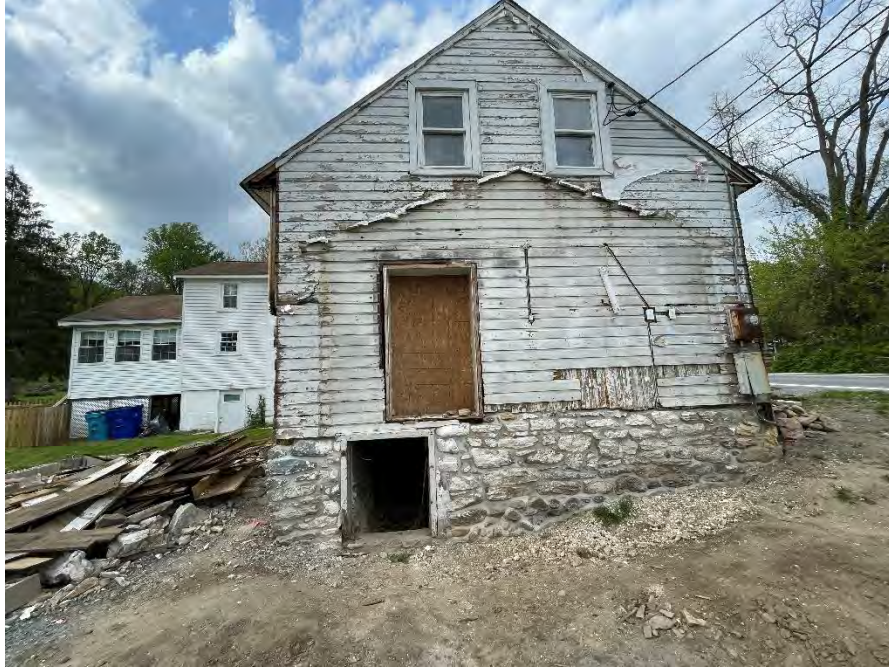
Like the west addition, the entire south addition, including the cellar, was removed during the excavation process. The only features remaining from it as of July 2024 are a depression in the ground, an outline of its roof and walls on the original dwelling's southern exterior, several electrical outlets and light switches, and the cased opening that connected it to the living room (*Figure 42*). Excavation has also uncovered a large portion of the main dwelling structure's original stone foundation, as well as the previous Dutch lap siding and original wood vertical board siding on the south elevation (*Figure 42*).

Figure 42: South elevation of the dwelling post-excavation, showing the outline where the south addition was once located, the cased opening connecting it to the original structure, and the entrance to the crawl space beneath it, which used to be in the south addition cellar. Excavation has revealed much more of the original stone foundation, as well as remnants of the previous wood Dutch lap siding and original vertical board siding right of the cased opening. (25 April 2024).

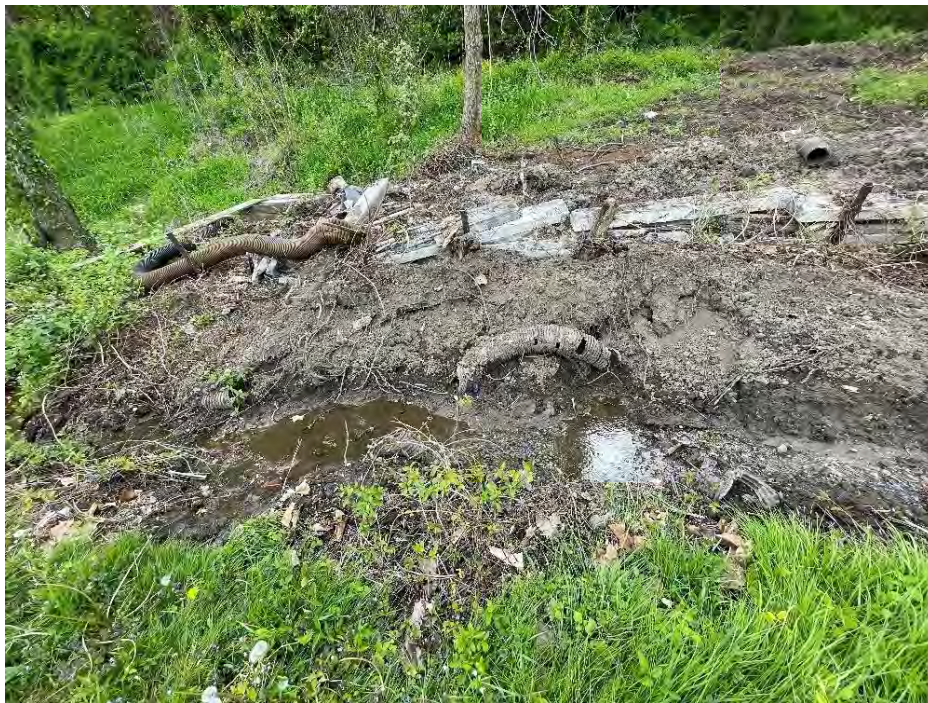
Figure 49: Section of the trolley bed hill post-excavation. Most of the brush has been removed, revealing the concrete slab wall and the disarticulated plastic culvert pipes. Flowing along the hill is water from the rusted grate in the Carty-Miller rear yard, which was temporarily uncovered when the stream pipe was ruptured in 2024. (25 April 2024).

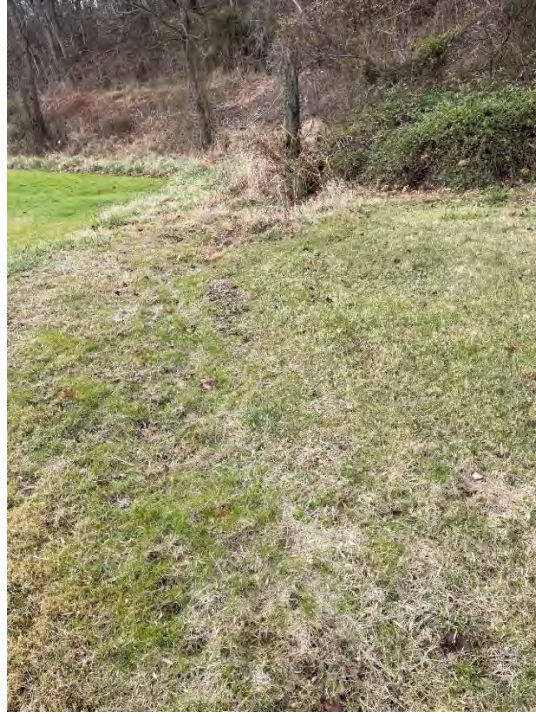
Figure 52: Largely deteriorated section of the former ditch stream from the middle rear yard until it disappears in the brush along the trolley bed hill.

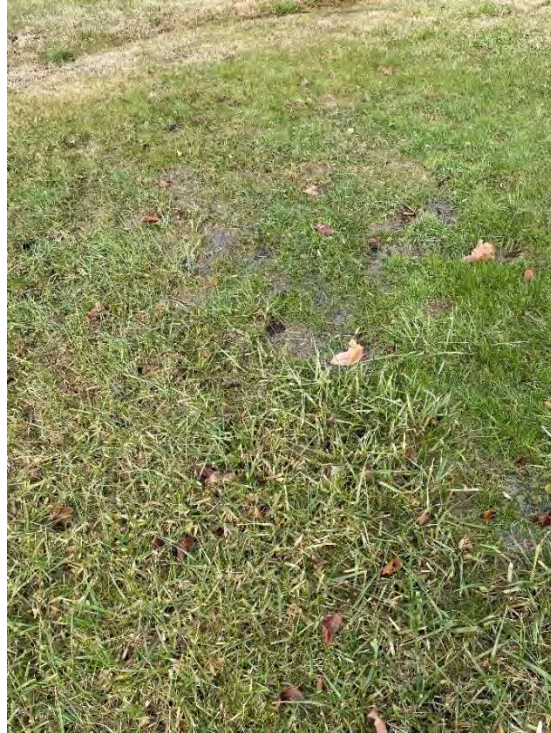
Before the damaged underground stream pipe was repaired in June 2024, there was noticeable oversaturation of the ground throughout the Hoke rear yard, especially near the former ditch stream. This saturation was severe enough that water would seep out of the ground, and it would easily sink when walked on (*Figure 56*). However, the oversaturation of the ground seems to have been greatly reduced since the pipe was repaired.

Figure 56: Inundated ground in the Hoke rear yard before any of the excavations or repairs in 2024.

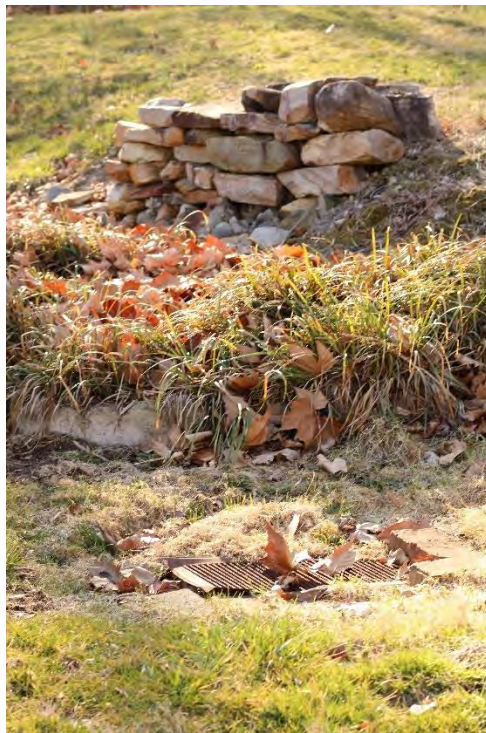
There is also a rusted grate on the northwest corner of the Carty-Miller property at 12606 (*Figure 57*), which was installed to control the ground seepage of water from the spring that flowed under the trolley bed hill. Around the time the stream in the rear yards north of 12604 was run underground through a culvert in 1963, Clint Miller – then the owner of 12606 – ran a narrow length of pipe underneath the grate to connect to the culvert in his rear yard. Later in the early 2000s, Joann Miller rerouted the water entering the grate underground through an entirely separate length of narrow PVC pipe that extended south from the grate and connected to the stream in the Hoke property near the foot of the hill. A significant portion of the ground at the base of the trolley bed was dug out as a result of the 2024 excavation (*Figure 49, Figure 58*). This exposed the water flow from the rusted grate, and could be seen along the western edge of the Hoke property until it was reburied with new pipe in summer 2024.

Figure 57: Rusted grate in the Carty-Miller rear yard. (5 March 2023).

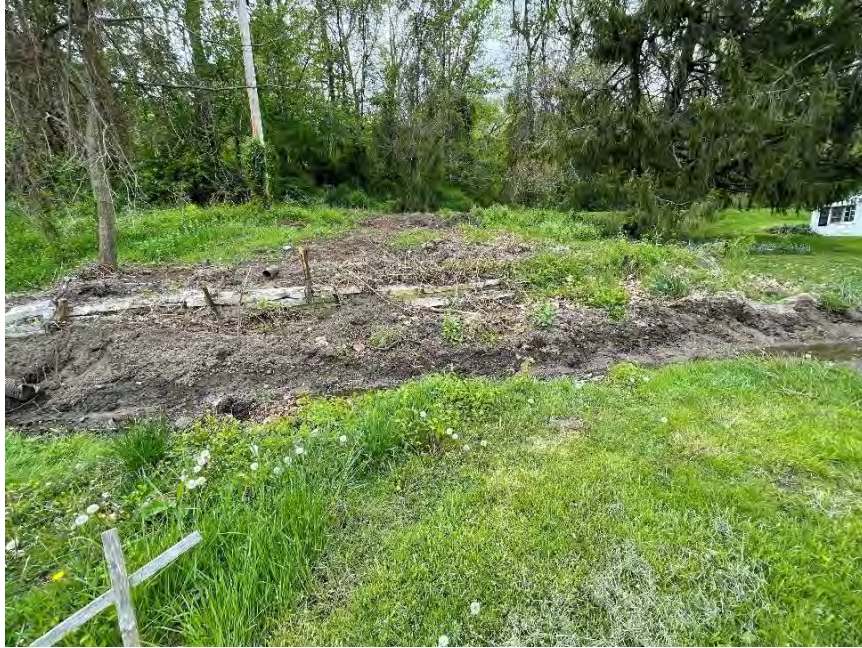
Figure 58: Trolley bed hill in the Hoke rear yard post-excitation. The concrete slab wall, waterflow from the rusted grate, disarticulated culvert pipes, and then extant cross are all visible. (25 April 2024).

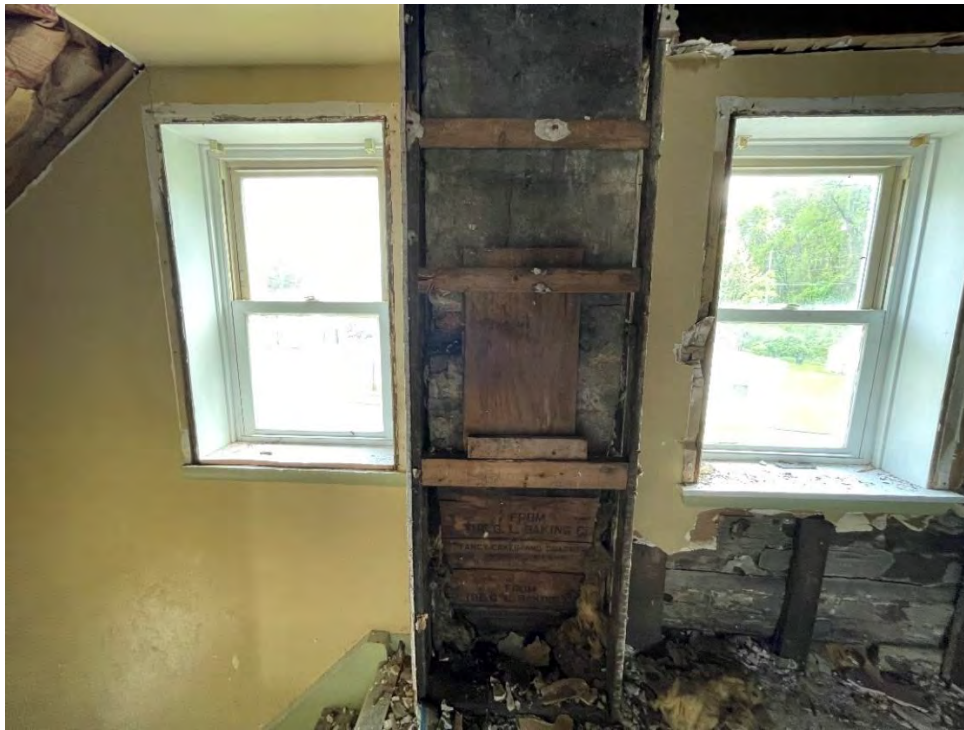
In the process of the previously referenced 2024 excavation and restoration, the bump-out on the second story was found to contain bricks stacked above fragments taken from two wooden crates (*Figure 69-71*). The bricks are remains of a chimney stack arising from what was once a large stone hearth in the living room that was original to the dwelling (*Figure 64*). Also revealed during excavation was the large stone base of this hearth in the original structure's crawl space (*Figure 29, Figure 72*). The Smith/Hoke family were unaware of the hearth base during their residence, but they did learn of the encased section of the chimney stack while they were widening the kitchen entrance in 2006, during which the stack was exposed from underneath. However, neither of these features were known by CFHS to still exist in the dwelling before the excavation revealed them, as the chimney was covered by the wall bump out, and the hearth base was difficult to differentiate from the surrounding stone foundation until it could be seen from above (*Figure 72-74*). The section of chimney above the roofline was removed when new asphalt shingles were placed on the roof between 1985 and 1990, while the Millers likely removed the first-floor portion of the hearth and chimney when they were building the south addition of the dwelling around 1941. The remaining portions on the second floor and in the crawl space, however, were left alone over the years because they did not cause any problems that would warrant removing them.

Figure 69: Post-excavation image of the stone brick chimney stack and two crates that were concealed behind the second-story bump out. (25 April 2024).

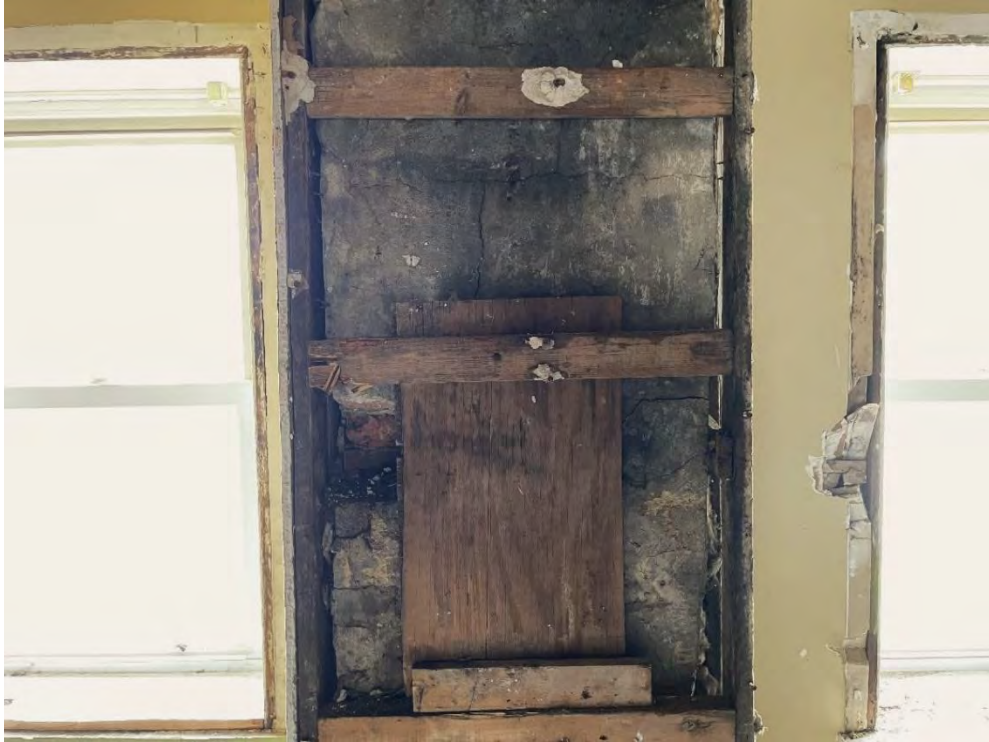
Figure 70: Remains of the chimney stack behind the second-story bump out, supported by wood boards. (25 April 2024).

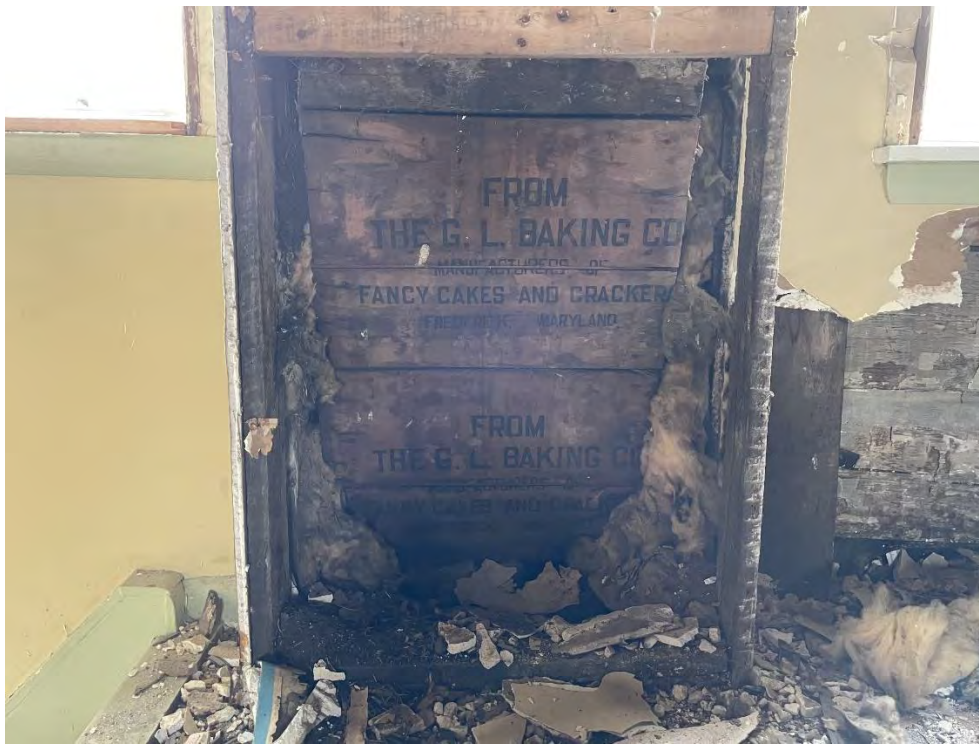
The sections of the two wooden crates beneath the chimney stack each read "FROM THE G.L. BAKING CO. MANUFACTURERS OF FANCY CAKES AND CRACKERS FREDERICK, MARYLAND" (*Figure 71*). As the text may suggest, the G.L. Baking Company was a baked goods company, and it was based at 125 South Carroll Street in Frederick, Maryland. The company was founded around 1909, and while it primarily produced cookies, cakes, and crackers to sell to local businesses and individual customers, it also produced hardtack to ship to American soldiers during World War I as part of a government contract. While the exact origin of the G.L. Baking Company crates in the Hoke dwelling is unknown, they may have been spare crates the company had made for packing and delivering baked goods that a member of the Miller family happened to have access to. The reason for the crates' placement at the base of the chimney stack is similarly uncertain, although it may have been to act as a support between the remaining portion of the chimney and the second-story floor.

Figure 71: Crate fragments wedged beneath the chimney stack. The words “FROM THE G.L. BAKING CO. MANUFACTURERS OF FANCY CAKES AND CRACKERS FREDERICK, MARYLAND” can be seen on both crates. (25 April 2024).

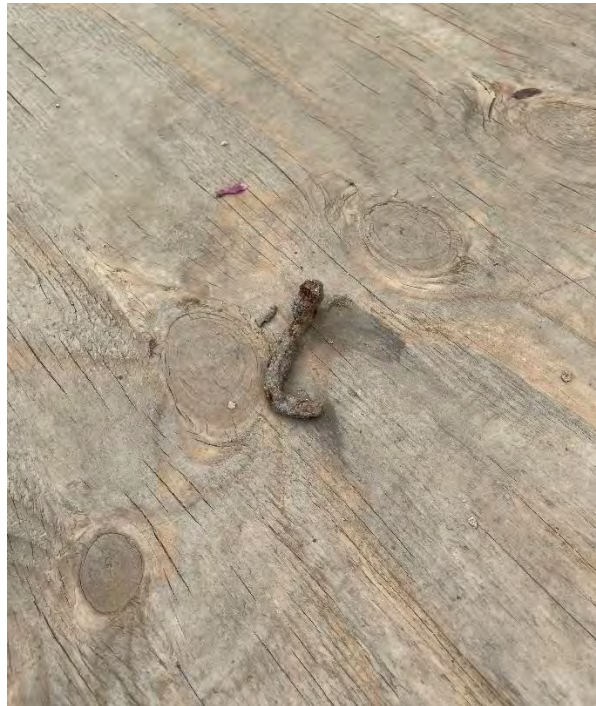
Figure 79: Heavily rusted hook found a short distance in front of the dwelling. (25 April 2024).
