Historic Paint Finishes Study:

Two samples from the Interior of the Forgemaster's House  
Catoctin Furnace, Maryland

Date: 29 January 2015

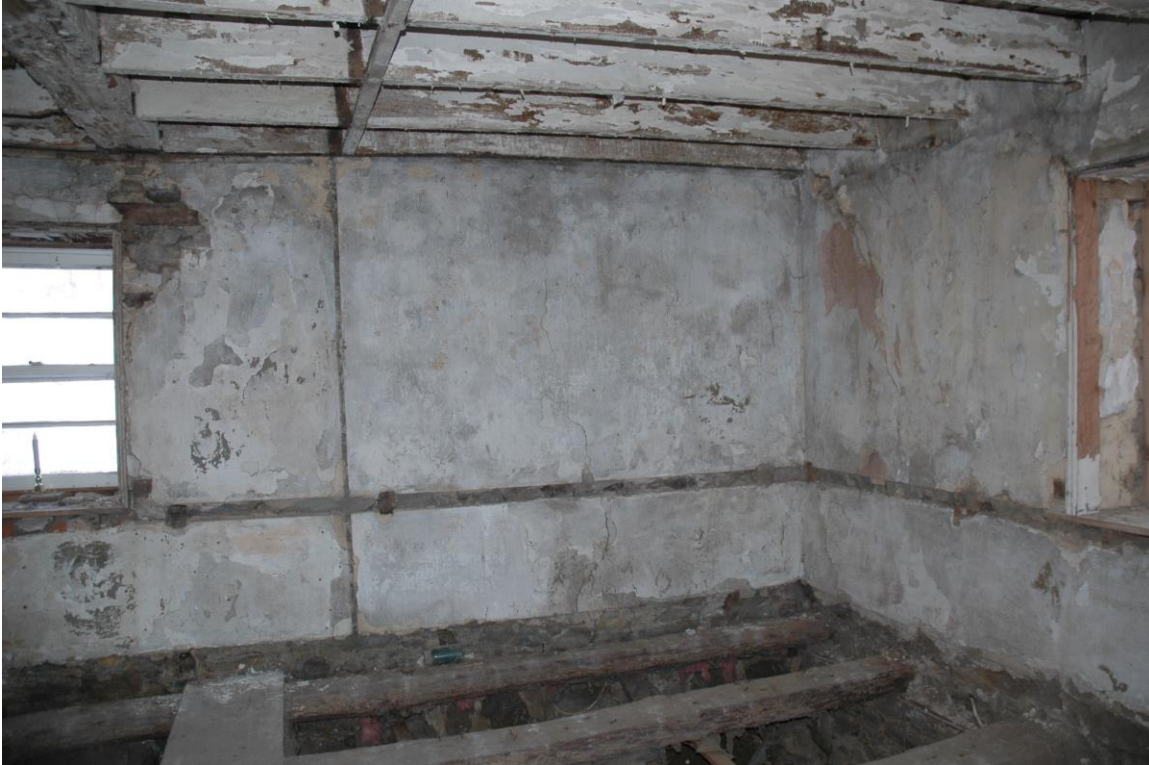
View of the interior, first floor, Forgeman's House. Note the ghosting of the chair rail, baseboard and board wall.

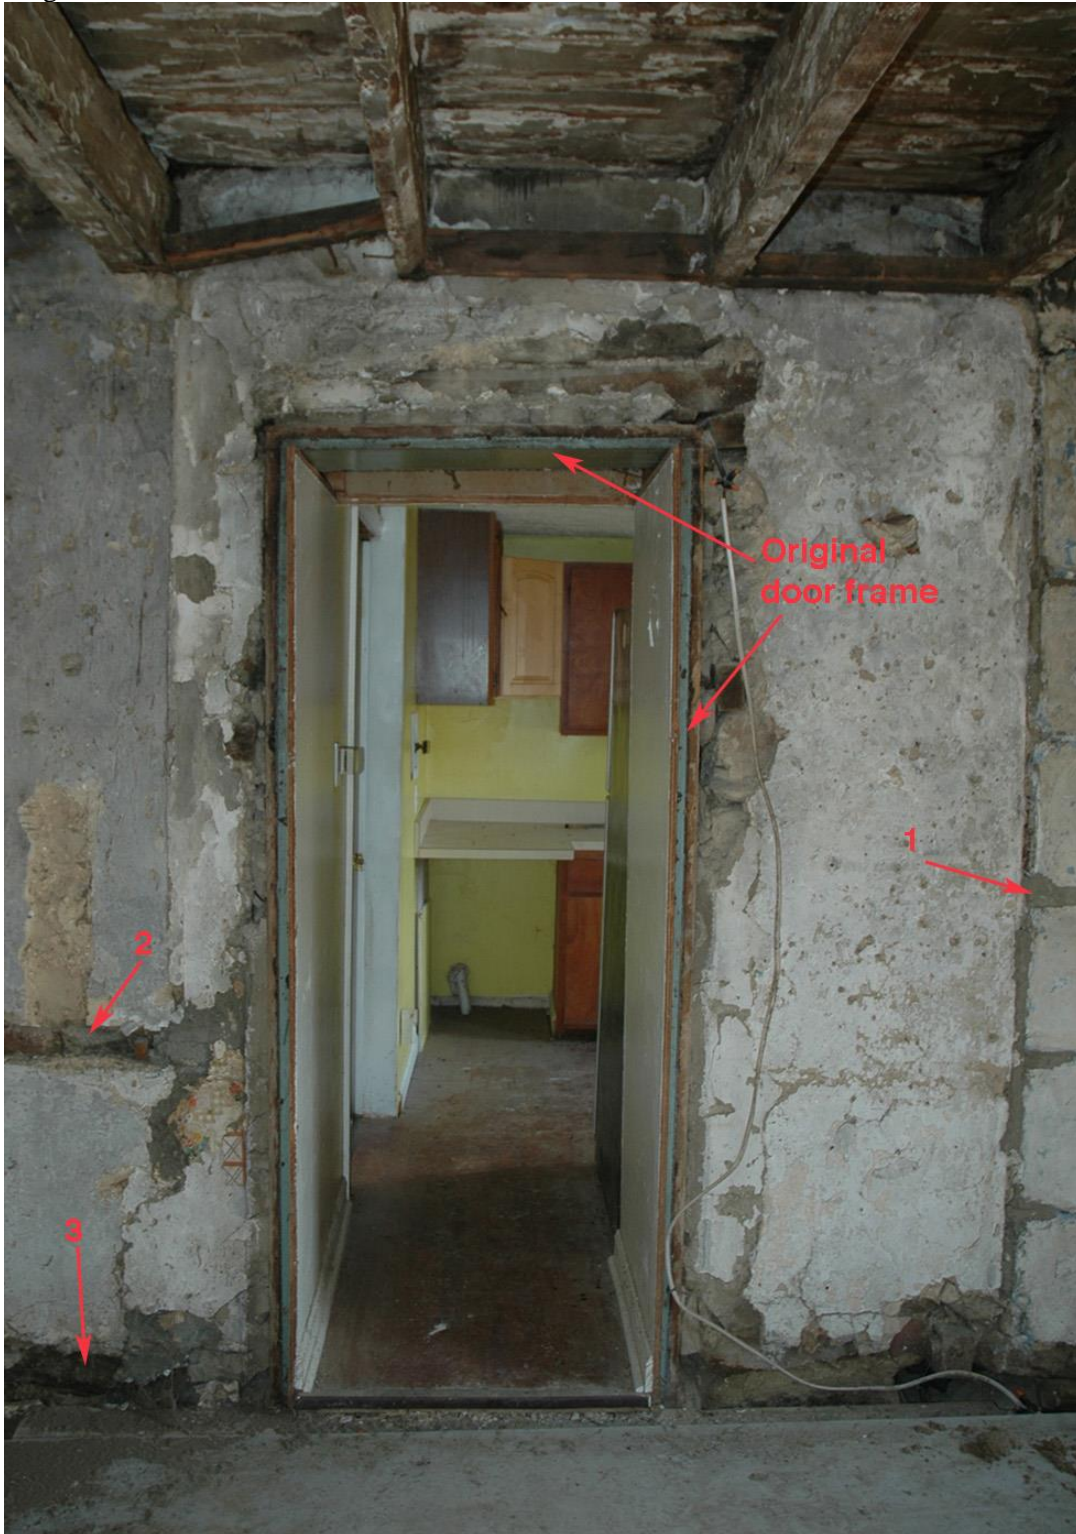
Original Door frame:

Note: The original door frame, which has been overpainted several times is seen in place, painted a blue-green enamel from the late nineteenth or early twentieth century. Note the ghost marks of the woodwork: 1: shelving, 2: chair rail 3: baseboard.

There are two finishes that survive in the Forgerman's House: a black oil based paint and the lime white wash. The black oil based paint finish was probably used on the following:

- Chair rails
- Baseboards
- Door frames (as in the case of the surviving example)
- Doors
- Window frames
- Window sash

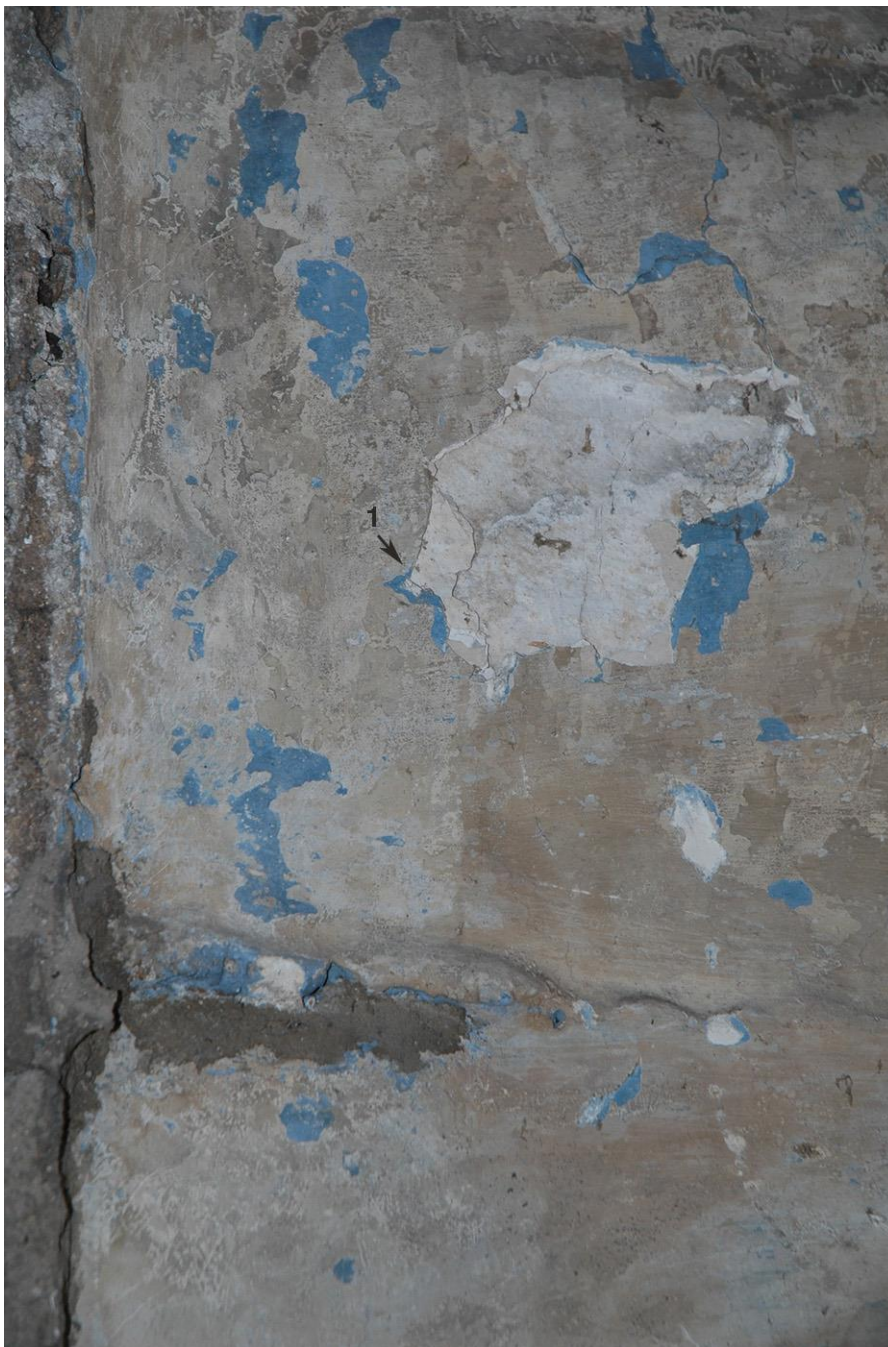
The plaster was painted repeatedly with lime white wash and later in the history of the house, a blue distemper finish was applied. This blue finish was probably applied in the early twentieth century.

Note the lime whitewash layers and the prominent blue water bound finish followed by additional lime wash coatings.

The sample collected for examination was taken at location 1.
