PRESENT CONDITIONS OF CATOCTIN FURNACE COMPLEX

THE SIGNIFICANCE OF THE CATOCTIN IRON FURNACE COMPLEX

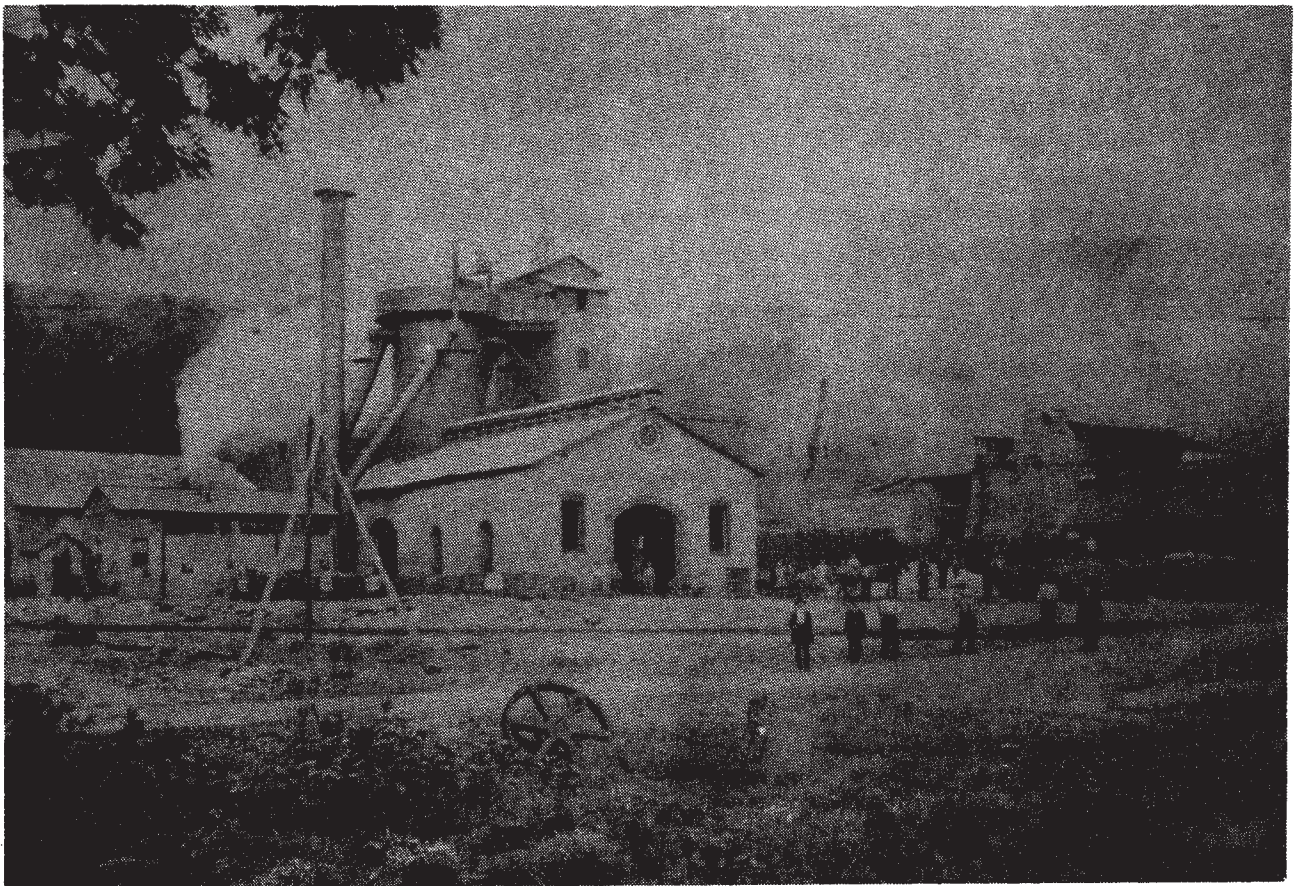
PLATE 1a

PLATE 1A:

A view, looking west, of Catoctin Furnace Stack #3, with cylindrical stack. To the right of the stack is the elevator which raised the ore to be dumped into the stack. To the left of the stack are the hot-air and engine buildings. The large shed in the foreground is the casting house. In front of the casting house are the Monocacy Valley Railroad tracks dating the picture as having been taken post-1886. On the extreme right is the Catoctin Furnace Stack #2 (Isabella), a charcoal furnace with its furnace bank, bridge, and charcoal shed apparently intact and operable. The fact that Stack #2 sat idle from 1893 to 1899 suggests that the photo was taken pre-1893.

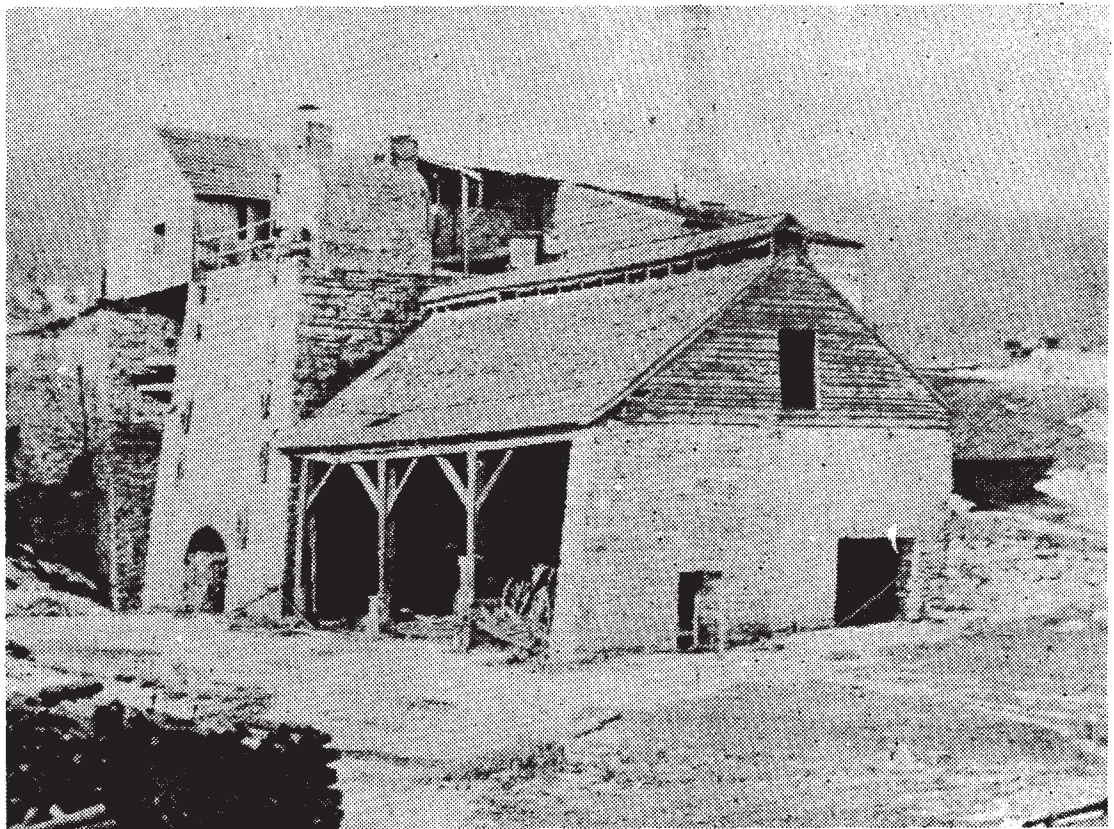
PLATE 1b

PLATE 1B:

A view looking northwest of the Isabella Furnace Stack. The stone furnace bank begins at the left rear and continues to the west of the stack, showing the bridge and charcoal shed directly north of the furnace stack. The large shed attached to the east face of the stack is the casting house. The Furnace Stack appears to be intact though not in operation, and we conjecture the photograph to be ca. 1893 - 1899.

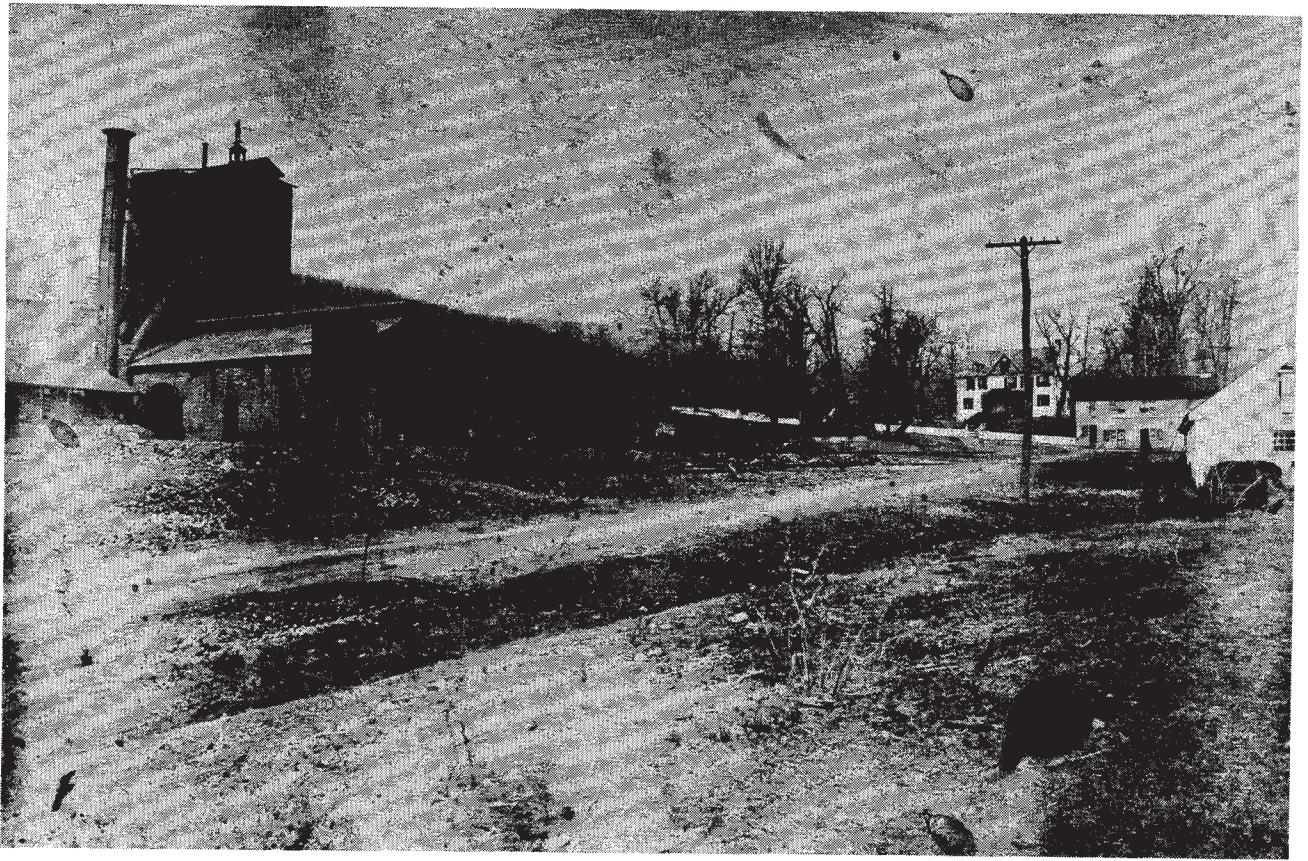
PLATE 2a

PLATE 2a:

A view, looking northwest, of the Catoctin Furnace Stack #3 and the surrounding area. The shed to the left-hand side of the picture in front of the cylindrical stack housed the steam engine. Note the extension of the shed roof and its support by wooden posts. Just to the right of the steam engine shed is a water tower that appears to be partially dismantled and was probably used by the railroad. Behind the water tower is the large casting house to Stack #3. In the center of the photograph, behind the telephone pole, is the iron master's house with dormers and pediment; to the right of that structure is the company store and offices. A small building in the far right-hand side of the photograph is the remains of a horse stable and blacksmith shop. In the foreground is the road identified as the Old Frederick-Emmitsburg Turnpike. The photograph appears to have been taken ca. 1903-05.

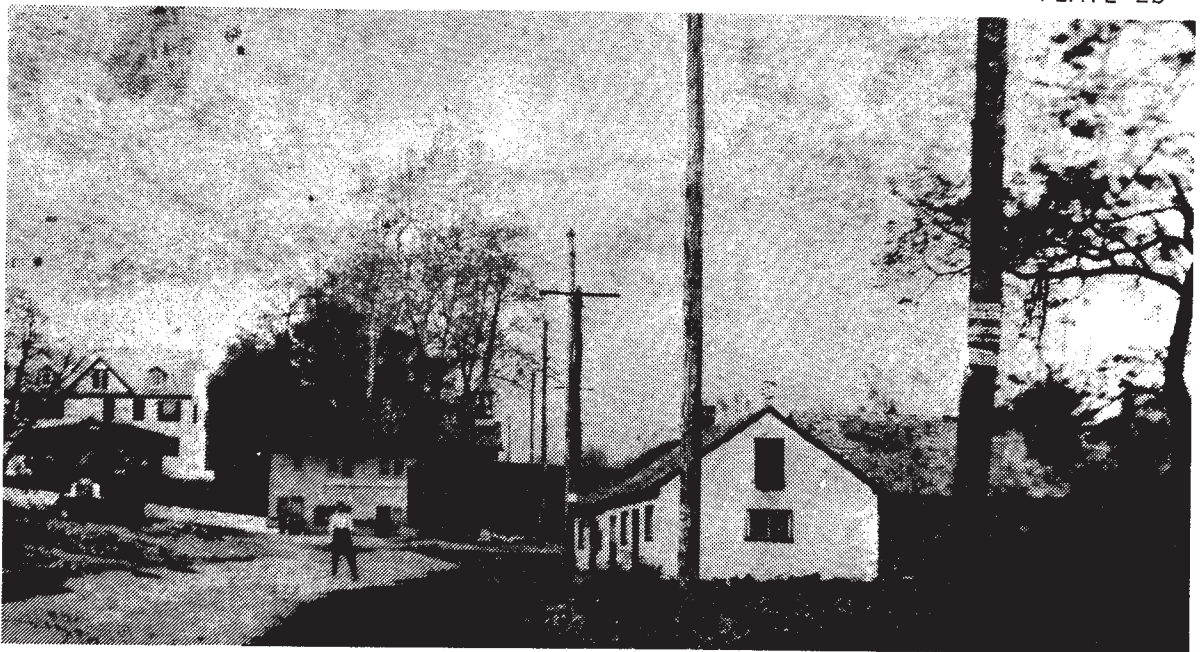
PLATE 2b

PLATE 2b:

A close-up of the above photograph, looking north, on axis with the Frederick-Emmitsburg Turnpike. The sign on the company store reads "Blue Mountain Iron and Steel Company." The additional telephone poles suggest a post-1910 date for the photograph.

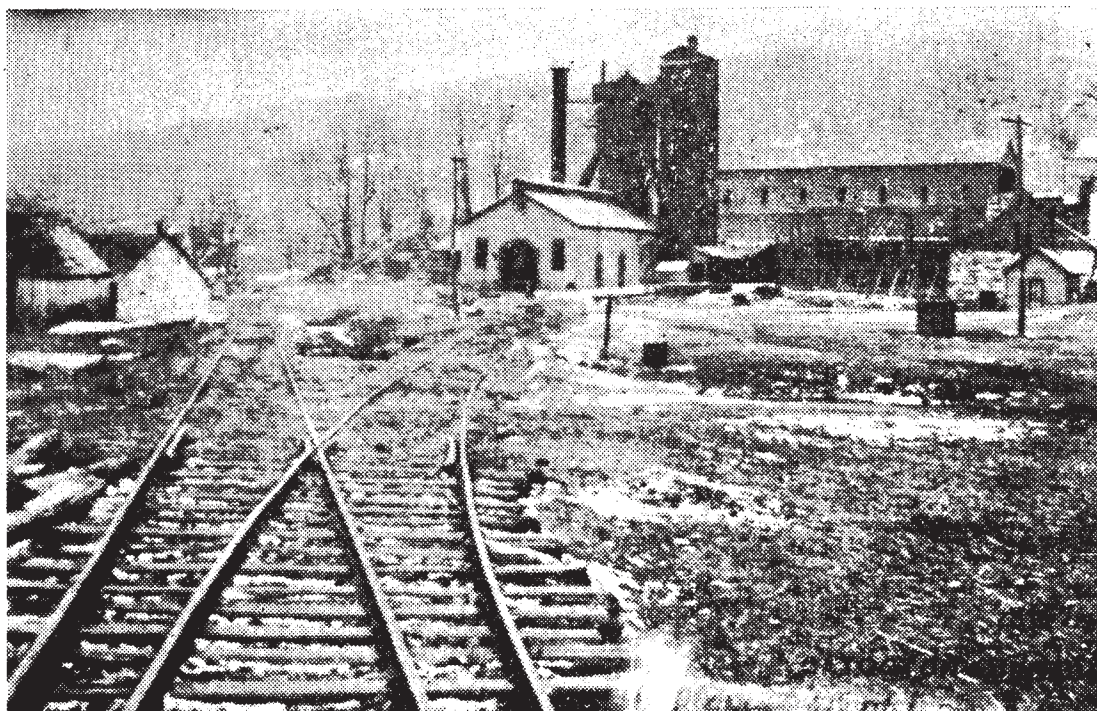
PLATE 3a

PLATE 3A:

A view, taken from the east side of the Frederick-Emmitsburg Road, looking southwest down the line of the Monocacy Valley Railroad track prior to its electrification. The buildings to the left side of the track in the photograph are unidentifiable. The casting house and the Deborah are clearly visible (top center of the photograph), as is a railroad spur to the north of the Deborah casting house. To the west is a long, gable roofed structure with seven visible windows and an open end conjectured to be the charcoal house for Stacks #1 and #2. To the right side of the photograph a small unidentifiable structure, east of Stack #2's casting house, is visible. Directly behind it is the casting house; and behind the casting house are the dismantled remains of Furnace Stack #2.

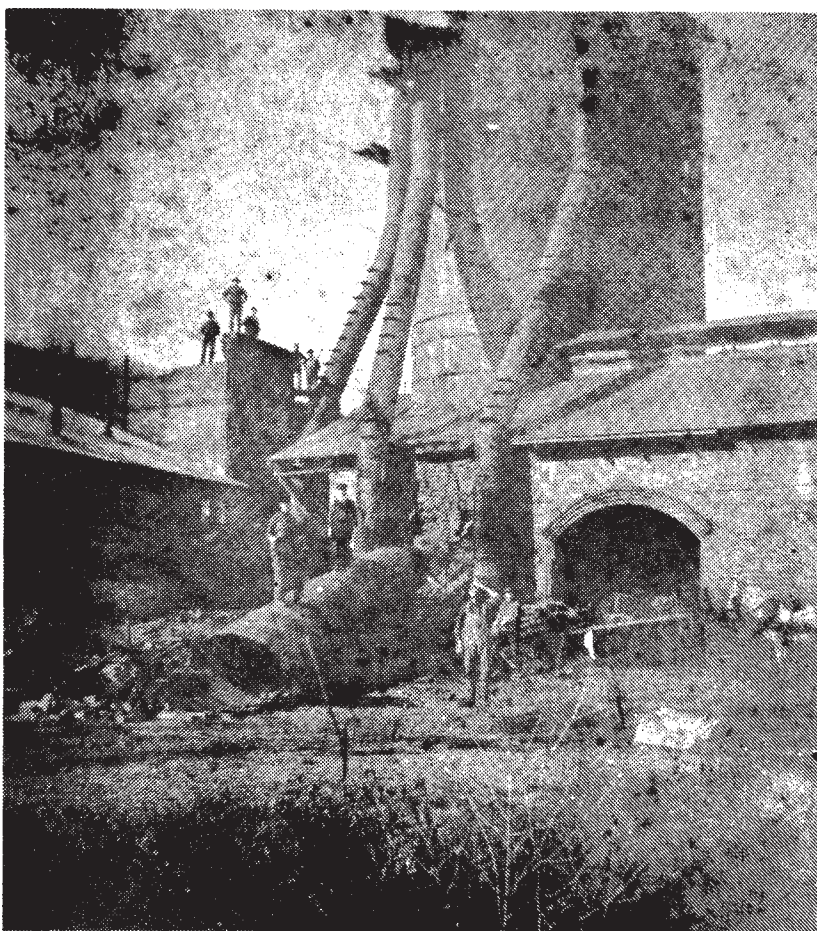
PLATE 3b

PLATE 3B:

A view, looking northwest, of the Deborah Stack being dismantled, ca. 1907. Note the hot-air oven stack and steam ducts being dismantled. The engine house to the east, and the charcoal house to the west of the "great retaining wall" have both been completely removed or destroyed. To the right center of the photograph are a series of horse-drawn carts.

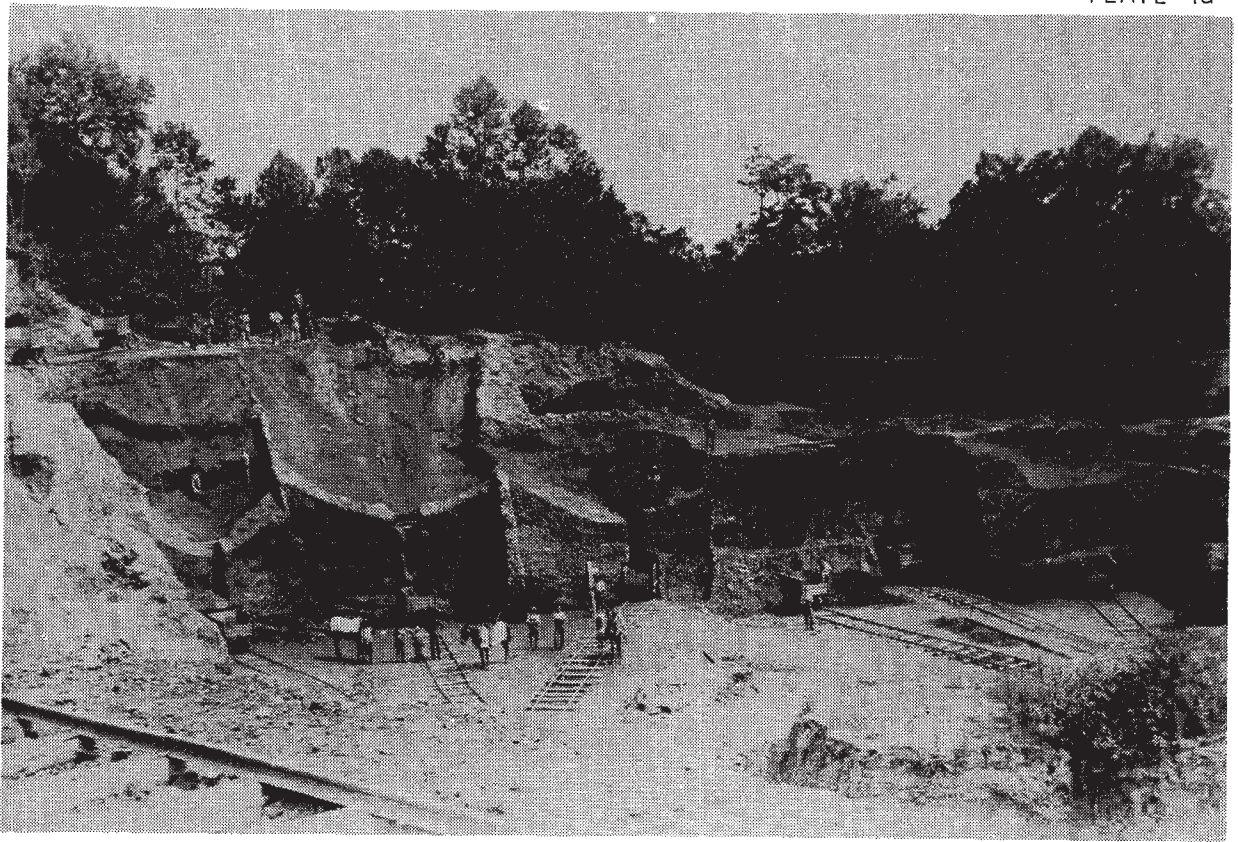
PLATE 4a

PLATE 4A:

The hauling of ore prior to ca. 1850's for the Furnace #1 was accomplished by mule teams pulling ore carts on narrow gauge tracks. The photo is a view of a large ore pit showing the use of mules and ore carts. The location of this ore pit is unknown, but Mr. William Renner of Catoctin Furnace indicates that it is a Catoctin Furnace pit.

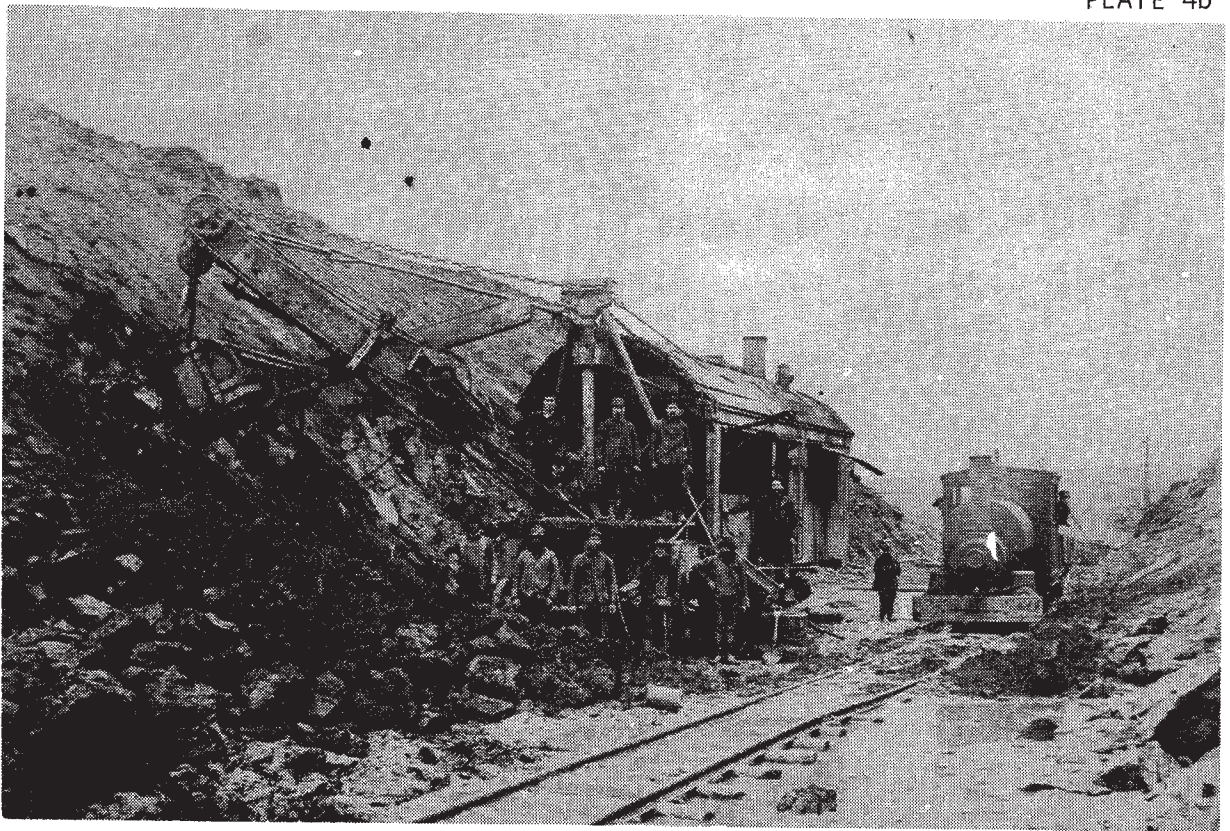
PLATE 4b

PLATE 4B:

A large steam shovel and crew working on the edge of an ore bank cut. The gentle slope of the cut suggests that it is from the Fitzhugh-Kunkel banks 1-1/4 mile from the Furnace and was worked by 100 men. To the right of the steam shovel, is the small steam engine used for hauling ore carts on a narrow gauge railroad. Tax assessment records show steam shovels as having been used as early as 1876 in the Catoctin Furnace Area.

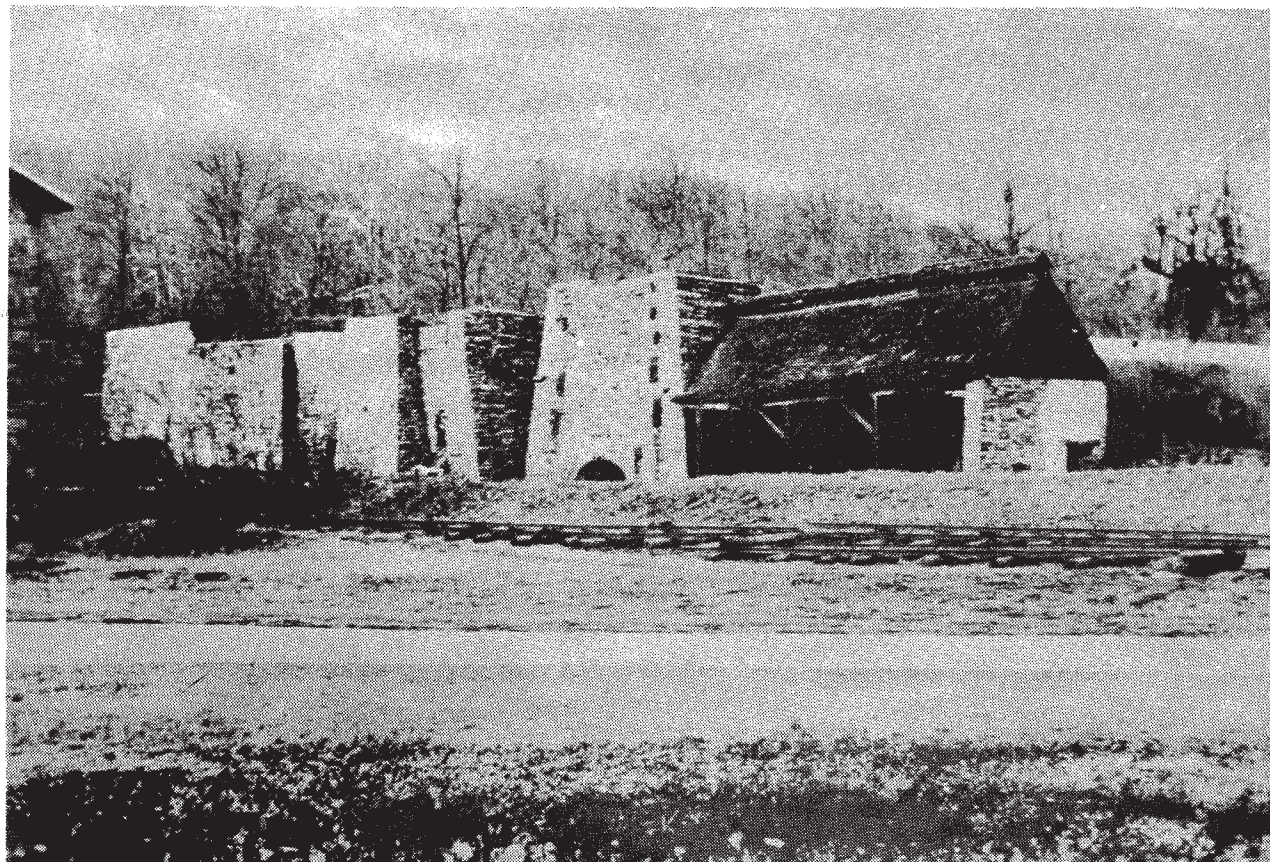
PLATE 5a

PLATE 5A:

A post-1905 view of the dismantled Catoctin Furnace Stack #2, looking northwest. According to local folklore, apparently both casting houses stood until 1924 before being torn down.

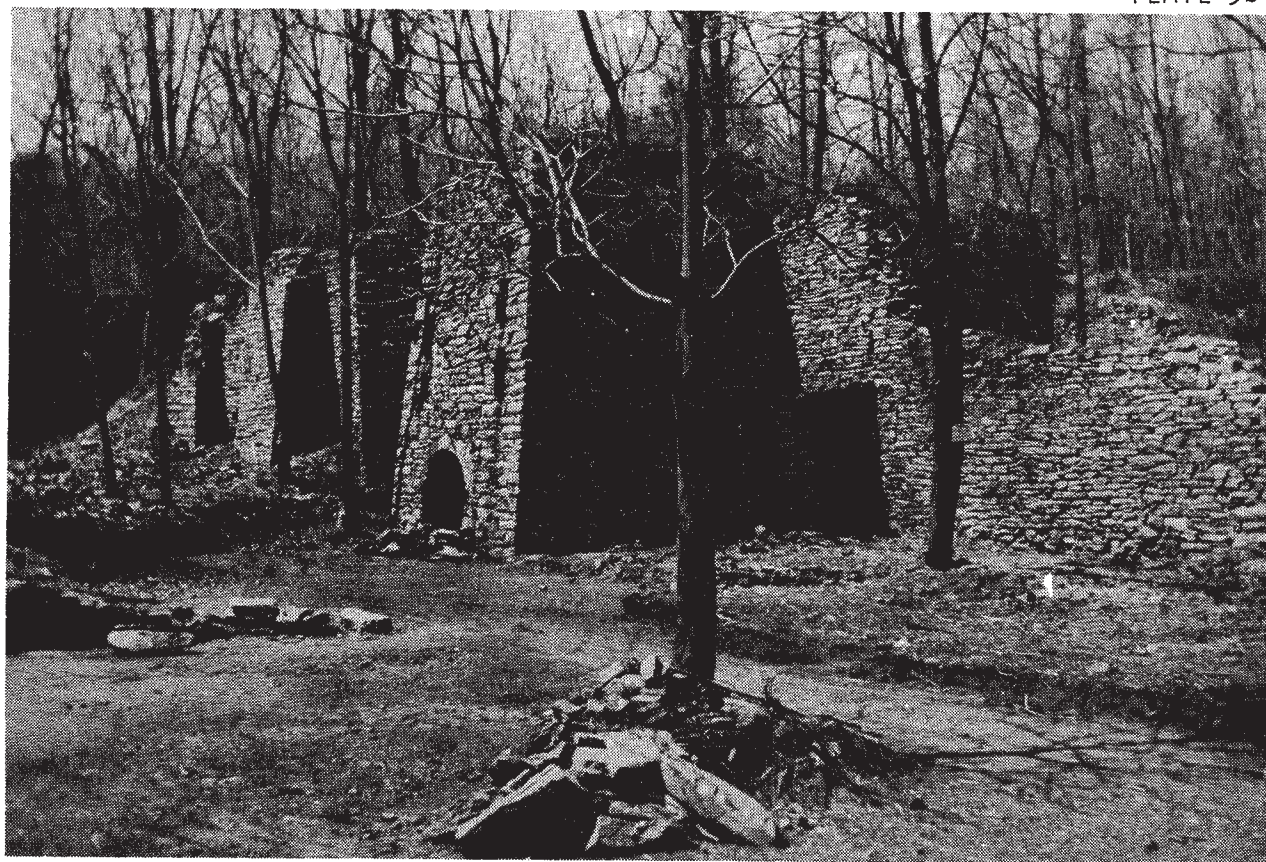
PLATE 5b

PLATE 5B:

A view of the Isabella Stack, looking northwest, showing archaeological test trenching accomplished in the 1930's under the WPA work program. The remains of a stone foundation appear on the left edge of the photograph, but unfortunately insufficient evidence is presented to identify it. The Furnace bank appears to be in decay. Directly to the north of the Isabella Stack are the remains of the building that appears in Plate 1B. Evidence of Catoctin Stack #1 does not appear in this photograph.

The WPA conducted an archaeological test program at the Catoctin Iron Furnace Complex directly south and apparently within 300 feet of Furnace Stack #2 (see Plate 5B). The exact amount of disturbance and

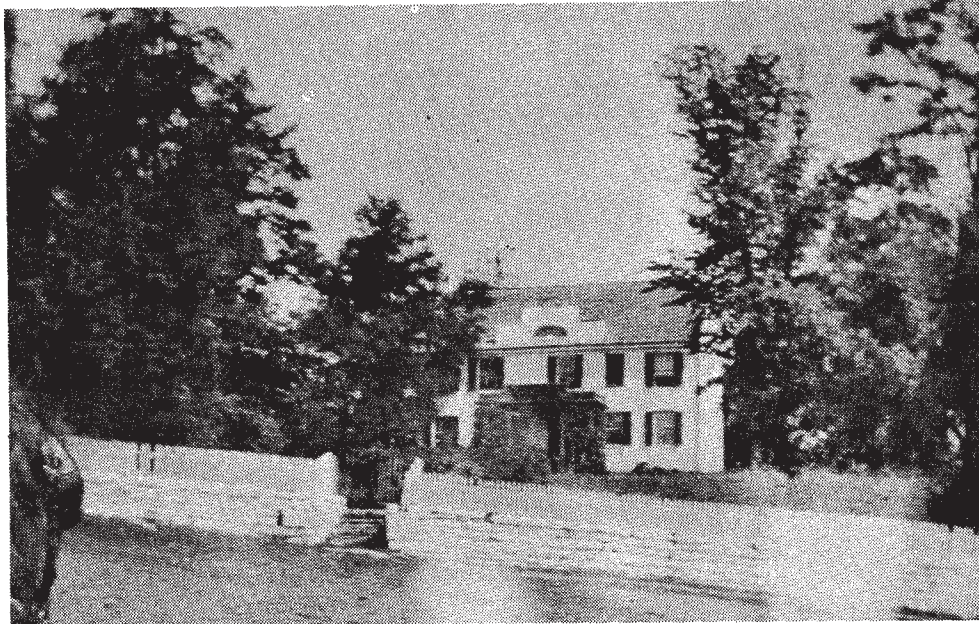
PLATE 6a

PLATE 6A:

A view of the iron master's house taken from a wagon or carriage (note horse's head with harness and blinders in left-hand lower corner). A white picket fence is directly behind the white-washed stone wall encircling the property. In Plates 2A and 2B, the white picket fence does not appear and has been removed. The roof lacks dormers and contains a simple Greek Revival pediment with small half-round window. At a later date the roofline is changed. This photograph is conjectured to have been taken prior to 1880.
