# COLLECTIONS ASSESSMENT FOR PRESERVATION (CAP) REPORT

## CATOCTIN FURNACE HISTORICAL SOCIETY JULY 7-8, 2022

Respectfully Submitted by: Mary Jablonski, architectural conservator &  
Lori Trusheim, objects conservator  
Final Report Submitted on: September 30, 2022

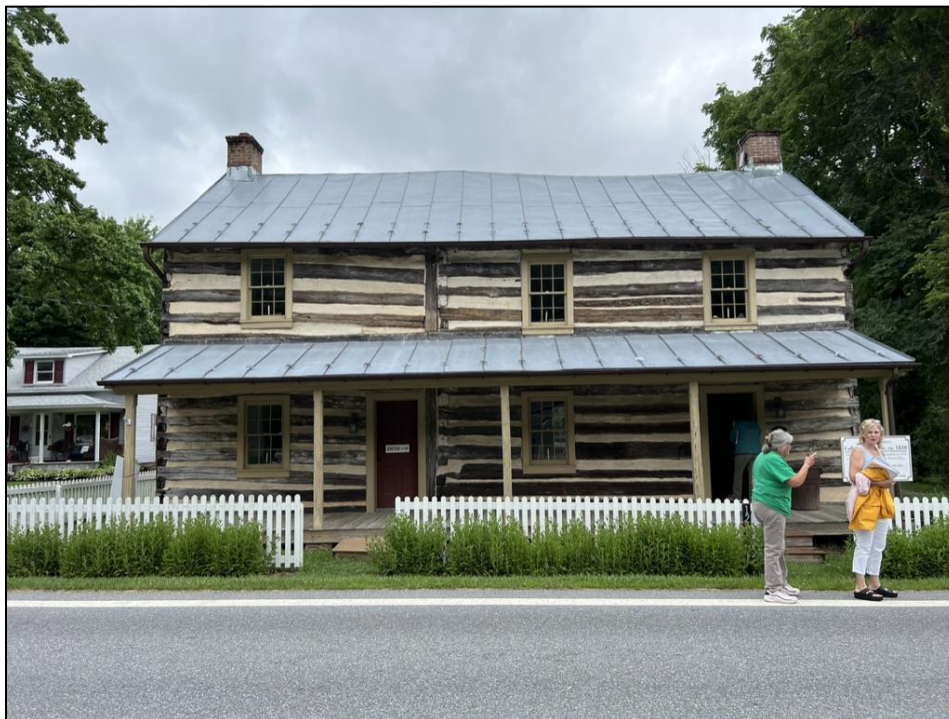
Figure 2: Collier's Log House

It is clear examining the buildings that CFHS has spent time and effort maintaining its buildings. The building with the most significant deterioration is the Collier's Log House; CFHS is waiting for the National Park Service to undertake repairs to the exterior log walls.

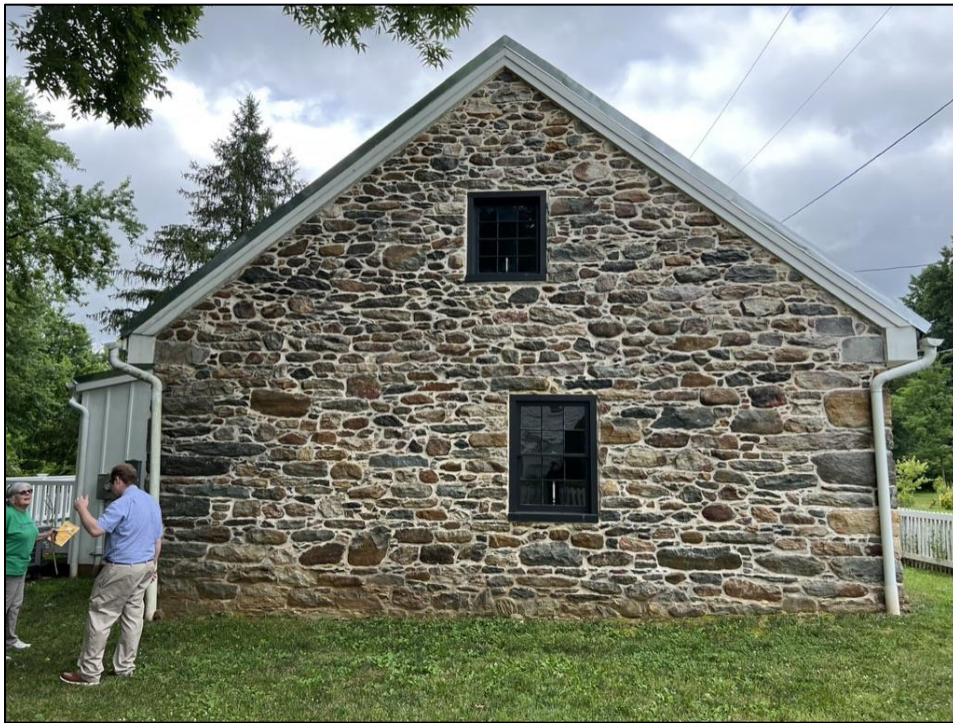
*Figure 4: Side wall of the Forgerman's House showing rubble exterior wall.*

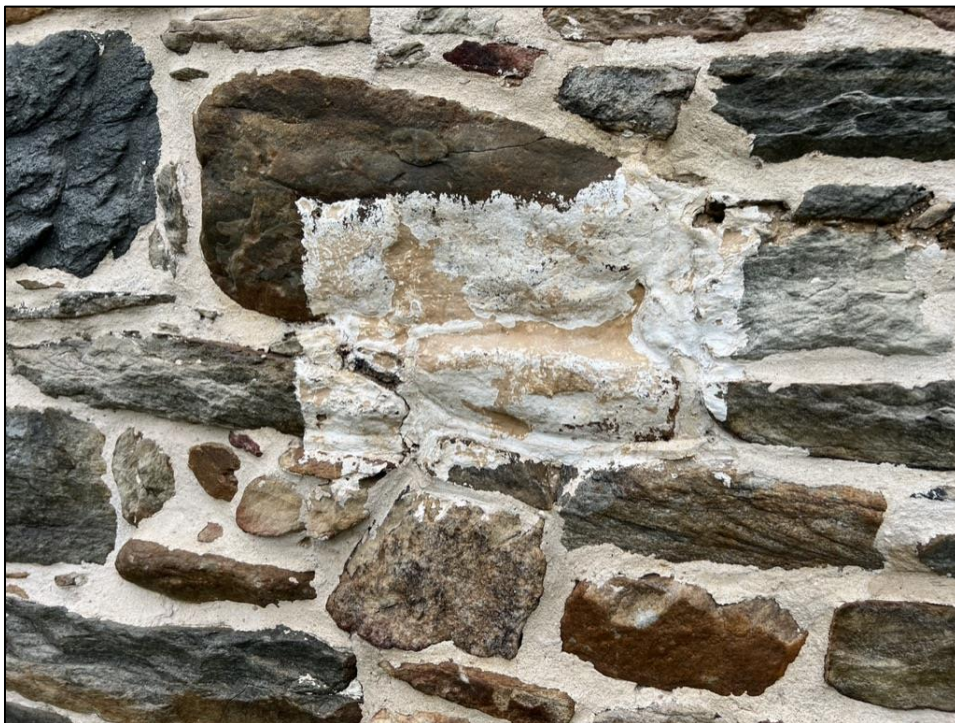
Figure 5: Detail of rubble wall with small section of old limewash or whitewash coating.

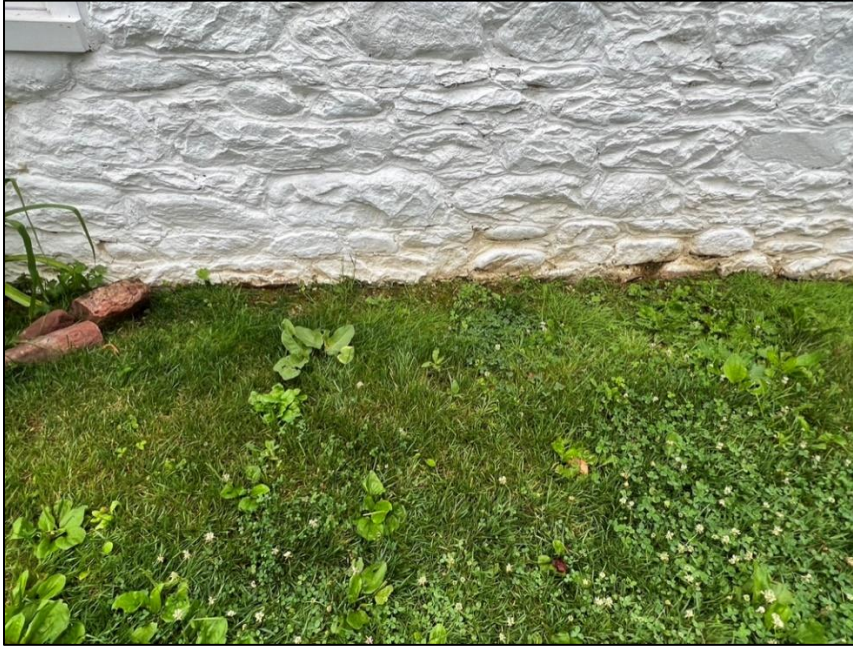
Some of the new paint at the ground level appears to be failing. This is probably because of rising damp. The conservators were informed after their visit that this was repaired.

*Figure 6: Painted finish beginning to lift at bottom of wall where it meets the soil.*

- On a quarterly basis, walk around the house and check on landscape grading, particularly near the leaders graded away from the building, especially at the addition where soil may settle over time.
- Check the functioning of the sump pump in the basement at least quarterly.
- Inspect the painted finish, particularly at the ground level for peeling paint caused by rising damp.

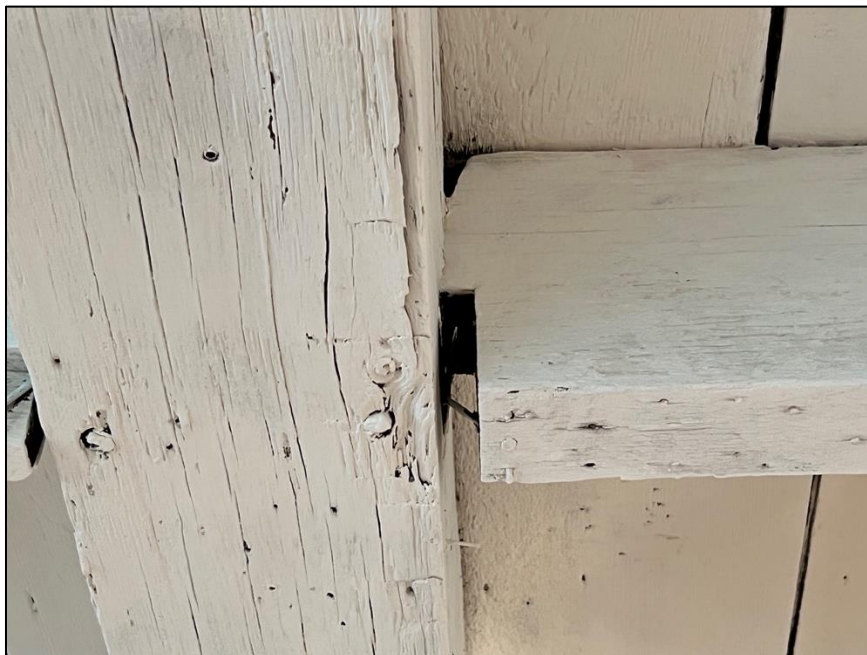
The interior has been restored with replastering of the walls and painting of the ceiling and floor joists. The floor joists have a slide-in joint with a beveled tenon. Over time, the some of the tenons have pulled away from their cavity in the summer beam although they continue to function. Several joists have significant checking. This probably is not a concern while the second floor has limited use. A structural engineer has examined this and CFHS has documented that the engineer designed a vertical support under the center beam and approved the existing framing. This vertical support was installed during building restoration in 2019. However, if the use changes and extra load is added to the second floor for any reason, the joists should be re-examined by a structural engineer who is conversant with historic wood framing.

Figure 7: Floor joist with a V bevel tenon. Typical for the second floor joist. Several have pulled away as is shown above.

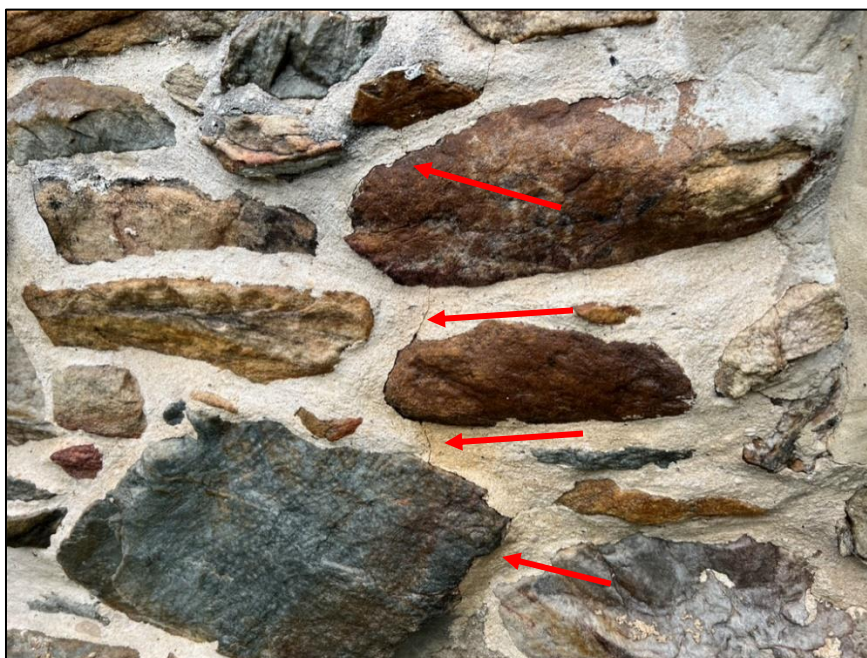
The cement mortar used to repoint around the rubble stones is cracking in numerous areas. This allows water to infiltrate the walls. It is not known how deeply the mortar was raked out for repointing. Cement mortar is hard, brittle and does not allow for movement. If the mortar behind it is a softer more flexible mortar, it will cause cracks in the cement mortar.

Figure 8: Cracks in the exterior rubble wall mortar. Found in multiple locations.

1. Consider applying a whitewash rather than a painted finish to the rubble exterior walls. This will help protect the soft mortar that might remain and it will also bridge some of the cracks that have opened.
2. Repair cracked mortar with a lime-based mortar.
3. Removed the damaged mortar around the second-floor window, fix the crack above and reseal around the wood frame.
4. Regrade around house to keep all water flowing away from house. Consider installing French drains around the perimeter and draining them to a dry well in the backyard.

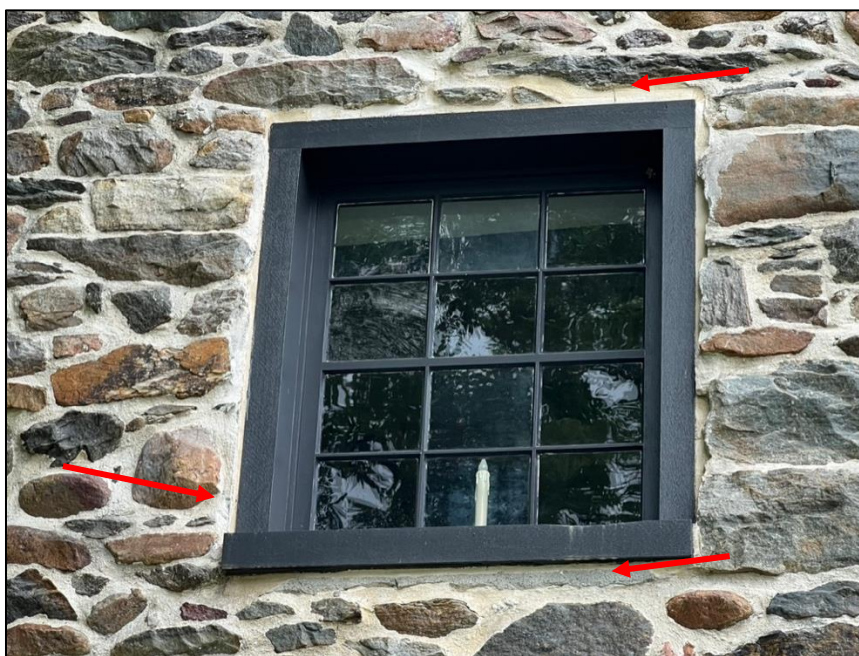
The mortar around the windows, especially the second-floor window on the north elevation has significant failure of the mortar around the wood frame and a crack above the window. There are signs of water infiltration above this window.

Figure 9: Cracks in mortar over window, mortar repair failing under window, and failure of mortar at side of window.

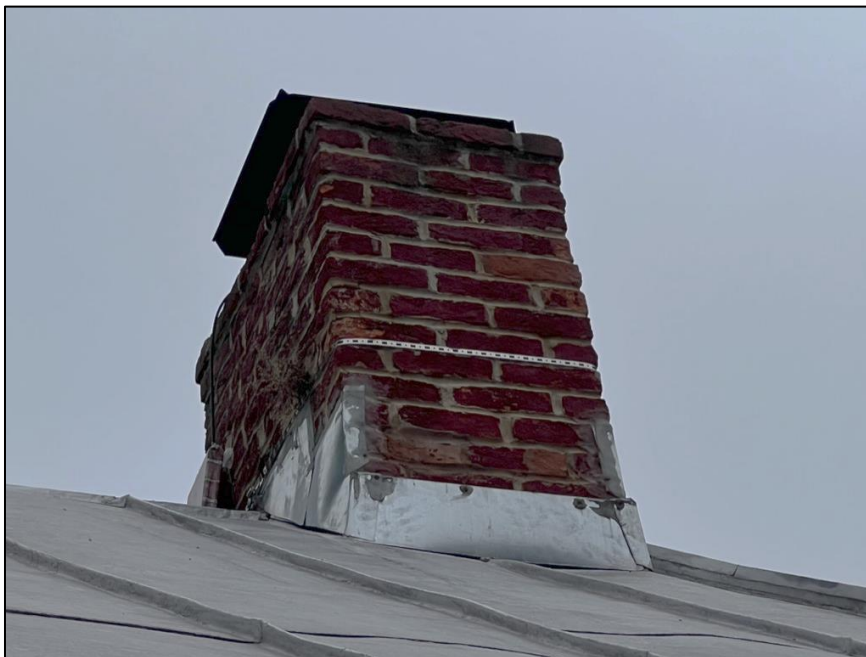
Another source of water infiltration appears to be the flashing at chimney which does not appear to be well installed. CFHS has reported that this has been repaired.

*Figure 10: Chimney flashing installed on chimney with fasteners and caulk. Not in the masonry.*

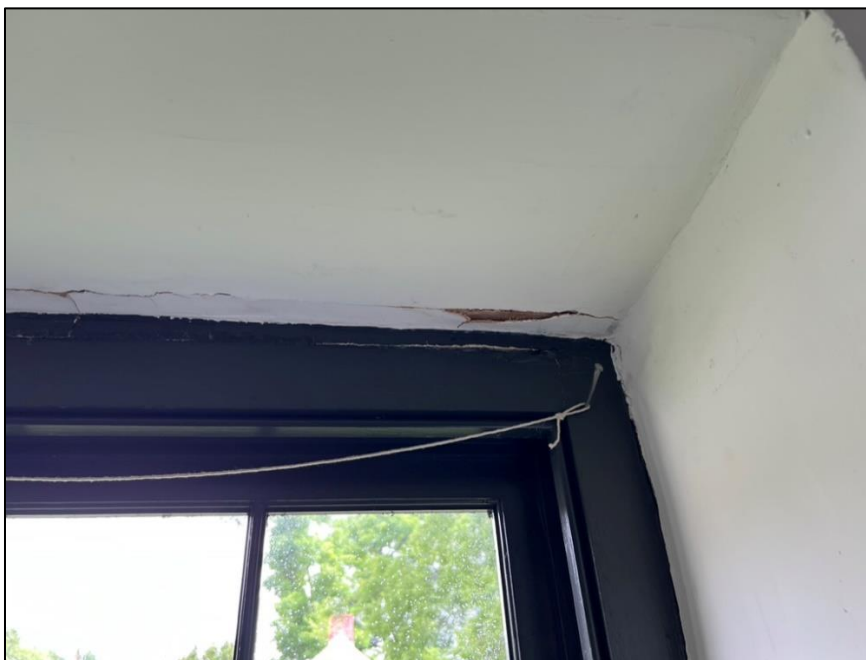
*Figure 11: Signs of water infiltration over window.*

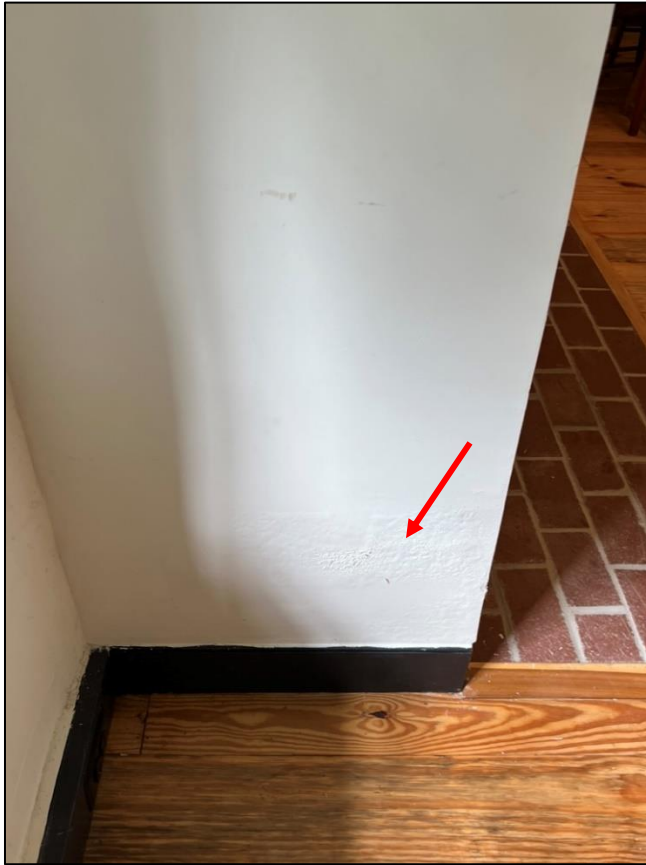
Figure 12: Signs of water infiltration at chimney.

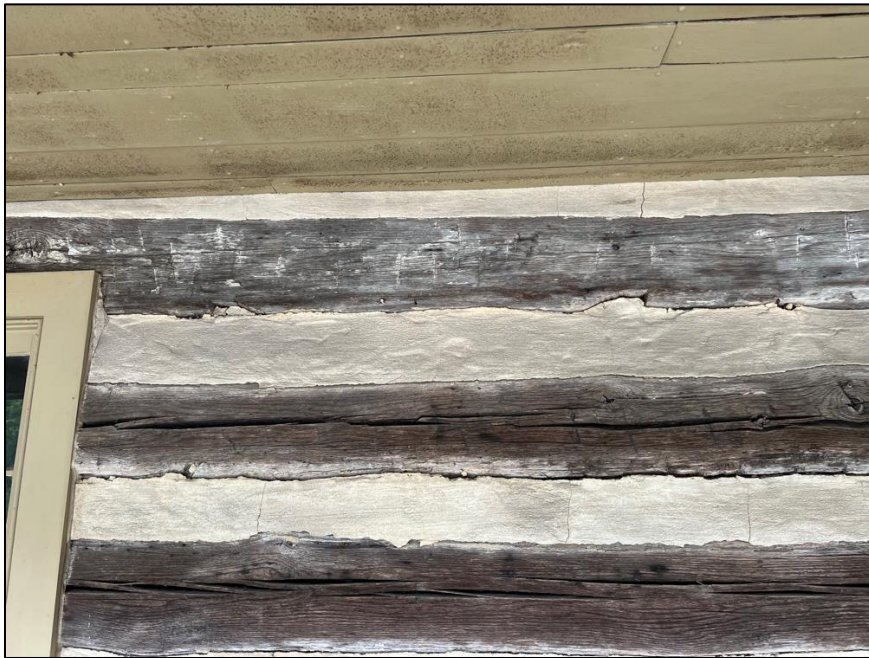
*Figure 13: Logs with significant checking.*

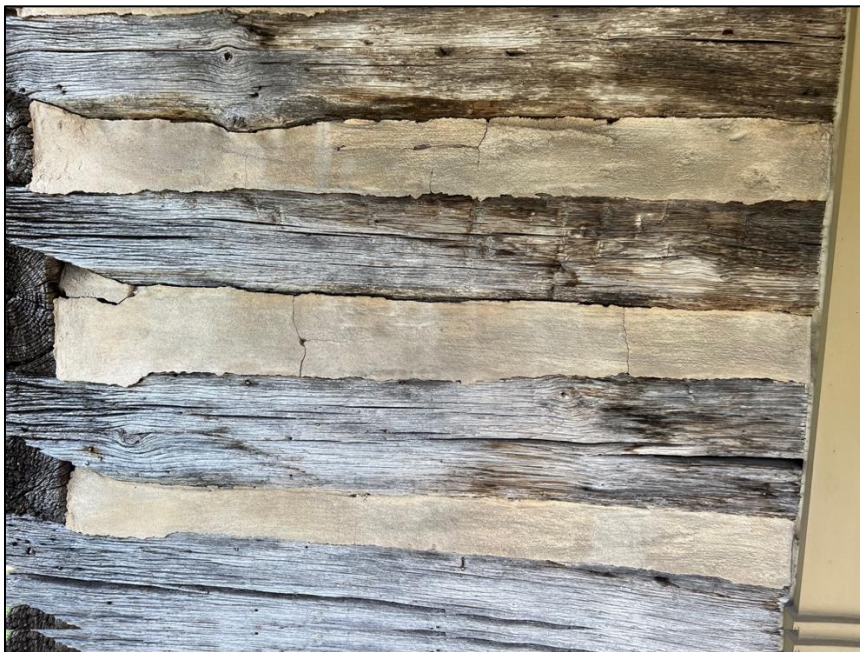
The logs deteriorated from a series of conditions that included failure of the chinking and daubing. It was applied with inappropriate materials and poor installation did not allow water to properly shed off the wood logs.

*Figure 14: Deteriorated chinking.*

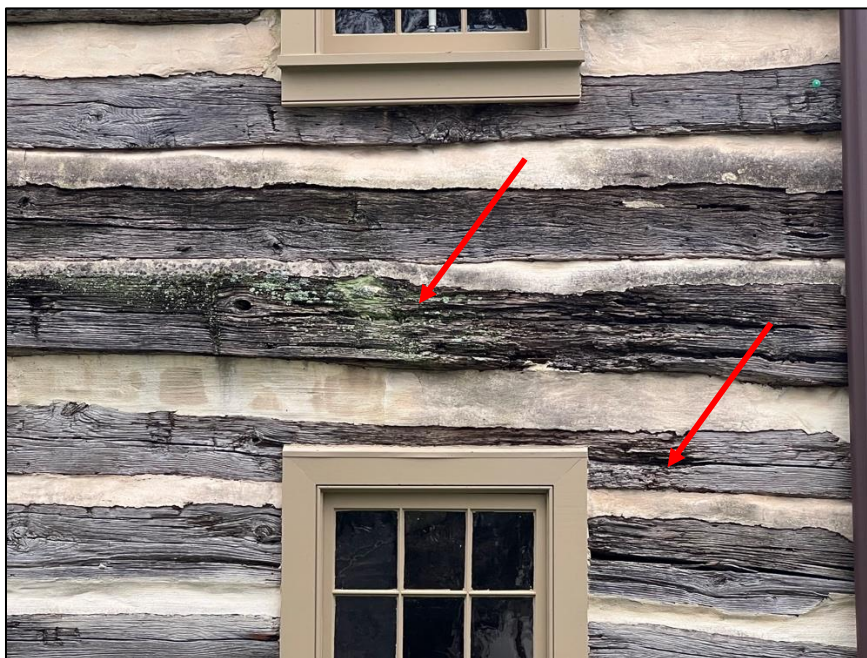
There is extensive rot in the logs and failure of the chinking at the Collier's Log House. This not only allows extensive amounts of water to infiltrate the house but it is producing an environment that is conducive to active insect infestation that is also contributing to the wood deterioration. Frass and tunneled wood were visible during the examination.

Figure 15: Wood that has rotted and is now hosting biological growth where noted with arrows.

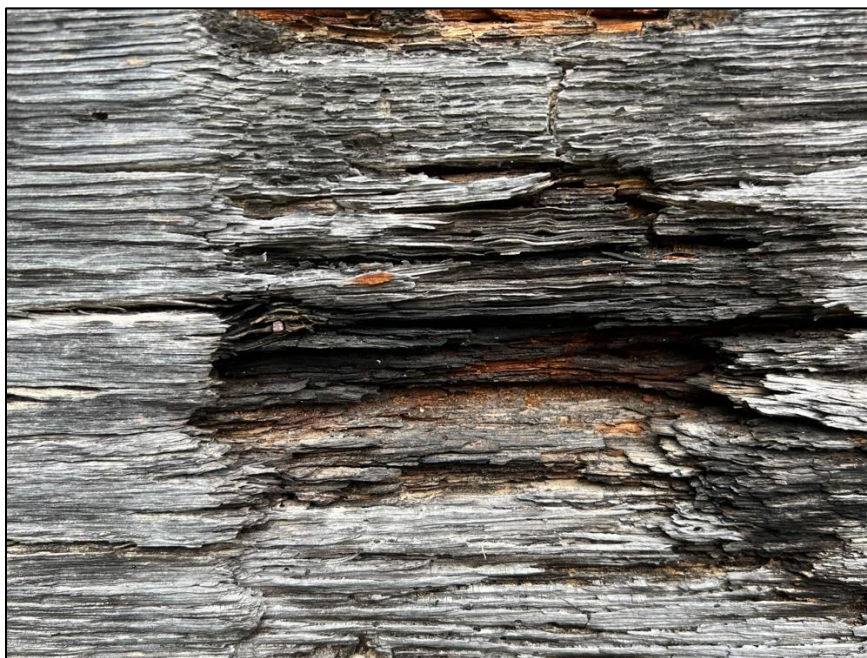
Figure 16: Frass found at area of rot in log.

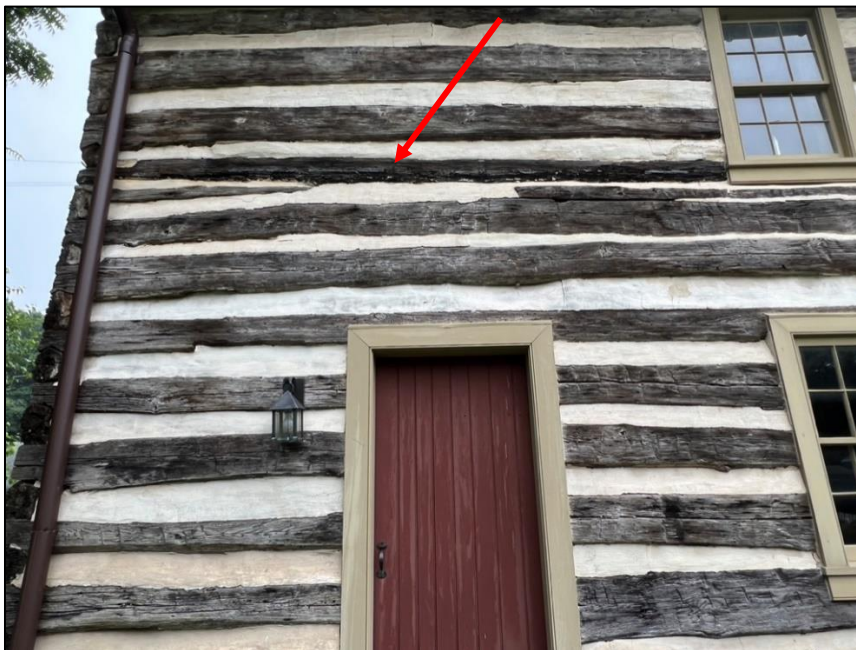
Figure 17: Log that is rotted. See figure below for water that has entered interior from this area.

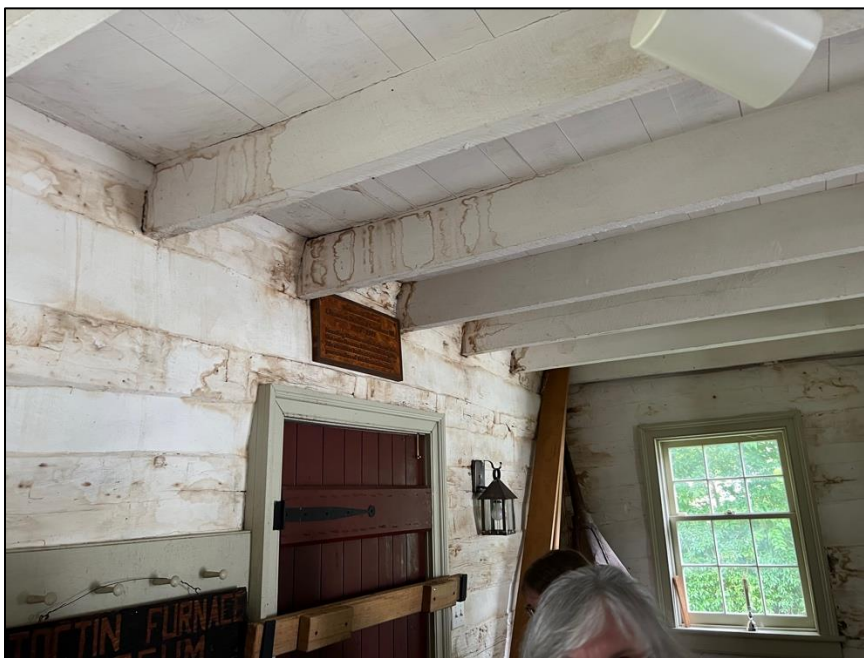
Water staining is visible on the first-floor finishes. The amount of water entering the building is also a threat to the collection within the building.

Figure 18: Water staining from water infiltration through rotted exterior logs.

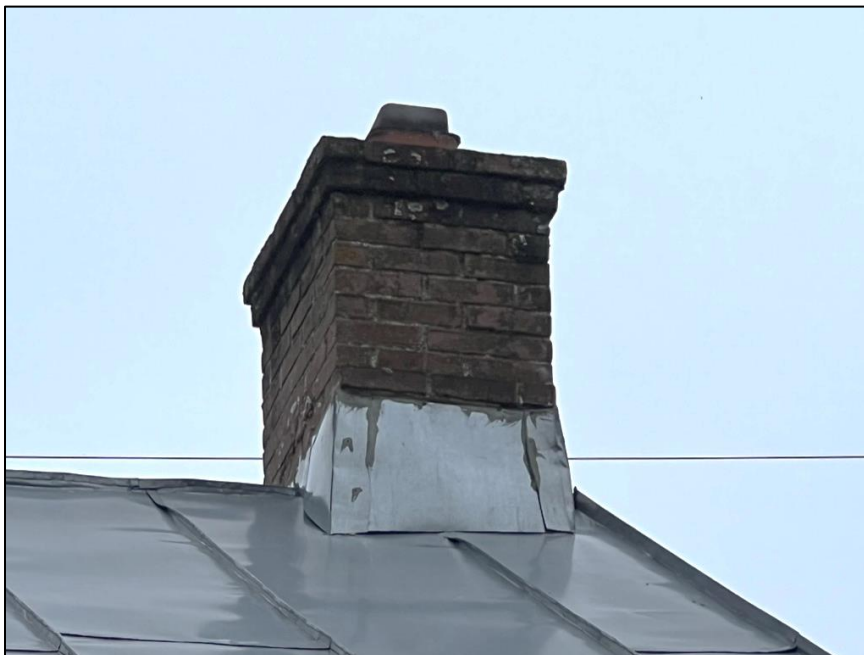
*Figure 19: Chimney flashing on Collier's House installed with fasteners and caulk*

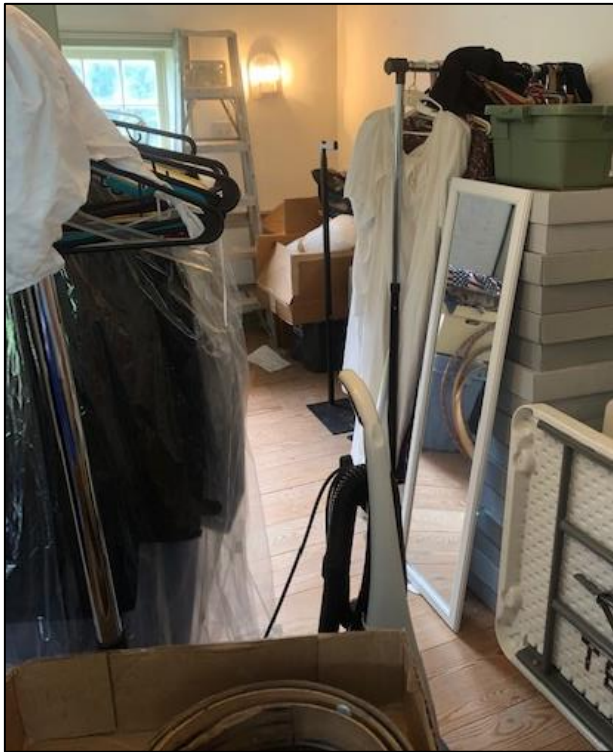
*Figure 20: Storage room of log house with stacked boxes containing textiles that should be moved to climate-controlled space.*

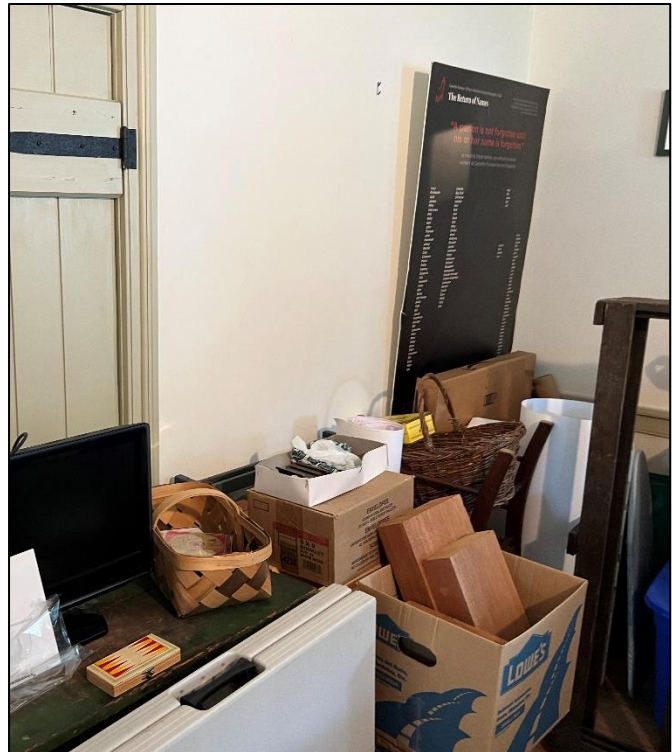
*Figure 21: Example of storage room corner where shelving could help de-clutter the floor.*

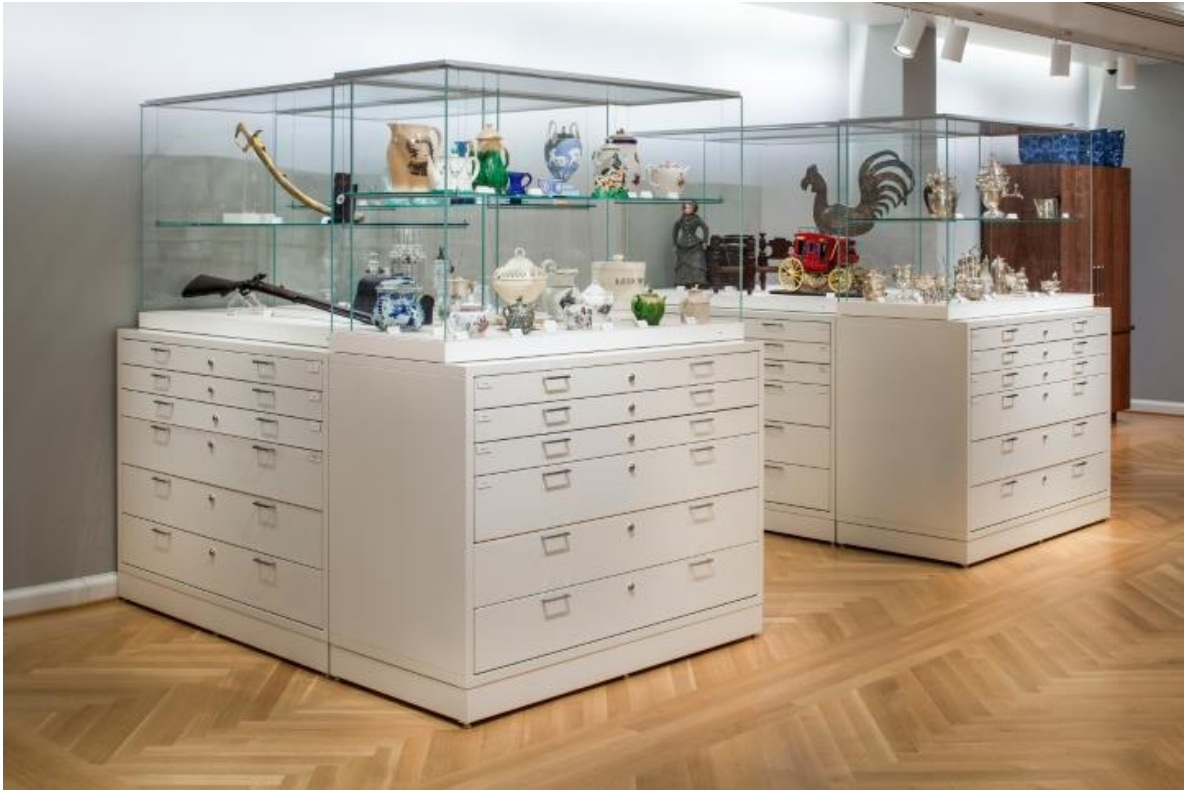
Figure 22: Example of an active storage display case on view at Daughters of the American Revolution Museum in Washington, D.C. The base unit with pull-out drawers was custom made by Delta Designs, LTD. The hinged glass door, adjustable shelf vitrine top was custom made by Casewerks, LLC.

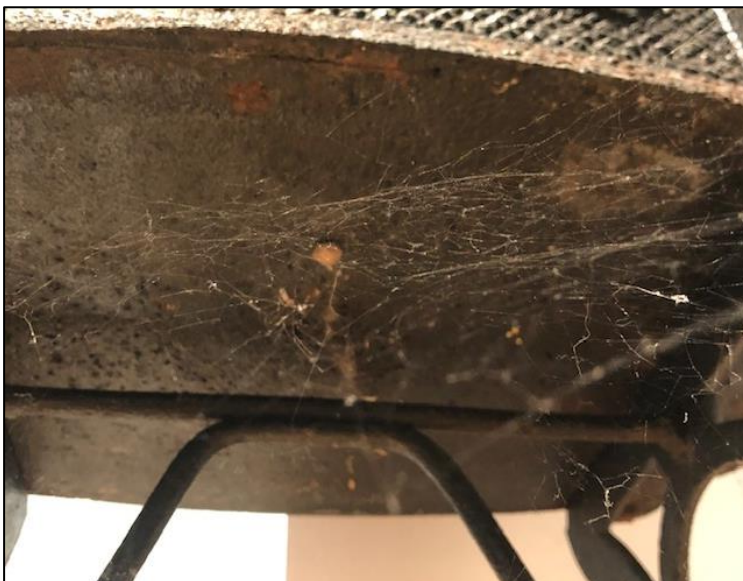
*Figure 23: Cobwebs on underside of stove in Museum of Ironworker.*

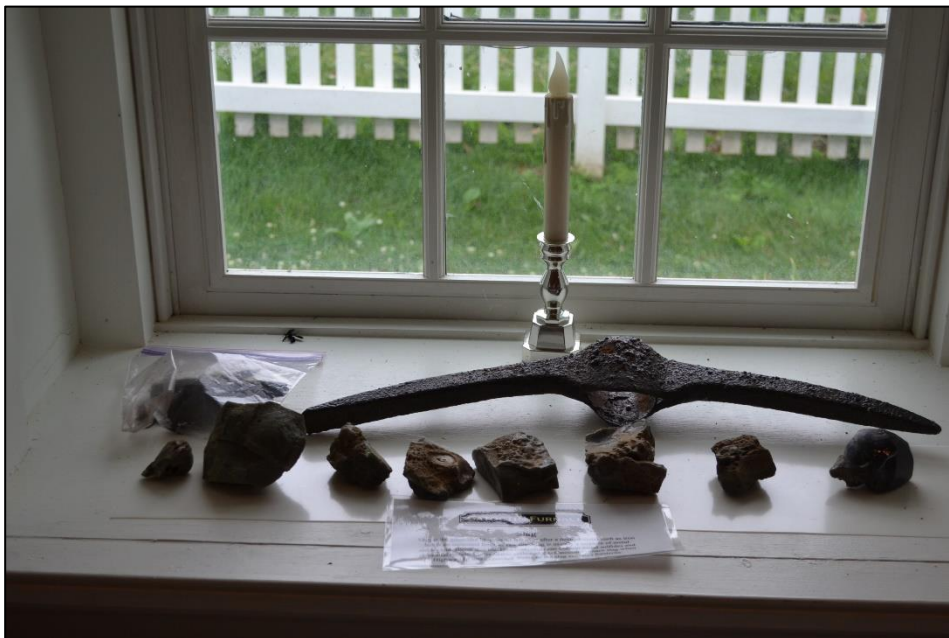
*Figure 24: Dead insect in windowsill of Museum of the Ironworker.*

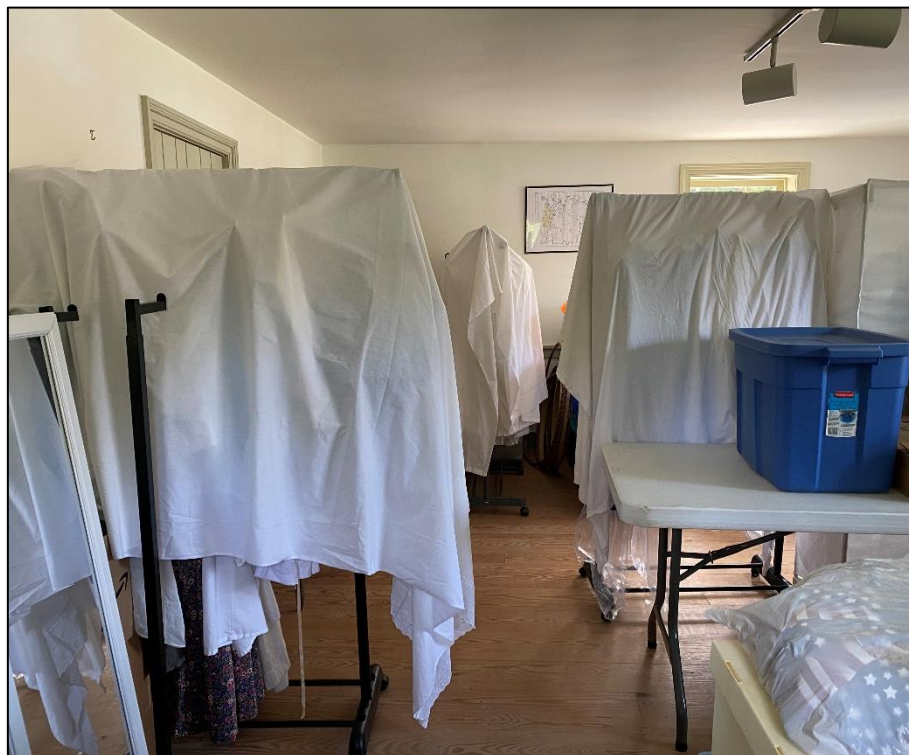
*Figure 25: Muslin or Tyvek cover recommended for costumes to minimize fading and protect from dust.*

- Prop textiles within the Collier's Log house should be routinely vacuumed with a HEPA-filtered vacuum to reduce dust accumulation, which can eventually become ingrained as well as a pest attractant. Once every one to three months is ideal.

- All textile props should be included in routine housekeeping and IPM measures. Pheromone traps for cloths moths should be placed near any wool, fur, or leather items and checked monthly. This is especially important to ensure infestations that begin in prop items do not spread to accessioned objects. Pests that are a risk to museum collections prefer dark, dusty, undisturbed areas. Therefore, efforts to reduce clutter and regularly clean around prop items can reduce overall risk.

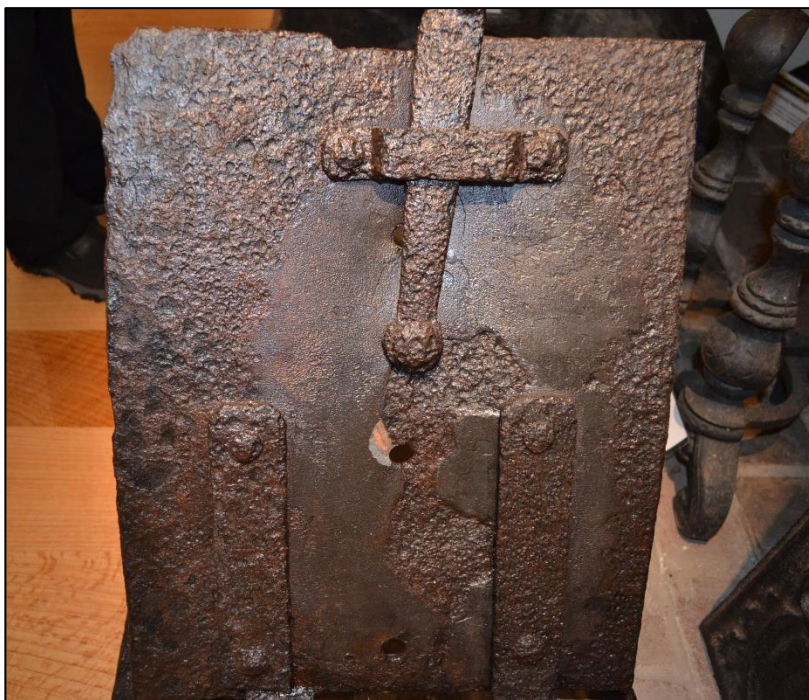
*Figure 26: Spalling iron with active rust at center of stove door in Museum of Ironworker.*

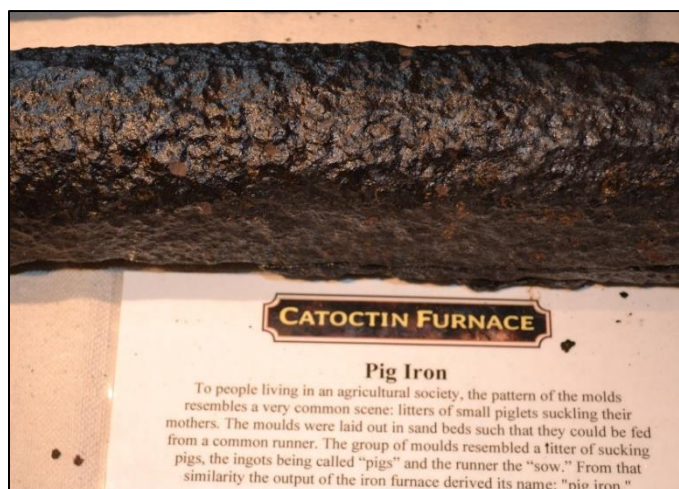
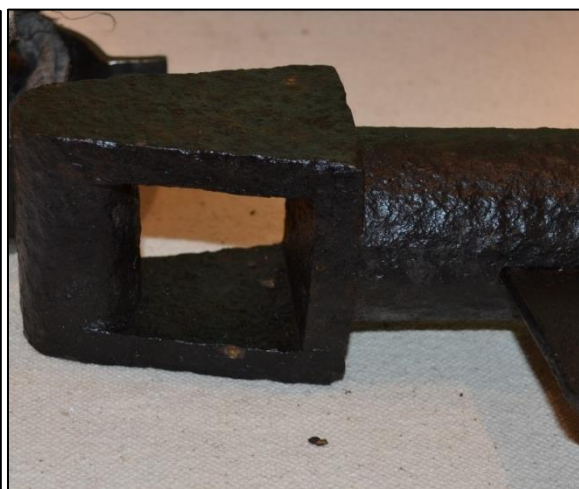
Figure 27: Spalling iron with metal flakes scattered around objects at the Museum of the Iron.

Figure 28: Spalling iron with metal flakes scattered around objects at the Museum of the Iron.

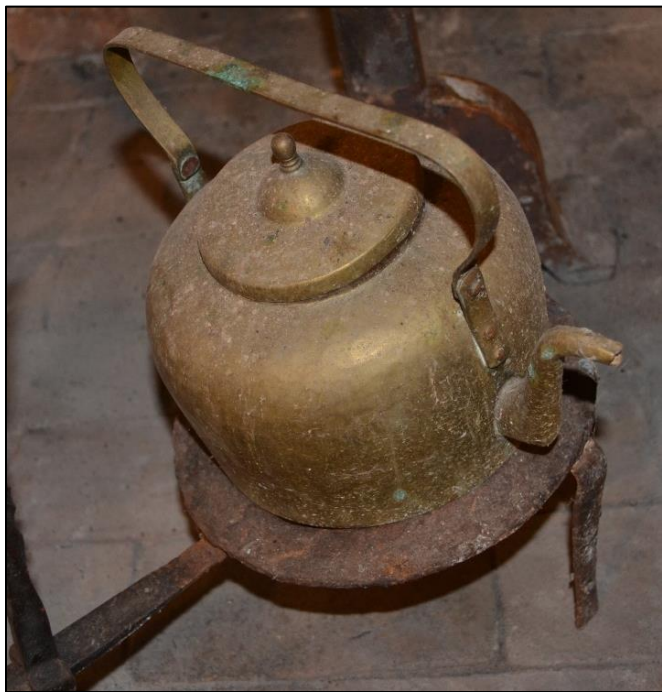
*Figure 29: Copper alloy kettle with corrosion, dirt/grime, and cobwebs on hearth in first floor main room, Collier's Log House*

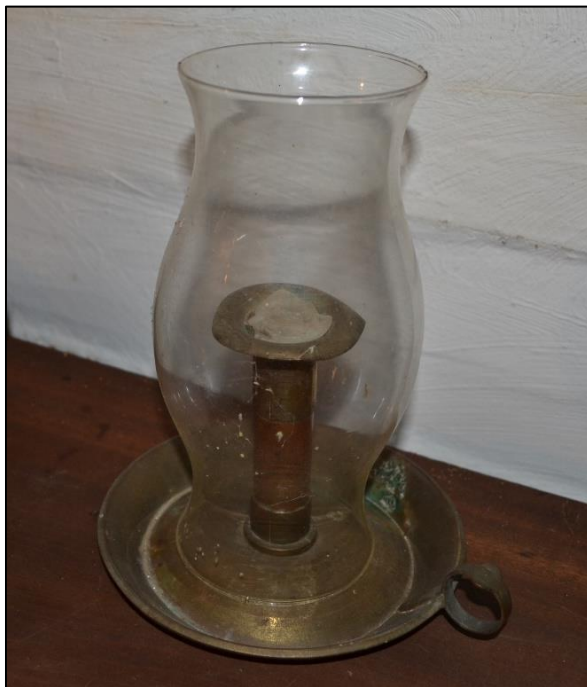
Some of the other copper alloy objects appeared very dirty, such as the candleholder with the hurricane globe on the wooden dresser across from the mantle in the main room of the Log House. Some of these condition issues could be remedied by routine object dusting as described 'Housekeeping Plan' under the Collections Care section.

*Figure 30: Corrosion on copper alloy and dirty glass globe on candlestick in first floor main room, Collier's Log House.*

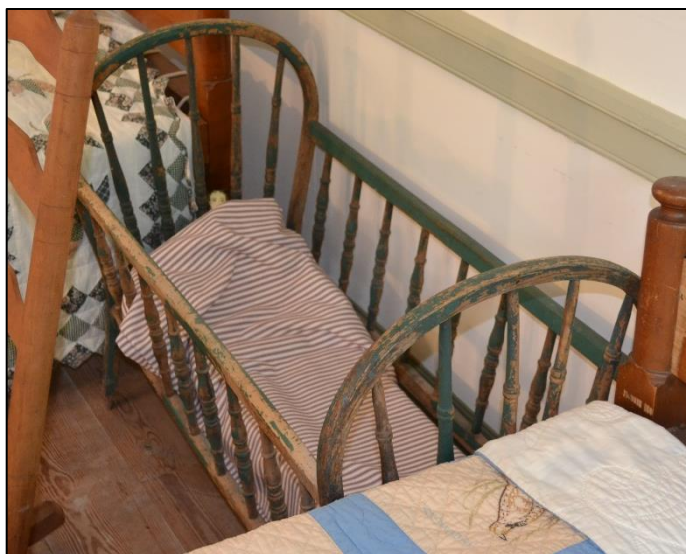
The seasonal environmental fluctuations in the house will cause wood to expand and contract, resulting in extensive paint loss on the crib that is visible today. Conservation treatment to clean and consolidate the extant paint is highly recommended for long-term preservation of this object. Consolidation treatment will introduce adhesive below flaking paint layers to stabilize the paint and slow the rate of paint loss with the object housed in an unconditioned space.

*Figure 31: Crib on second floor of Collier's Log House has significant paint loss. Conservation treatment to consolidate extant paint is recommended to slow the rate of deterioration.*

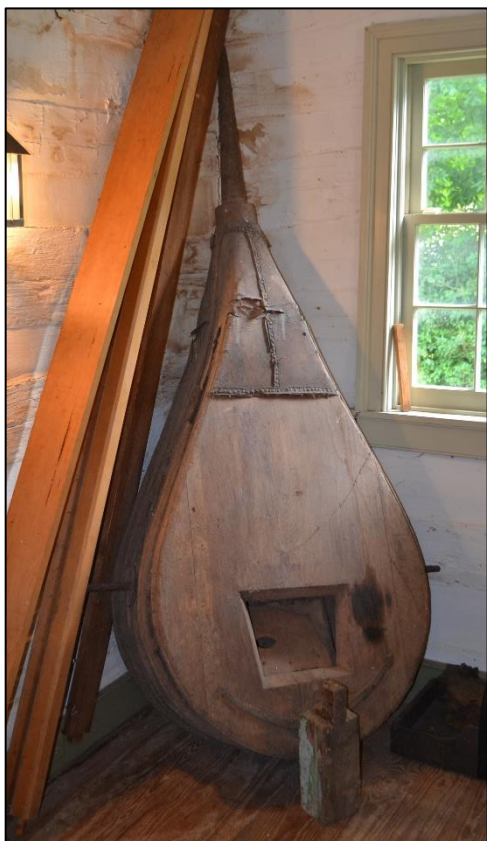
The large bellows in the corner of the Log House is in very poor condition. The surface is very dusty/dirty; the wood is stained, gouged, and has insect damage; the leather is brittle, torn, distorted and fragmentary, and the iron components are rusting. CFHS plans to have the bellows fully restored for use in the future blacksmith shop; the bellows was purchased by Elizabeth Comer's father and does not have direct provenance to CFHS. This restoration should have written and photographic documentation for the record-keeping of collection objects. There is also a small kitchen tool hanging on the fireplace below the pewter mugs; the iron blade is very rusty and needs to be stabilized to slow the rate of corrosion.

*Figure 32: Bellows in Collier's Log House with multiple condition issues.*

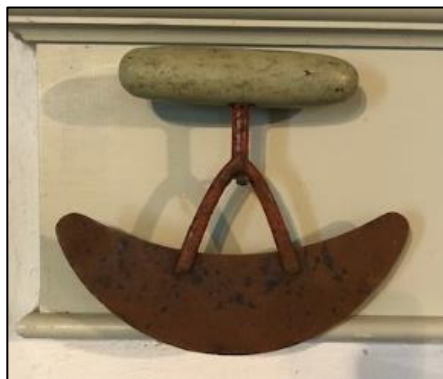
*Figure 33: Tool on mantle of fireplace in main room of Log House with unstable iron.*

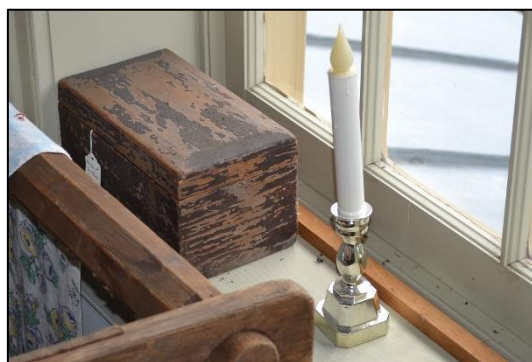
*Figure 34: Insects on windowsill of Collier's house, second floor, and wooden box in poor condition.*

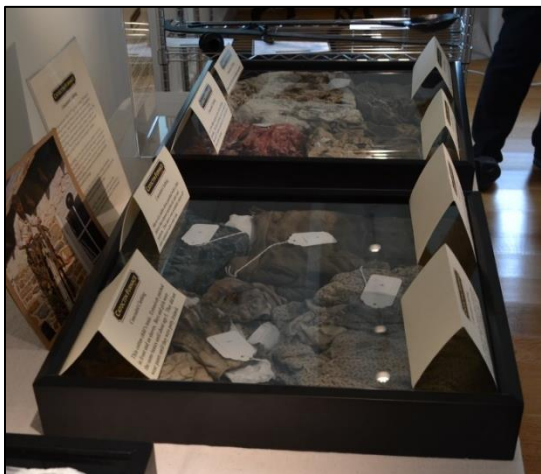
Figure 35: Cover textile shadow boxes with dark cloth when museum is closed to slow rate of fading.

The recent renovations in Museum of the Ironworker included the input from a lighting designer and in April 2021 a Lutron LED system installed. The bulbs in this system are LED SORAA Vivid bulbs, 3000K, 50/60 Hz. The new windows in museum are insulated, double hung, argon filled glass. There is no UV protective glazing, but the museum plans to acquire plastic scrims depicting associated landscapes from Vista print and apply these to the windows, which will block some of the UV and visible light entering the space. The installation of LED lights was a positive update because LED light has a low UV output. Unfortunately, it still produces visible light which can cause fading. Traditional recommended light exposure levels for collection objects are: 50 lux for textiles, works on paper, watercolor, photographs and 150 lux for oil/acrylic paint, polychrome, furniture. It is important to remember that light damage is cumulative and irreversible. To protect the light sensitive materials in the museum – the paintings and textiles – consider covering items while the museum is closed. Drape a dark cloth over the shadow boxes containing textiles and acid-free boards could be propped over the paintings on the mantle. Any framed, hanging light sensitive items of high value/importance in the MIW and Collier's Log house should be framed or placed in a shadow box with UV protective glazing.

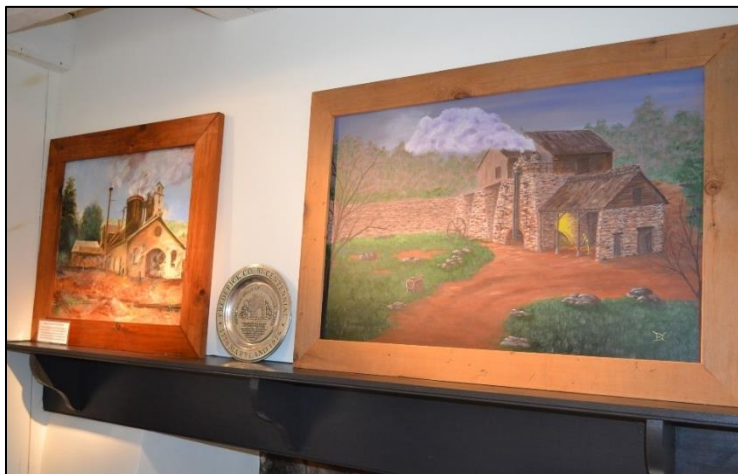
Figure 36: Place acid-free boards in front of paintings when museum is closed to protect paint from unnecessary light exposure.

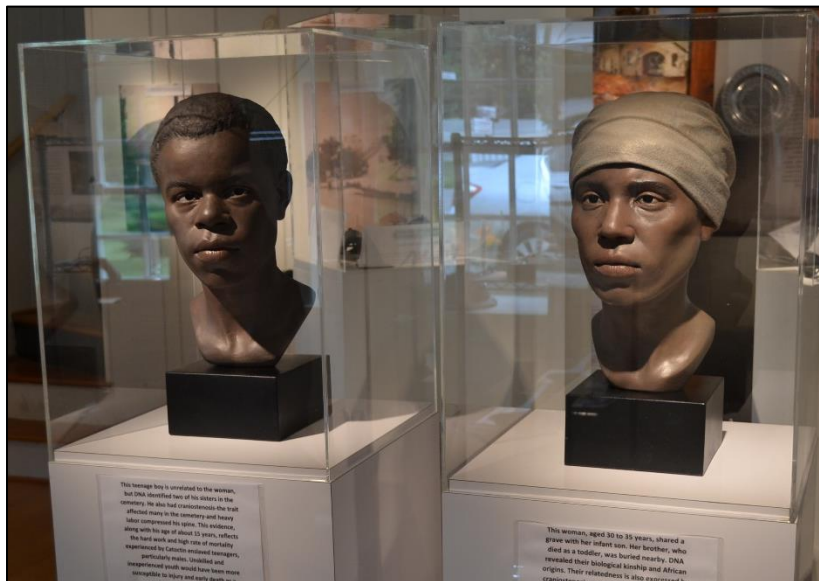
Figure 37: Security screws can be added along bottom edge of Plexi-glas® vitrine for added security.

There are four cases with plexi-Glas® vitrines located in the Museum of the Ironworker. Two contain a forensic facial reconstruction of enslaved workers buried in the cemetery on site. These highly realistic objects are extremely valuable, not only from a cost perspective, but also from their connection to the site and the extensive amount of time and expertise given by the researchers who analyzed and interpreted the data to create a precisely rendered three-dimensional product. The other case contains an iron artifact. None of the plastic bonnets have security screws to lock the vitrine in place. Security screws and screwdrivers can be purchased from a company like McMaster-Carr, but the knowledge needed to measure, pre-drill, and install the screws requires an experienced hand so that the plastic bonnet does not crack and that the holes are the correct size to function as a locking system.<sup>14</sup> Given the size of the space, it is highly possible that a visitor could accidentally bump into the cases. Monitor visitor flow in exhibition space to determine if intervention to secure or weight the cases is necessary.

<sup>14</sup> A full-service art installation company like Bonsai should be able to easily install security screws for all casework.

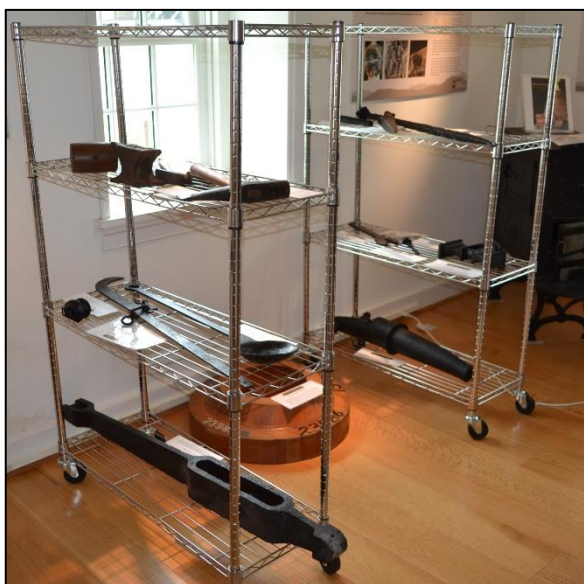
Figure 38: Iron objects on open wire shelving at Museum of Ironworker.

Consider retrofitting the shelves to promote best practices for object storage and display. For the short term, cut thin Plexi-glas® sheet to the size of each shelf and place the objects on the plastic so they are more evenly supported. Small pieces of high density, closed cell polyethylene foam can be attached to the plastic sheet using hot-melt glue, to make small stops placed at key locations around lighter objects to prevent them from skipping off the shelves.<sup>15</sup> For more flexibility in terms of object placement, one option is for each object to have its own archival board that cradles/secures the object using foam stops in a similar way. Thin Volara foam should go below any objects with extremely pitted or fragile surfaces.<sup>16</sup> The mounting boards do not need to be much larger than the footprint of the object and should not detract from the open viewing through the shelving unit. Invisible monofilament wire can go through small holes

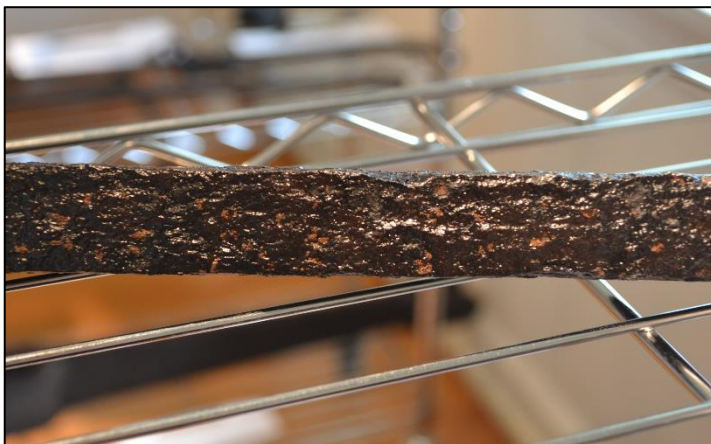
Figure 39: Spalling iron at Museum of Ironwork. Open shelving does not provide even support or security for object.
