# COLLECTIONS ASSESSMENT FOR PRESERVATION (CAP) REPORT

## CATOCTIN FURNACE HISTORICAL SOCIETY JULY 7-8, 2022

Respectfully Submitted by: Mary Jablonski, architectural conservator &  
Lori Trusheim, objects conservator  
Final Report Submitted on: September 30, 2022

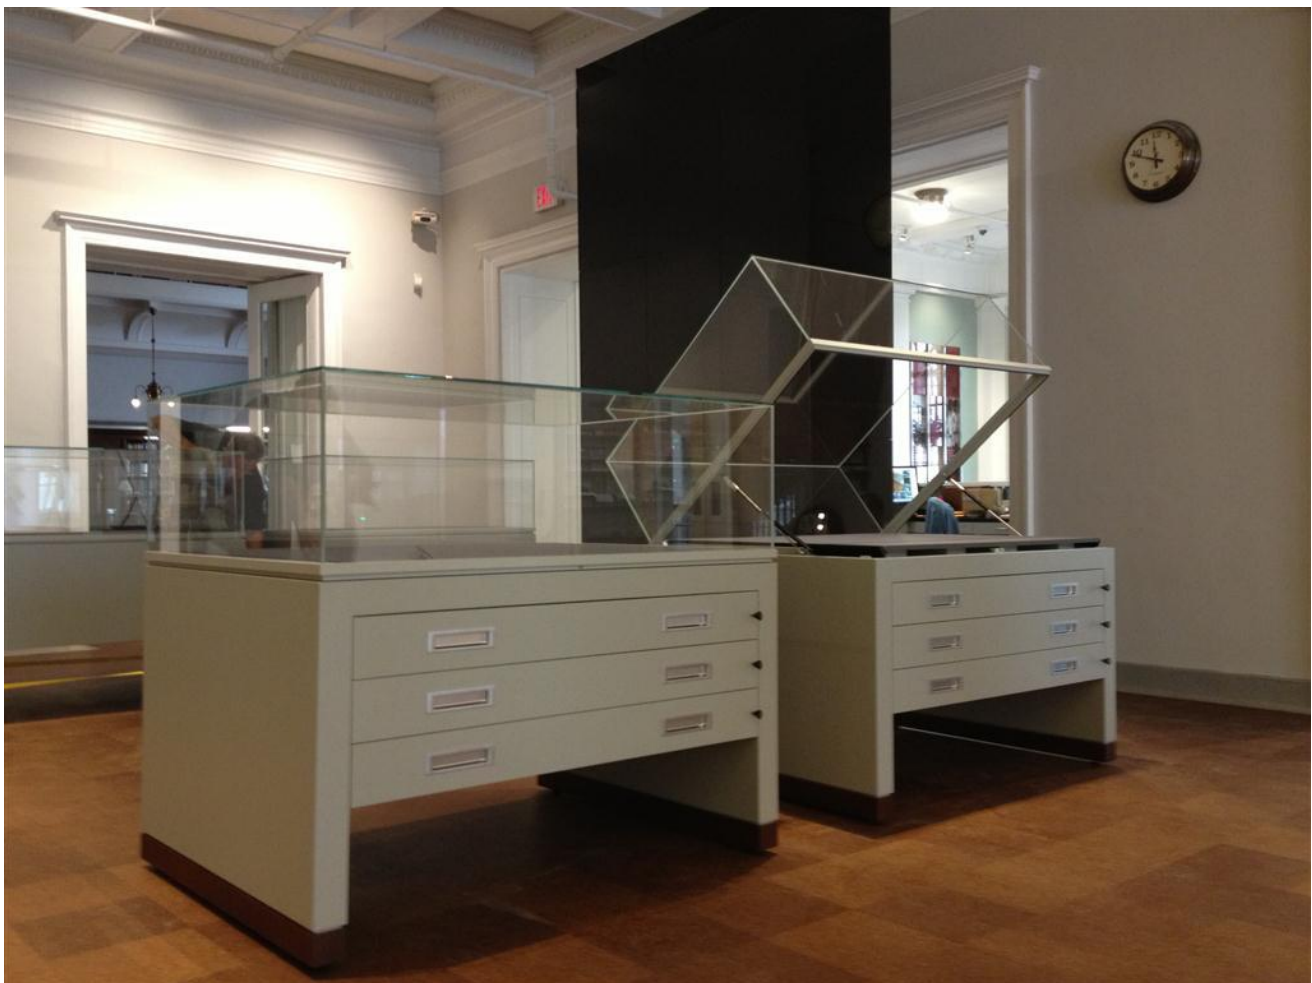
Figure 41: Image of hinged glass hood custom vitrine from Casewerks mounted to a custom base cabinet made by Delta Designs, LLC. Image provided by Bill Beitel, [bill@casewerks.com](mailto:bill@casewerks.com), Casewerks, LLC.

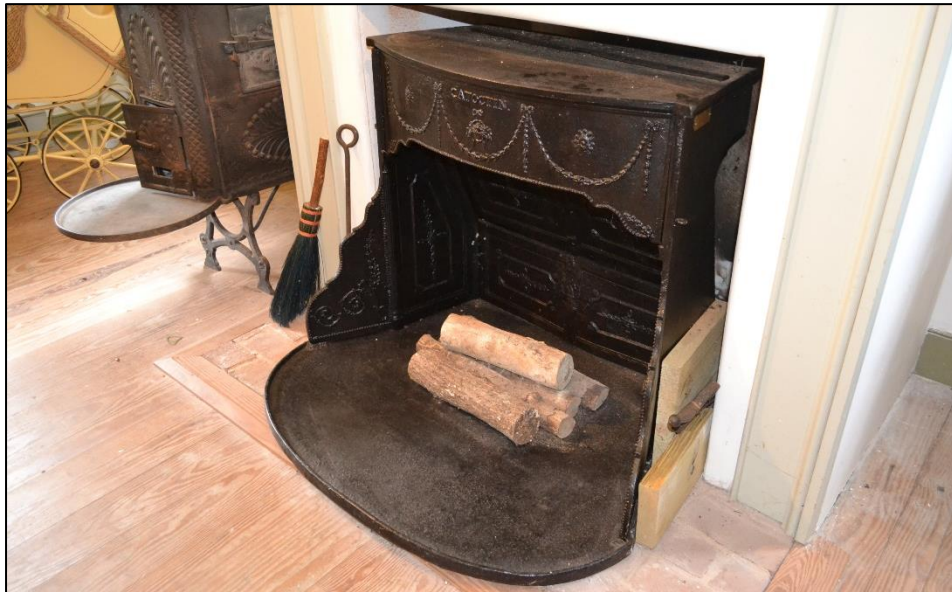
*Figure 44: Fresh wood can harbor and attract insects. Investigate replica logs for display, but Mylar should be placed between replica log and metal surface.*

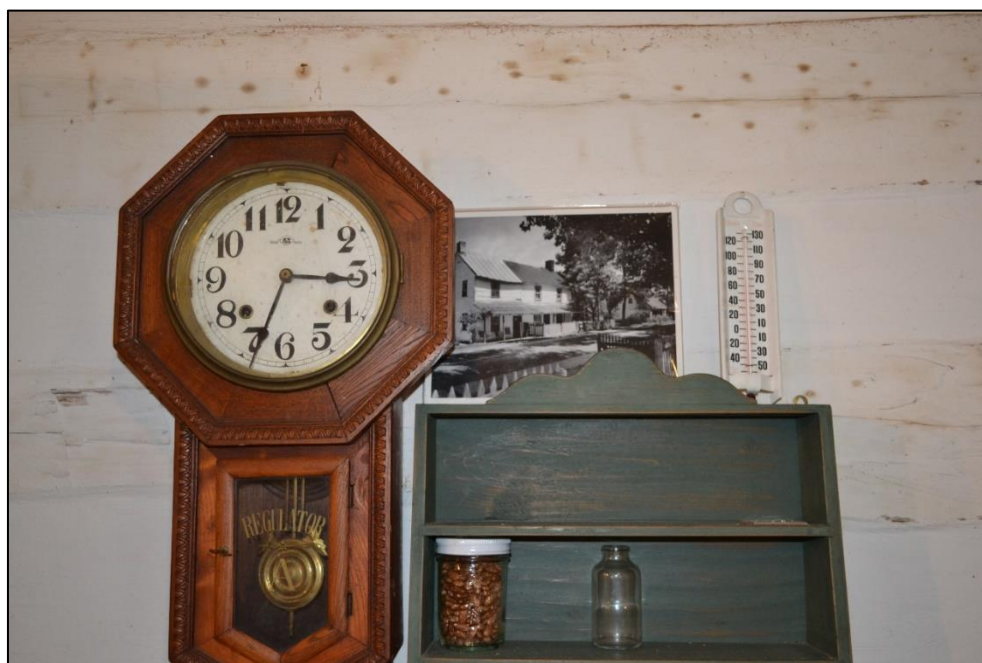
*Figure 45: Thermometer often falls off the shelf and loose coin on shelf is vulnerable for theft. Explore methods to increase security of objects.*

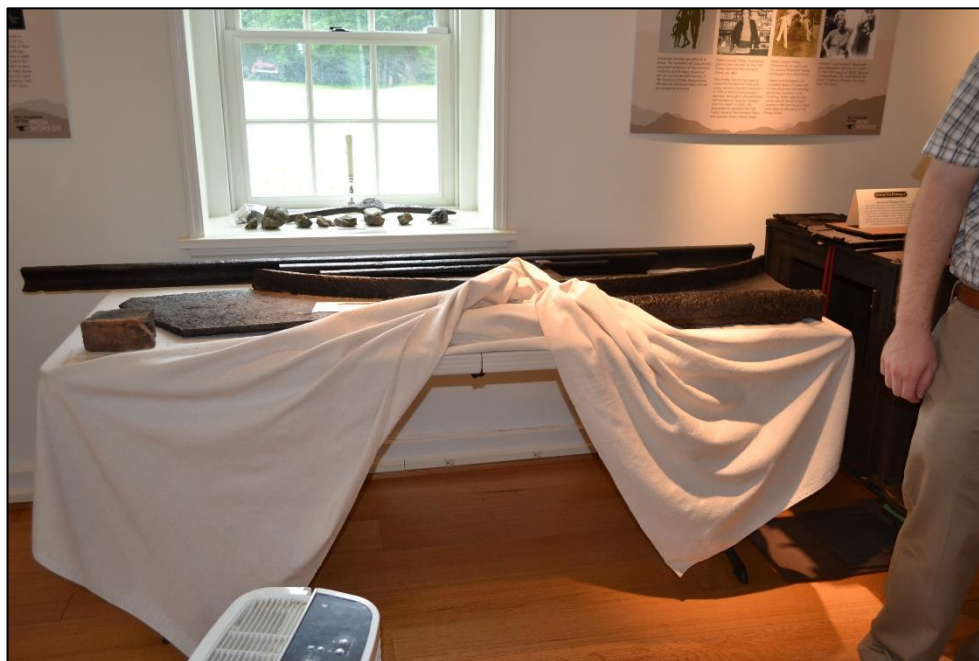
*Figure 46: Folding table at Museum of Ironworker slated for replacement to better support the heavy iron objects.*
