**CAPSULE SUMMARY****Implements Building****MIHP#: F-6-20-1****No street address; National Shrine of Saint Elizabeth Ann Seton****Emmitsburg, Maryland****Date: c.1898-1906****Access: Private**

# Maryland Historical Trust

## Maryland Inventory of Historic Properties Form

Inventory No. F-6-20-1

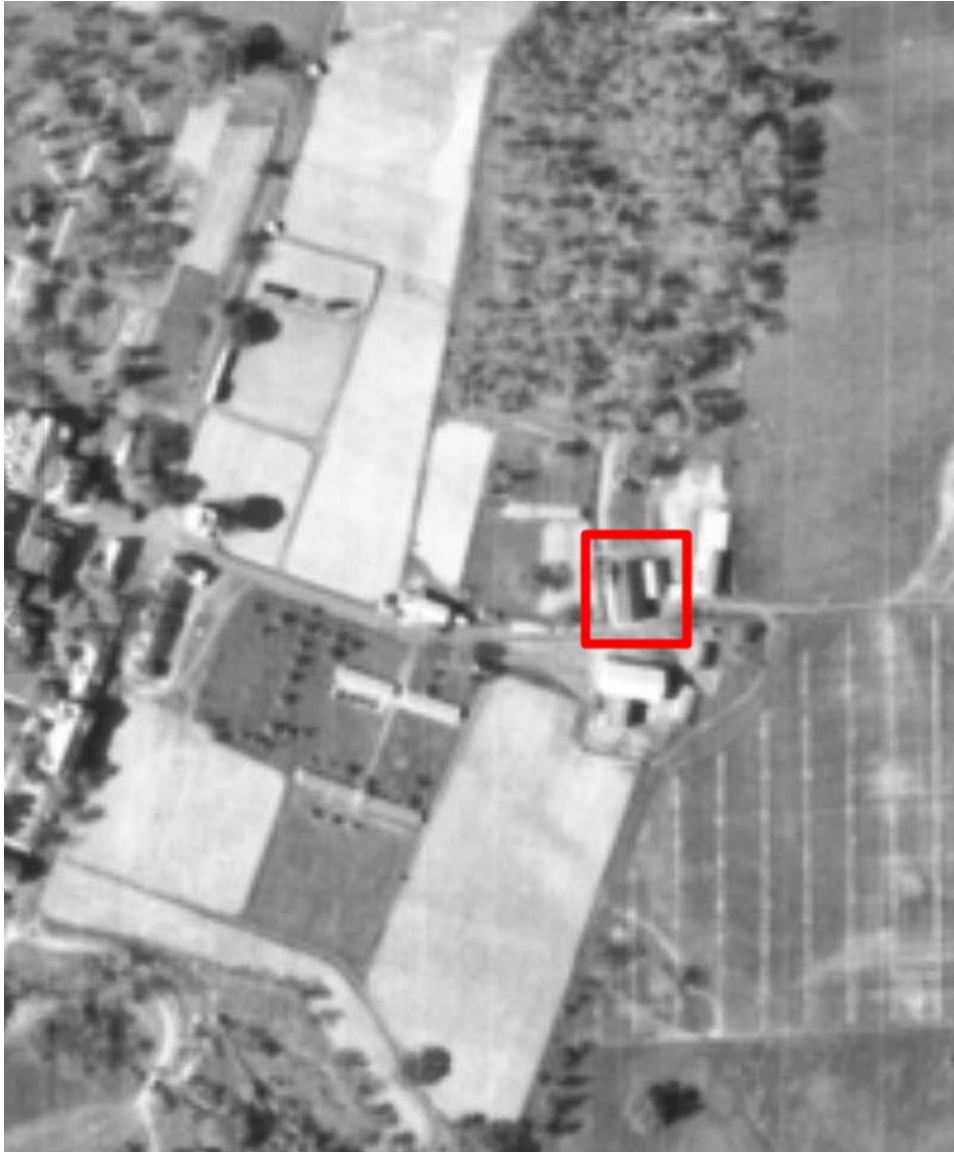
**Figure 4: St. Joseph's Farm, 1938; Implement Building Highlighted.**  
**Source: Record Group 145: Records of the Farm Service Agency, National Archives at College Park - Cartographic (RDSC). Taken by Department of Agriculture. Commodity Stabilization Service. Aerial Photography Field Office.**

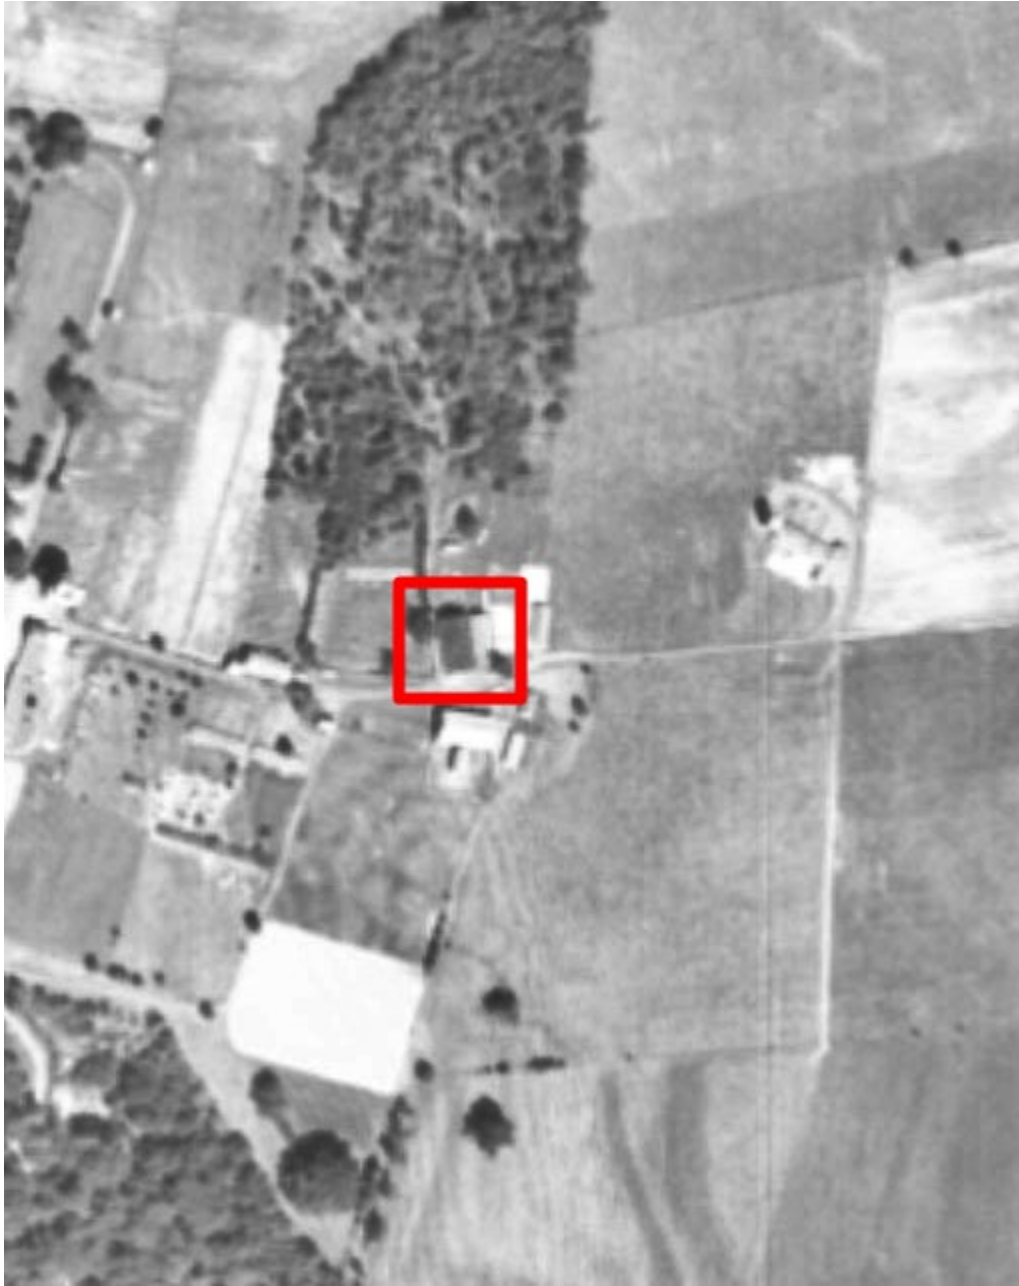
**Figure 5: St. Joseph's Farm, 1952; Implement Building Highlighted.**  
**Source: Record Group 145: Records of the Farm Service Agency, National Archives at College Park - Cartographic (RDSC). Taken by Department of Agriculture. Commodity Stabilization Service. Aerial Photography Field Office.**

Sister Mary Bernard McEntee, who graduated from St. Joseph's Academy in 1925, recalled the school's — and therefore its farm's — offering: "The food was good, wholesome, and plentiful, but the routine menu disposed any need for calendar, for the day was known by its fruits, meat, and potatoes, etc."<sup>8</sup> It is unknown how the farm operated beyond the 1920s. An aerial photograph from 1938 shows the complex, much as it appeared in 1906, with the Implement Building and Brick Barn still dominant features on the landscape (Figure 4). They are surrounded by active fields to the northwest, south, and southeast of the complex. Directly north of the farmstead is a small woodlot that still stands today. An aerial image from 1952 reveals a similar scene, though the farm fields appear to be fallow or in pasture (Figure 5).

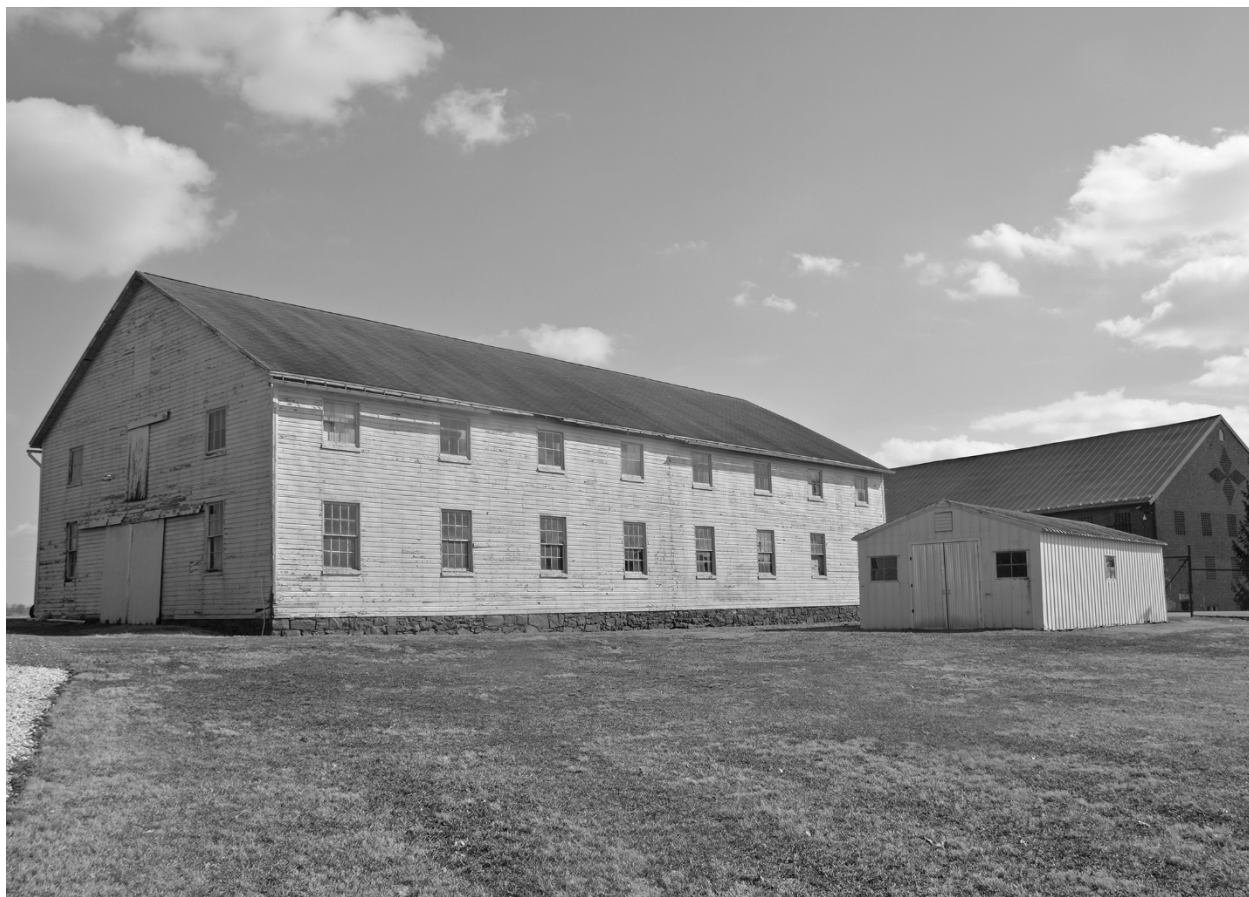
F-6-20-1\_2022-02-26\_01.tif

West elevation, camera facing southeast. February 26, 2022.

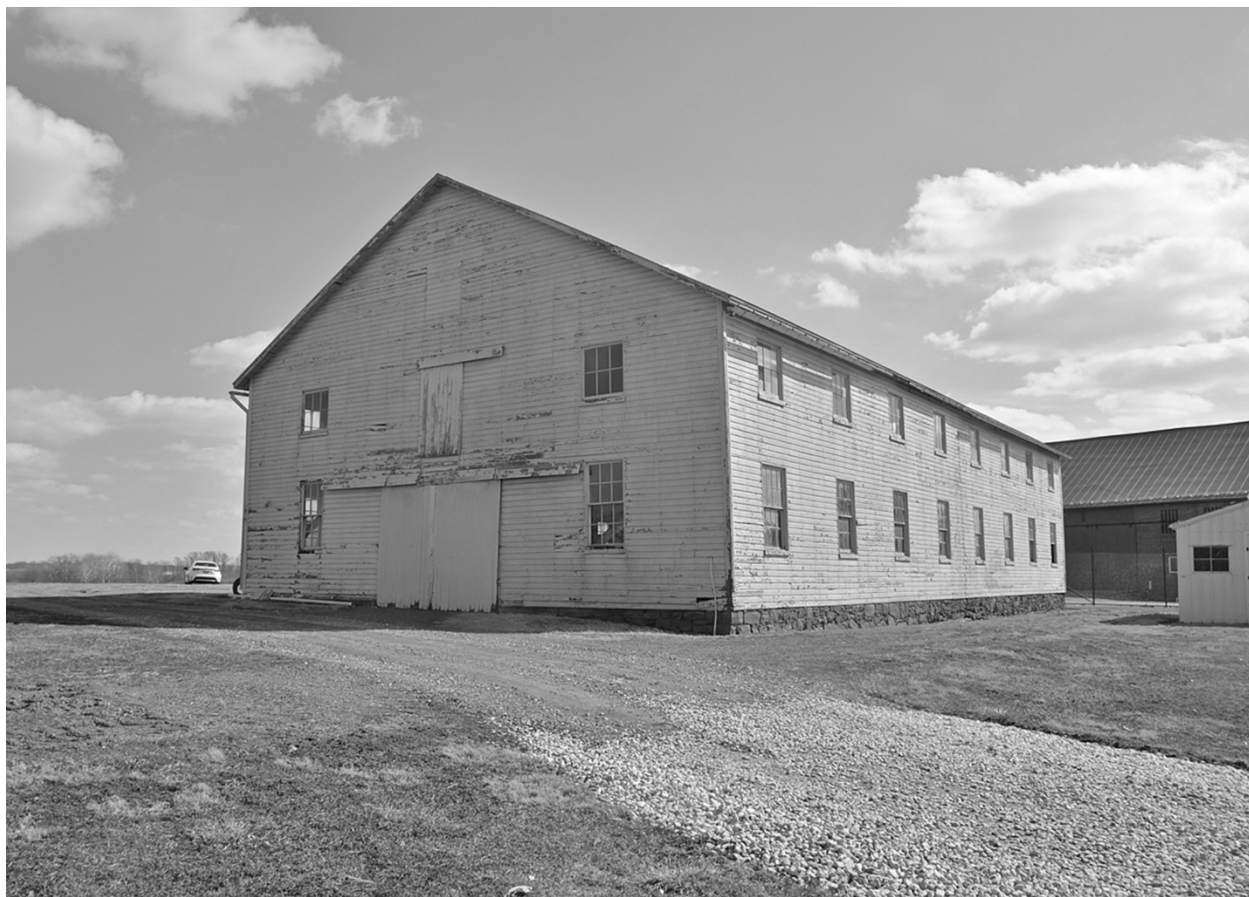
The 50'x100' rectilinear structure has a two-story height with a gable-front form. Its long side elevations are divided into eight bays (Photo 2). These are fenestrated with windows at the ground and loft levels. The ground-level units are tall, 8/8 wood sash, with a 0.75" muntin width. Shorter six-light fixed sash windows with the same muntin profile daylight the loft. Large sliding wood doors give access to the barn at the north and south elevations (Photo 3). The doors are made of two 28½" x 99" panels of bead board siding arranged on a rolling track. Above are hayloft openings arranged at different levels.

F-6-20-1\_2022-03-03\_02.tif      East elevation, camera facing southwest. March 3, 2022.

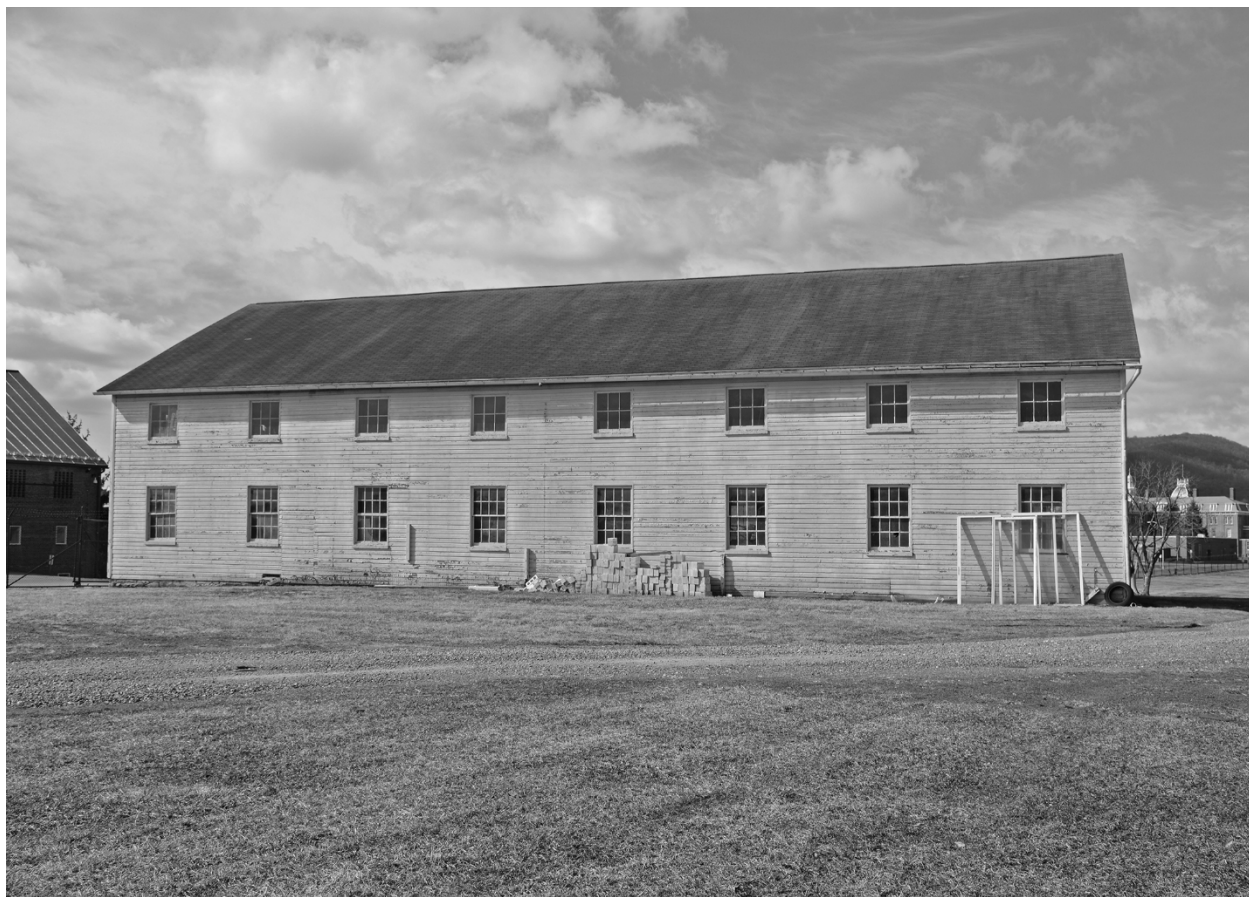
F-6-20-1\_2022-02-26\_03.tif      North elevation, camera facing southeast. February 26, 2022.

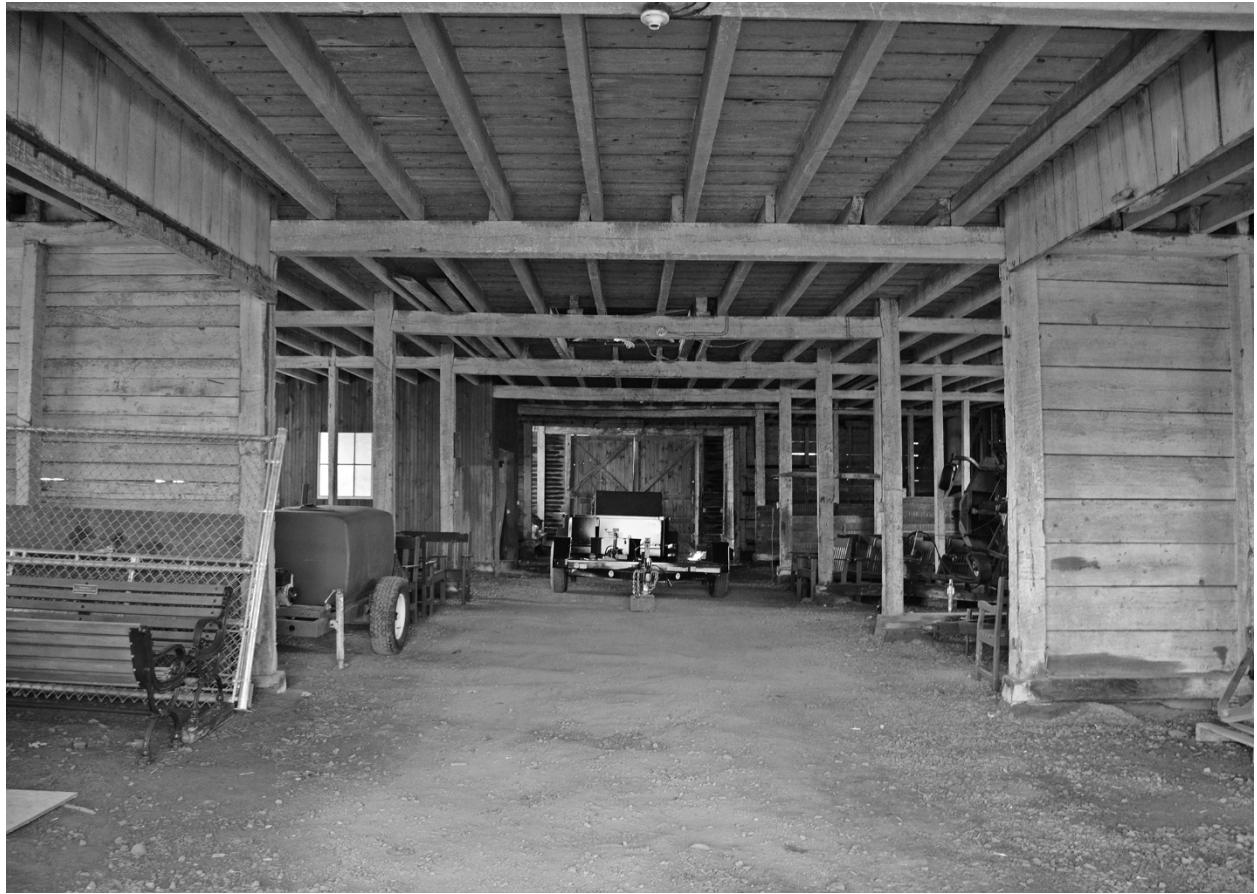
The interior is divided into 16 stalls or bays arranged along a 20'-wide center aisle (Photo 4). The stalls differ slightly in dimension and design, indicating their different uses.

F-6-20-1\_2022-03-03\_04.tif      Ground floor, camera facing south. March 3, 2022.

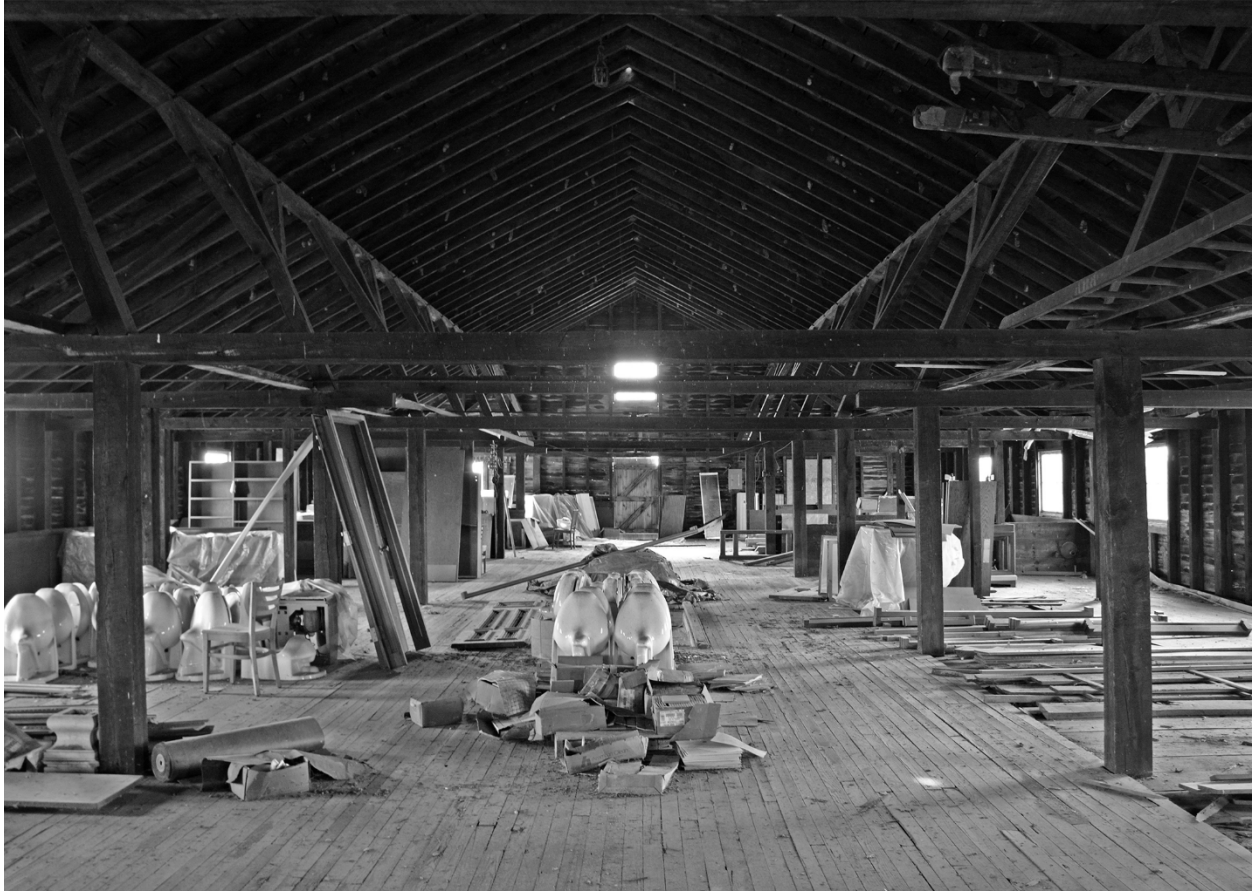
The loft is accessed through a stall at the southwest corner of the building. Thirteen wood steps, without railing, lead to the attic. The loft is a roughly 4,886-square-foot open space arranged into similar bays as the ground level but without partitions (Photo 5). It historically stored hay and various grains milled for animal feed.

The light and airy space is created by its tall, 26'-4" headroom and a line of windows along the side walls. It has a mixture of flooring material, including sections of tongue-and-groove and random width boards. A 62"x115" hay hatch at its center correlates to a block and tackle above. Simple 48"-wide plank doors mark

**Photo 4 of 5:**  
**Loft, camera facing south. March 3, 2022.**  
F-6-20-1\_2022-03-03\_05.tif

F-6-20-1\_2022-03-03\_05.tif      Loft, camera facing south. March 3, 2022.
