CATOCTIN FURNACE DOUBLE LOG HOUSE

A HISTORIC STRUCTURE REPORT

THE CATOCTIN FURNACE HISTORICAL SOCIETY

PRESERVATION ASSOCIATES

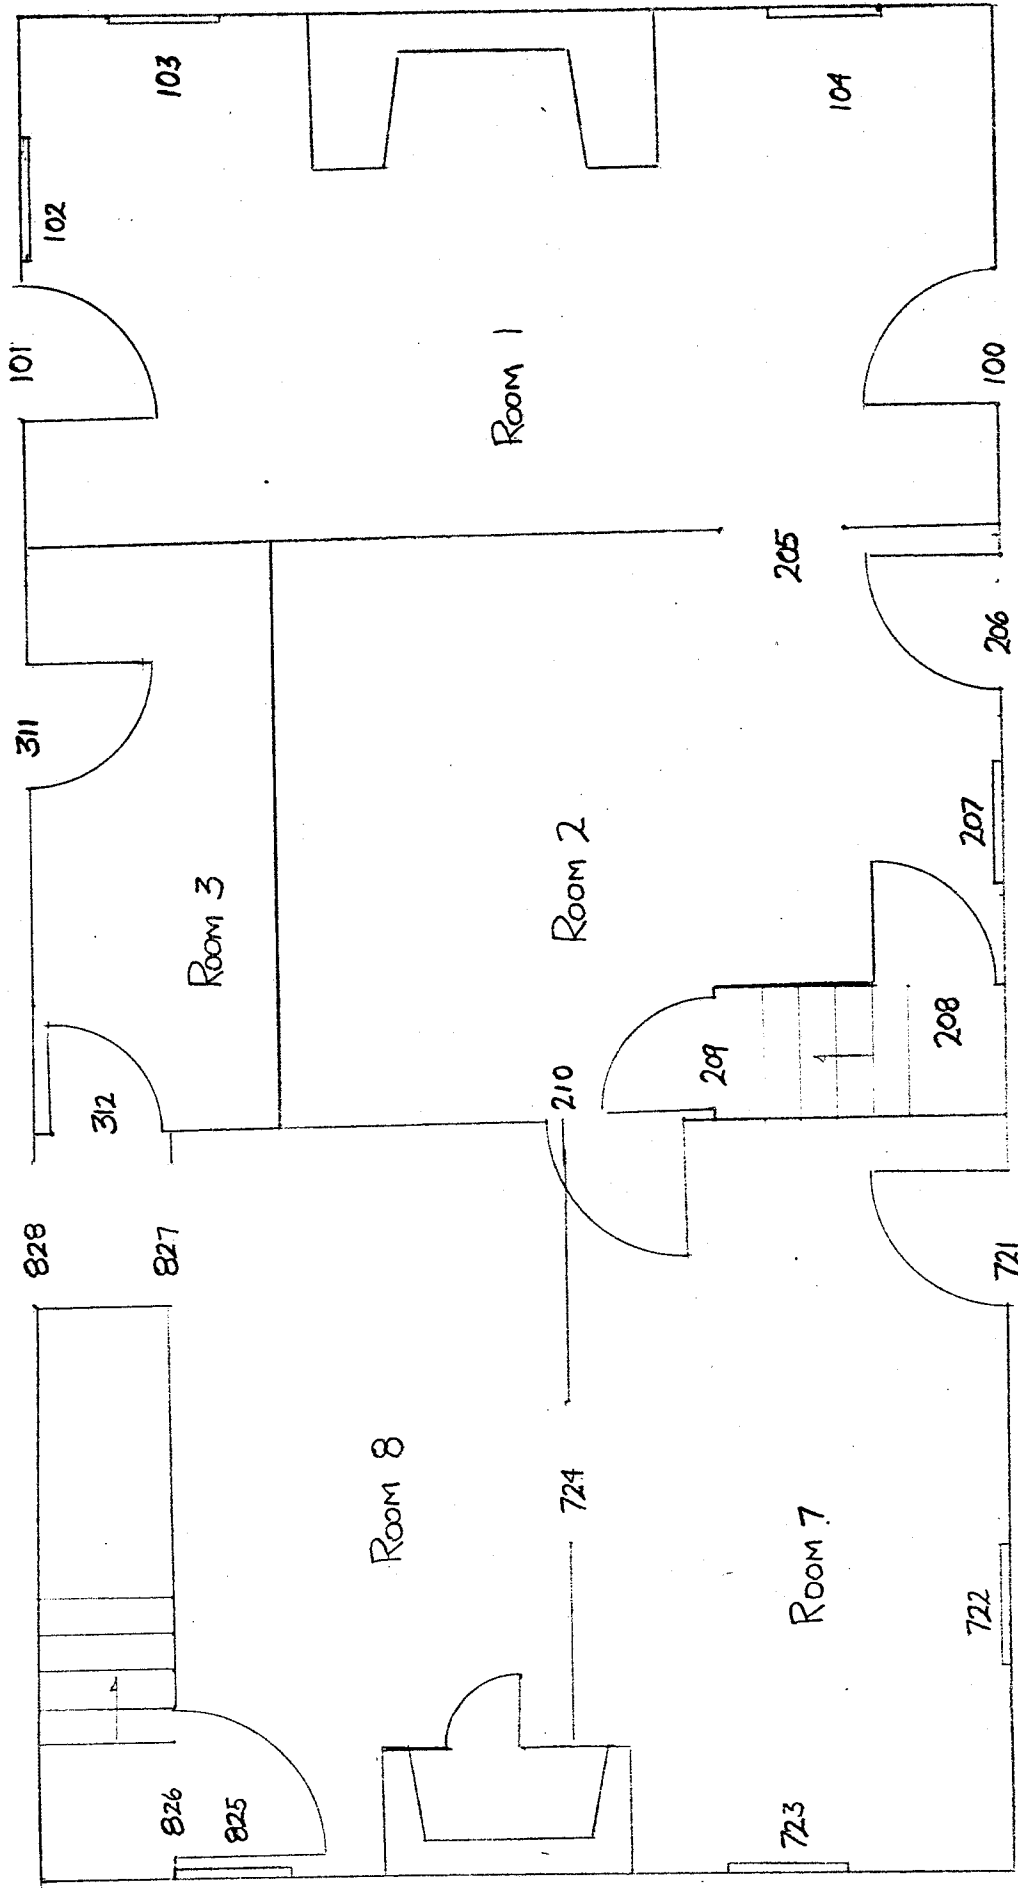
First Floor Plan.
 Scale: 1/4" = 1'
 N

Room 2, probably an original parlor, is divided from the kitchen by a modern stud partition. The jamb for door #205 shows extensive termite damage. Although further examination is required to determine whether it follows an original partition, a wall in this location is consistent with typical floor plans of the eighteenth and nineteenth centuries. Like the kitchen, this room retains little original work having been remodeled extensively at various times during the twentieth century. The board and batten exterior door (#206) which is presently nailed shut gave this room a separate exterior entrance. An enclosed winding stair has been installed in the northwest corner of the room. Beneath the rough plastered wall, immediately east of the stair, was found a door (#210) which led to the addition. Dating from the late nineteenth or early twentieth century, the door had horizontal panels and was cased with beaded trim having a back band. The present particle board floor dates after the mid-twentieth century.

Room 3, a small area at the northeast corner of the house, is divided from room 2 by a vertical board partition which is plastered on its west side. This room retains more nineteenth century woodwork than any other part of the first story in the main house. The floor, however, has been replaced with one inch particle board and is in poor condition. In the north wall of this room is an original exterior door which later opened into the addition. It displays original red and blue paint, red being the first coat on the casing with deep blue applied above. The entire door is red. The door trim is pine, 1" x 2-3/4" with mitered corners and a one-half inch bead at the inside edge. In the east wall of the room is another door which now enters into the twentieth century one story addition that extends the length of this portion of the house. The door appears to date from the mid- to late nineteenth century and has a hand-made Suffolk latch. Original dark grey-blue paint can be seen on the baseboards which are 1" x 6" with a half inch bead at the top edge.

The general condition of the house is fair with most deterioration being the result of water damage or the dampness of the ground beneath the house.
