# CATOCTIN FURNACE

A Design Program for the  
Investigation, Repair and Stabilization of the  
Retaining Walls and Furnace Stack at  
Catoctin Iron Works  
Cunningham Falls State Park

The Construction History of the Stone  
Retaining Walls and Furnace Stack

Project #P-016-741-401

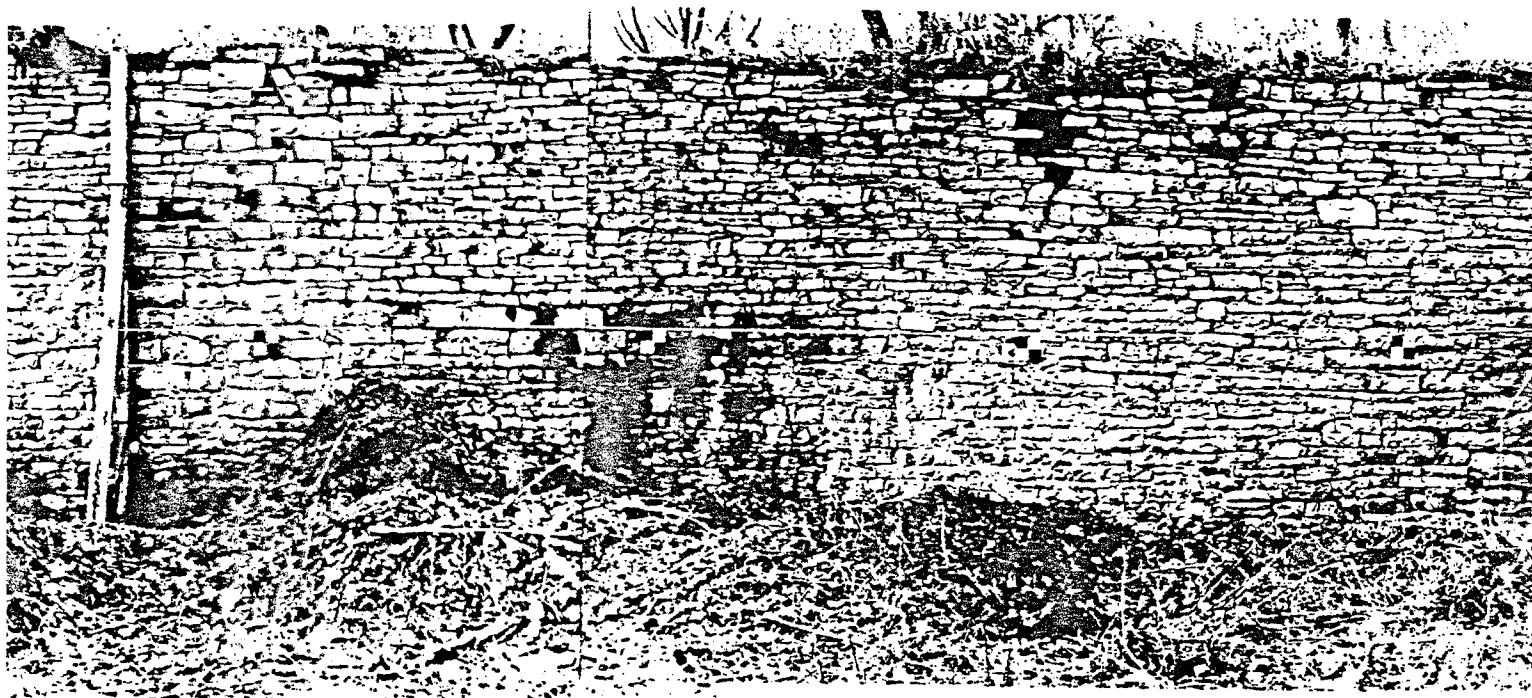
Plate 8, 9, 10, and 11

South end quadrant of long retaining wall, mid south quadrant of long retaining wall, mid north quadrant of long retaining wall, north end quadrant of long retaining wall.

This is the longest uninterrupted section of the wall. It runs in a north-south axis for approximately 135 feet. (Refer plates 8, 9, 10, & 11). Its construction of rock-faced sandstone cut into rectangular blocks is that already discussed for the entire wall except for the "Isabella" stack and the wall to its north. The wall has deteriorated due to weathering, lack of maintenance, and overgrowth of vegetation. In 1974, a wooden brace was planted against the east face of the wall, 72 feet north of the beginning of this span, between grid lines H and I. Approximately two feet north of the brace is a vertical crack in the wall. This area of the wall has moved and bows outward or

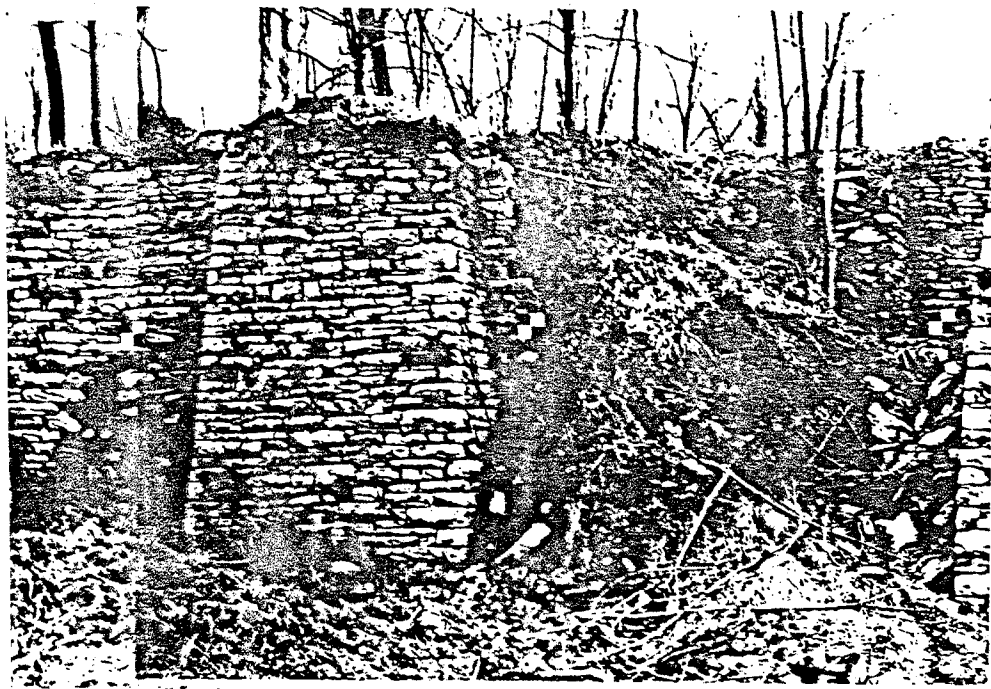
Plate 17

As was typical of stone construction in the 18th and 19th centuries, the rocks were cushioned by a soft bedding of clay or naturally oxidized silacious material combined with lime. (Refer plates 2 & 17). The purpose of the bedding (the interior mortar) was not, as usually construed, to bind the stones together, but rather to hold them apart. The mortar acts as a shock absorber to cushion the stones during movement of the wall caused by thermal changes and freeze-thaw action.<sup>3</sup> Soft mortars such as this were used predominately until the late 19th century when hard cement mortars were introduced. The principle behind the use of hard mortars is opposite that of soft mortars. A hard cement-mortared wall depends upon rigidity for its structural stability while a soft mortared wall depends upon flexibility.<sup>4</sup>

Inner wall construction, 18th Century bellows house wall.

The next section of the wall to the east, marked by the two protruding buttresses is approximately 25 feet in length. Much of this part of the wall has tumbled down, particularly toward its west end where the wall still follows its original configuration only for about six feet of its height. (Refer plate 17). The wall returns or is finished at each end indicating that this small section was between two openings, which may have resulted in the need for the buttressing. Joist pockets are in evidence in the recess between the buttressing and on the surface of the buttresses. These holes may indicate that some sort of structure was built into the wall, or they were simply unfilled holes left from the construction scaffolding. Photographs do not give a clear indication of what, if any structure was located in this area. In the recess between the buttresses is an area where stones have fallen away. The damaged section is about four feet wide near the base of the wall at grid line 4. Borings though the wall indicate that the wall in this area is not as thick as elsewhere.
