# Historic Structures/Cultural Landscape Report: The Carty-Miller House

12606 Catoctin Furnace Rd, Thurmont, MD

**The Catoctin Furnace Historical Society**

August 2023

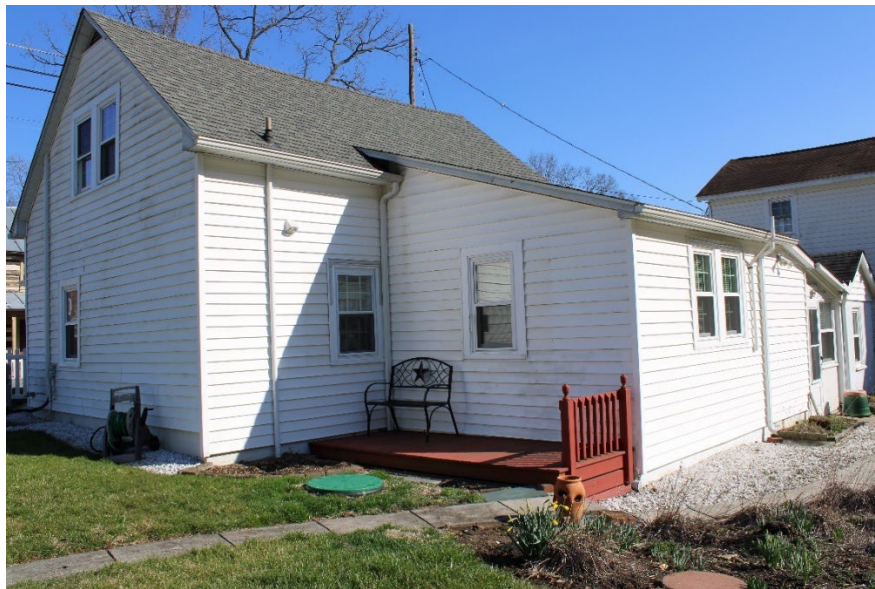
*Figure 3: A view of the dwelling, looking southeast, showing the rear deck with its bench, the two single windows around it, the concrete walkway stemming from the driveway, some of the gardens that run alongside it, the double kitchen window, the breezeway, and the laundry room. Chimneys have been removed above roof line. The spigot and hose attached to the side of the dwelling can again be seen to the left, and the septic tank's access riser can be seen just in front of the back deck.*

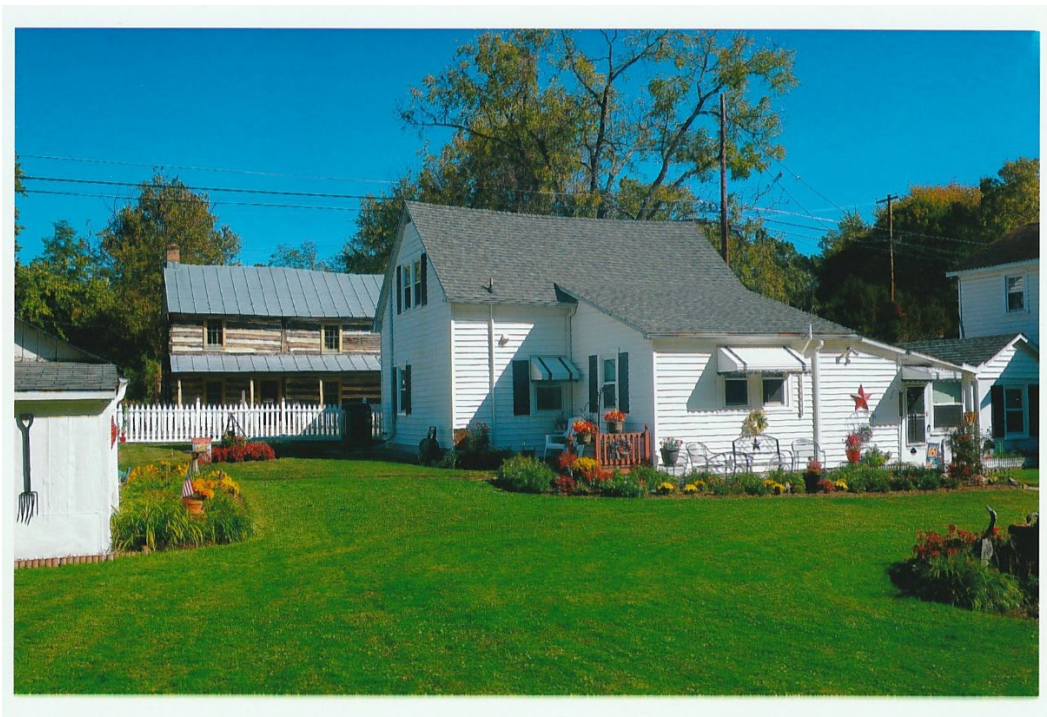
fueled the dwelling's stoves (*Figure 53*). The barrels which fueled this heating system are the same barrels which are currently placed inside of the garage (*Figure 15*). Furthermore, the dwelling included two chimneys, one which rose from the living room, through the second story, and emanated from the southern elevation of the gable-framed portion of the roof, and another which arose from the kitchen (*Figure 55*). These chimneys were used when the dwelling still utilized the kerosene stove heating system, and they were removed in June 2014 when new shingles were placed on the roof (*Figure 7*).

*Figure 7: View of the dwelling from the northern rear yard. The awnings on the breezeway door, kitchen window, and window over the back deck are all visible, as are the shutters on the two windows on the north elevation of the dwelling, the two above the back deck, and the one on the laundry room. Chimneys have both been removed above roof line. Various gardens, lawn ornaments, and exterior house decorations can be seen, such as the red star to the left of the breezeway door. (ca. 2021). Photograph by Joann Miller.*

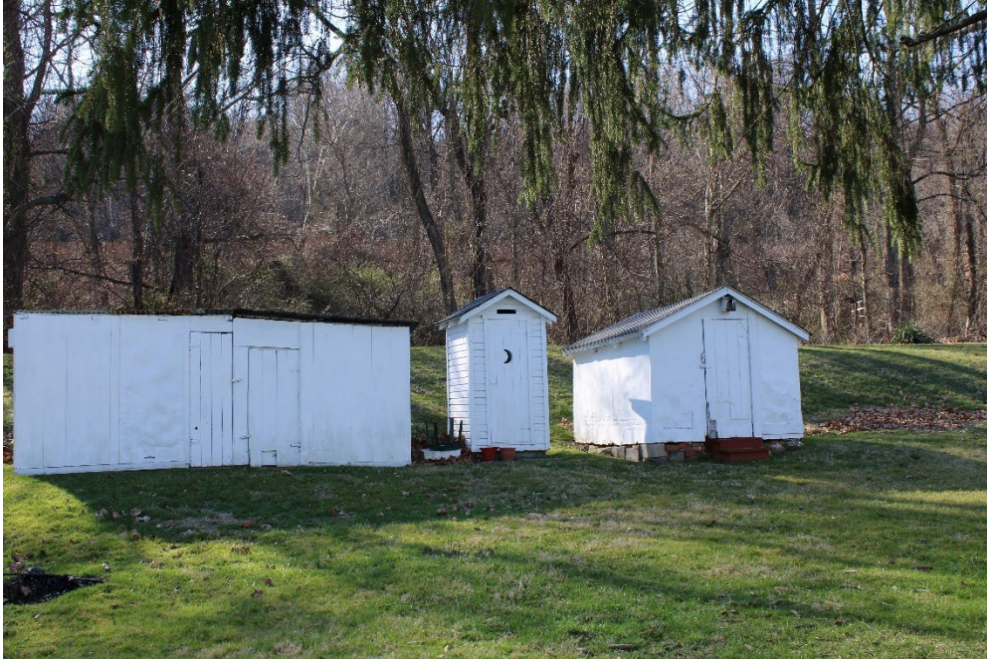
rooted into the ground, it is possible that the placement of the tree on such a steep slope could be hazardous if it were to fall, as it would almost certainly fall into the properties of 12606 and 12604 as can be estimated by the manner in which it is leaning. The plants around the yard, as well as the grass, are also currently in serious need of maintenance, as is the case with the outbuildings, particularly the outhouse and hog pen.

*Figure 26: The three outbuildings at the western edge of the rear yard. From left to right: The chicken coop, the outhouse, and the hog pen.*

recommended to organize a plan for regular lawn maintenance, and to repaint and repair the outbuildings as necessary.

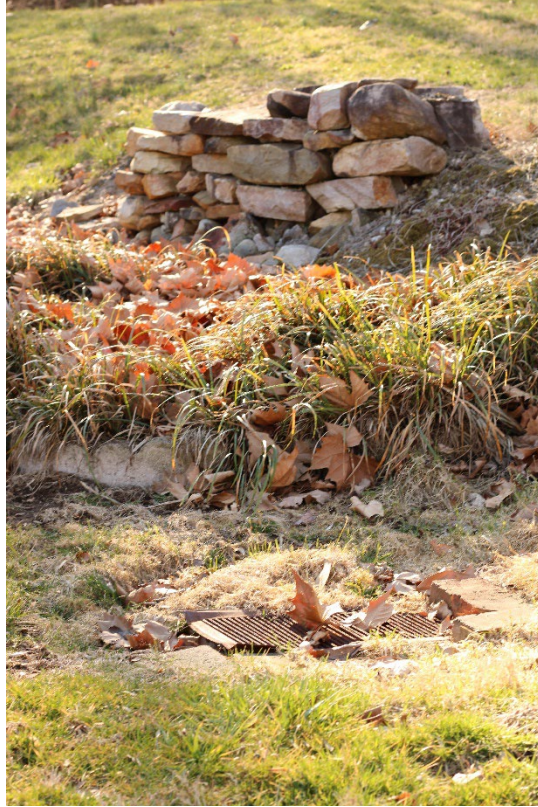
The rusted grate near the burn pit was originally placed where it is due to the fact that a spring flowed under the trolley bed, although this was not always the case throughout the property's history. Nevertheless, after the north and southbound lanes of Route 15 were laid, drainage from the roads and mountains west of them began to flow into a ravine on the west side of the trolley bed hill, causing water to collect and seep through and underneath a bank of cinder blocks along the west side of the trolley bed hill. This cinder block bank was installed along with the highway lanes as a form of drainage system. The water flowing down from Route 15 made, and still makes, its way into the ground in the adjacent rear yards, thus allowing some of it to flow through the rusted metal grate in the Carty-Miller property. Around the time the stream in the rear yard was run underground through a pipe, Clint Miller ran a small length of pipe underneath the grate to connect to the culvert. The exit of the culvert into the ditch portion of the stream is roughly where the grate just inside the Rohwein property described in the "Current Conditions" section is located. As late as March 2023, there was no such grate, and the end of the piped stream was instead covered with dirt, halting the water flow and allowing it to seep directly into the ground, which caused noticeably severe oversaturation of the surrounding ground areas in the Carty-Miller and Rohwein properties.

*Figure 38: The grate's position in regard to the paper burn pit.*

I recommend that CFHS consider hiring a consulting hydrogeologist to investigate the moisture in the soil, the culvert through which the stream runs and the pipes connecting to it, the pipe running directly south from the rusted grate, connections they may have to the water problems affecting the entire community, and make further recommendations for methods to solve them. This is because there are signs of an overabundance of groundwater in the Carty-Miller rear yard, particularly in areas around the culvert. Given the consent of the homeowners, the water in the grate on the Rohwein property line should also have its iron concentrations tested. Furthermore, given that the grate and pipe system installed by the Rohwein family appears to be considerably effective, it would most likely be optimal for it to remain. However, it should be inspected by the hydrogeologist in order to confirm that it is in fact the ideal method of continuing the historic ditch stream's flow. The CAP report prepared in July 2022 recommended removing water from the dwelling's basement, which should be dry; I highly agree with this suggestion. CFHS should also have said hydrogeologist consider if there is a correlation between the oversaturated soil and the water in the basement. Another course of action to consider in regard to the basement is to either clean out the ditch in front of the Carty-Miller house or work with the state to have pipe put in and have it covered. Prior to the early 1960s, the water in this ditch would dry up and water would not make its way into the Carty-Miller dwelling's basement. However, after a new artesian well was drilled at 12616 Catocin Furnace Road in the early 1960s, water began flowing in the ditch throughout the year, which continues to the present. It was around this time that water began to seep into the basement, which would noticeably increase if there was anything blocking the ditch's waterflow. As such, Clint Miller would routinely clean it out, which Joann continued to do after his death in 1988 until she sold the property. This did not entirely prevent water from entering the basement, but it would keep the amounts at a manageable level. Therefore, the ditch needs to be kept cleaned out, or pipe must be placed in order for the water to flow freely away from the property and not flood into the basement.
