Historic Structures/Cultural Landscape Report: The Hoke House

12602 Catoctin Furnace Rd, Thurmont, MD

December 2024

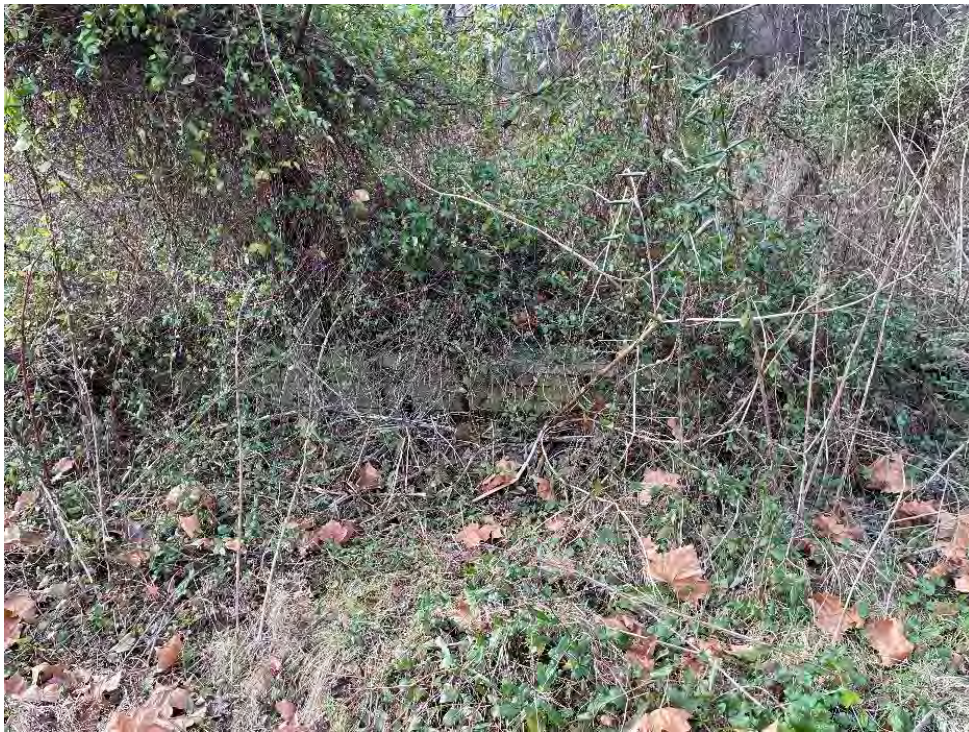
Figure 47: Concrete slab wall built along the trolley bed hill by Francis Smith, partially obscured by brush.

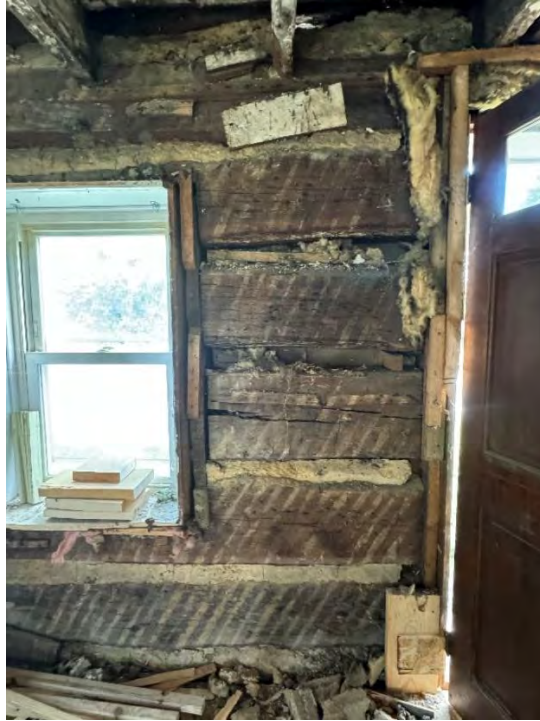
Figure 86: East elevation interior wall between the northernmost front window and the front door post-excavation. Small planks and blocks of wood can be seen intermittently attached to the original log wall. The chinking around the third highest log appears to have deteriorated or otherwise been stripped away, leaving gaps between the logs above and below it. (10 September 2024). Image courtesy of Elizabeth Comer.
