Historic Structures/Cultural Landscape Report: The Hoke House

12602 Catoctin Furnace Rd, Thurmont, MD

Tyler Wilson

December 2024

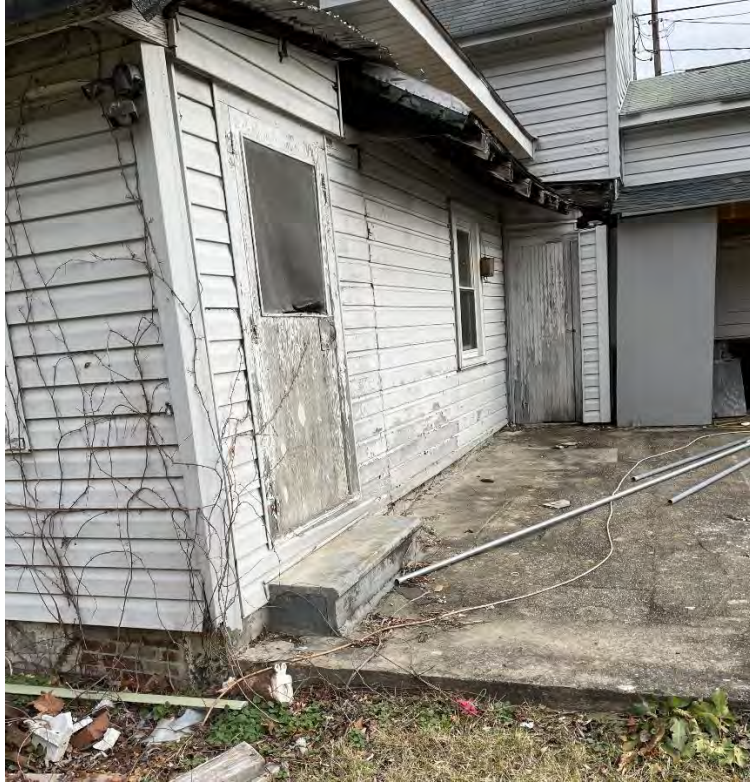
Figure 12: South elevation of the west addition, displaying the concrete patio, the screen door exiting the anteroom, the south-facing summer kitchen window, and the outside tool closet. At the far right of the image is a partial view of the lean-to structure covering the shallow entrance to the crawl space area. The south elevation's wood Dutch lap siding is also visible.

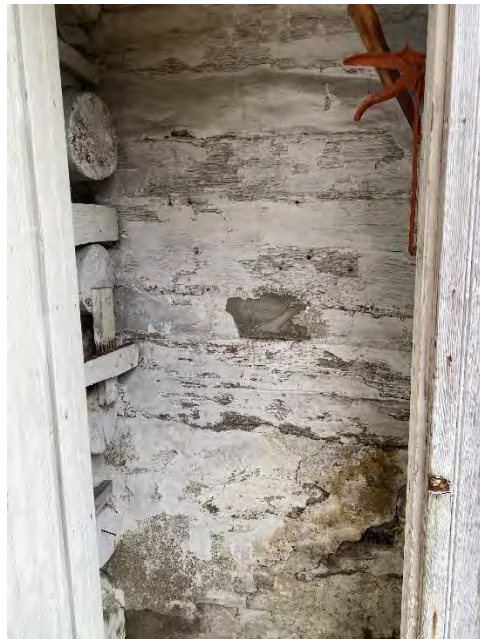
*Figure 13: Inside the outdoor tool closet, revealing part of the dwelling's original log construction. (19 December 2023).
Photograph by Elizabeth Comer.*

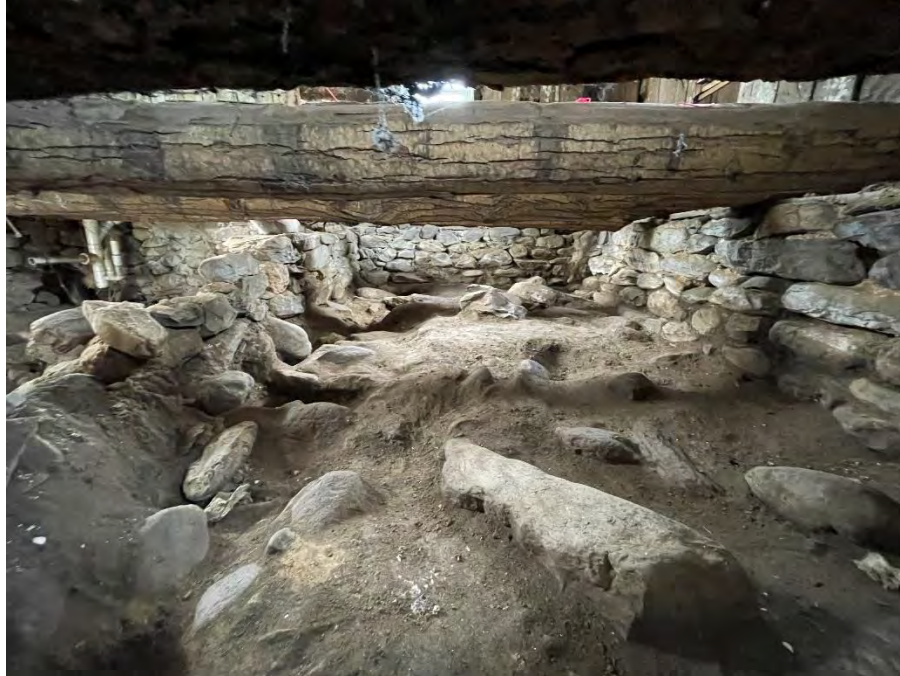
Figure 26: Eastern section of the crawl space area post-excitation, showing the area filled in with stone and earth, as well as the stone wall on the left, which blocked it from access prior to excavation. (25 April 2024).

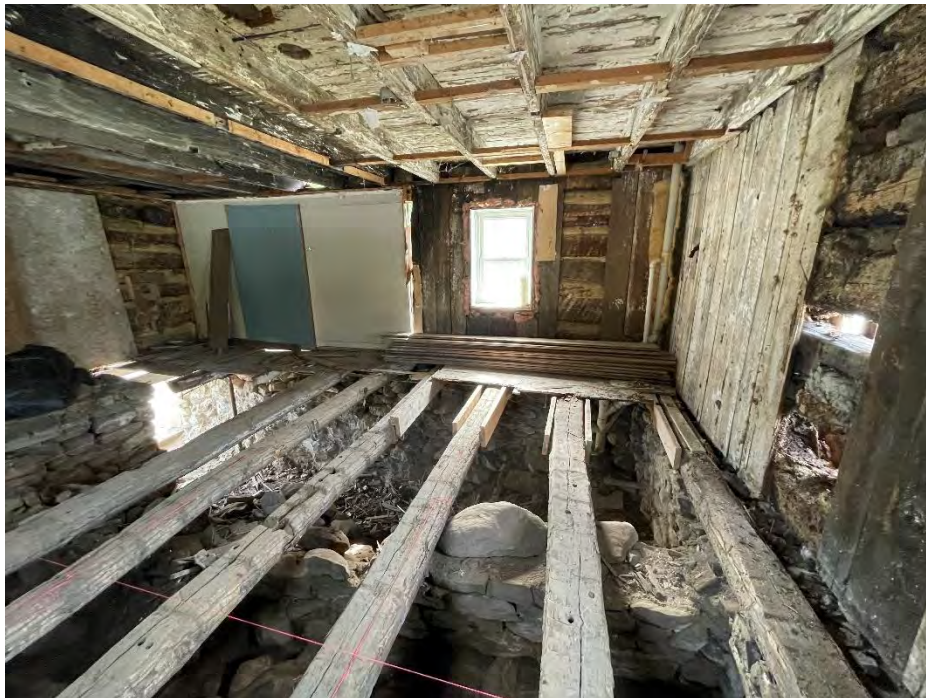
All the nonoriginal flooring in the original structure's first floor was removed during the excavation except for a roughly three-foot-wide section spanning the length of the west elevation (*Figure 27*), support boards attached to the original wooden floor joists (*Figure 28*), and the floor underneath the staircase. Similarly, almost all the nonoriginal components of the first-floor ceiling and drywall have been removed, save for the drywall along the staircase and the former west addition, as well as support boards for the original wooden ceiling joists (*Figure 29*). This has in turn revealed most of the structure's extant original components. It has also uncovered previous wallpapers on the east elevation, as well as pieces of printed paper, including multiple advertising posters, on the south and southwest elevations which were used for insulation (*Figure 30-31*). The wall separating the two upstairs rooms has been mostly removed, with only the frame of the wall and door (*Figure 32*) remaining. Furthermore, the second-story wood floor, which is original to the dwelling, has not been removed, although it is not particularly stable (*Figure 33*).

Figure 27: Post-excitation living room from the northeast elevation, showing the small section of nonoriginal flooring left along the west elevation after excavation; the section of drywall that once connected to the west addition; the original log floor joists, walls, and ceiling beams; some of the nonoriginal wood support blocks; and the stone hearth base (far left). (25 April 2024).

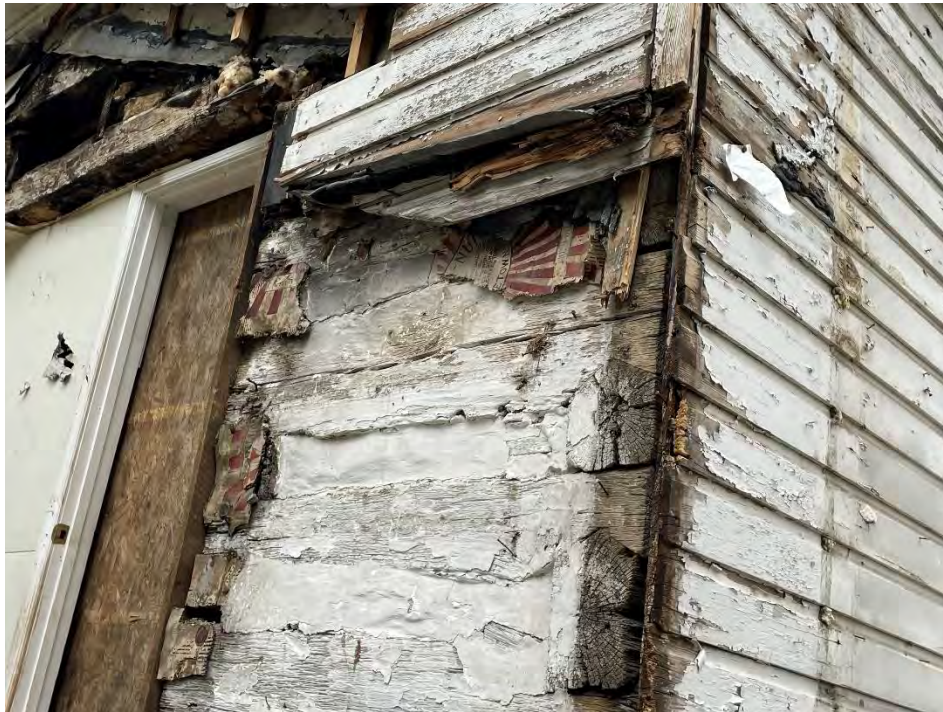
Figure 31: Exterior remnants of poster paper used as insulation attached to the original log wall in the southwest corner of the dwelling, where the outdoor tool closet once was. (25 April 2024).

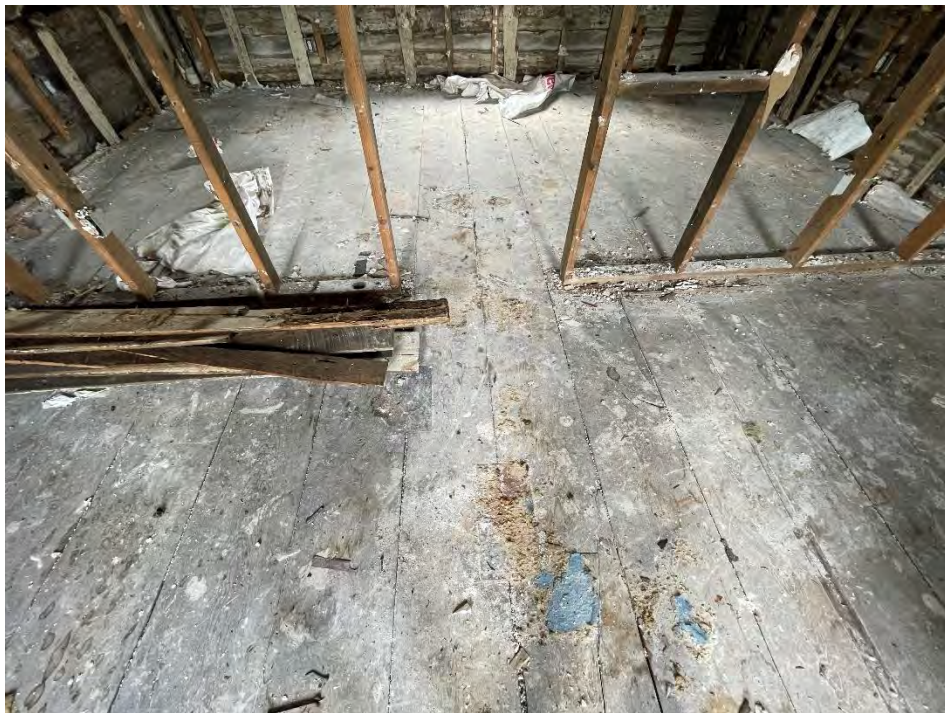
Figure 33: The original upstairs wood floor post-excavation. (25 April 2024).

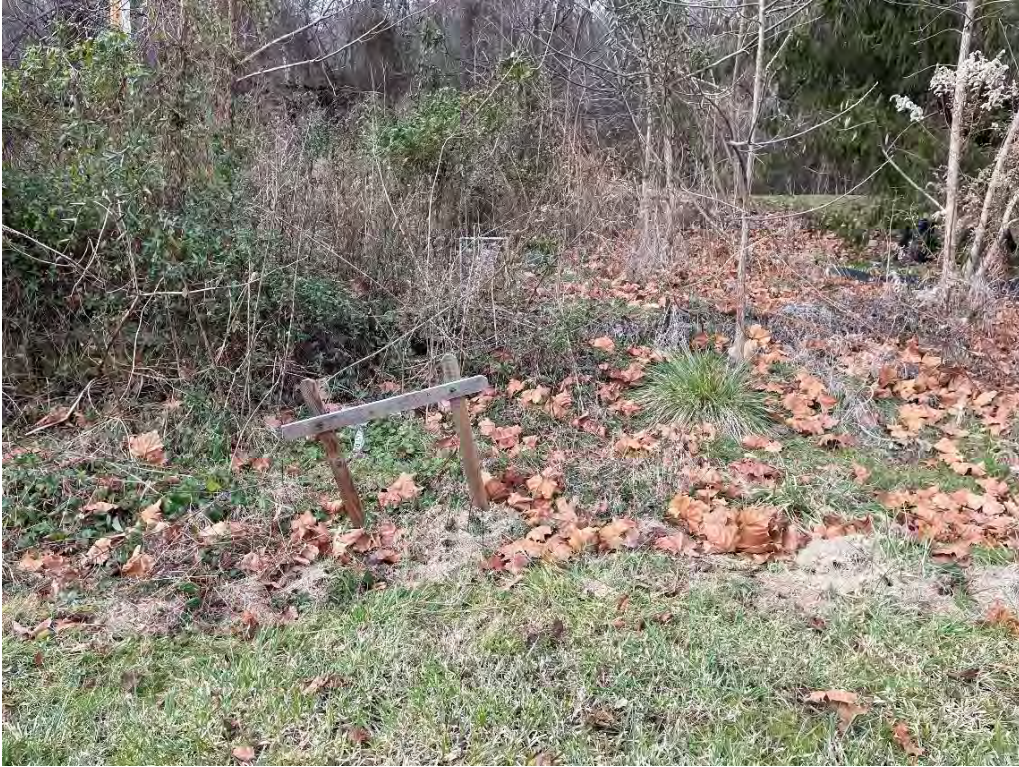
Figure 46: Target hangers Beverly Hoke's grandson used. The wood hanger is in the foreground, while the metal pipe hanger is tucked into the brush on the trolley bed hill behind it.

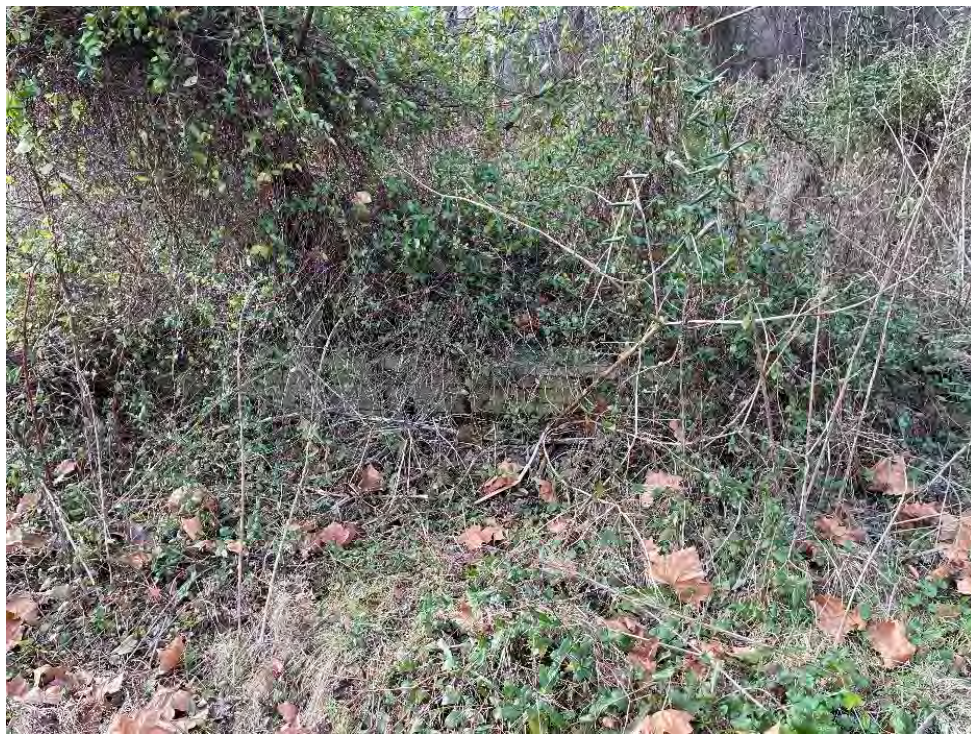
Figure 47: Concrete slab wall built along the trolley bed hill by Francis Smith, partially obscured by brush.

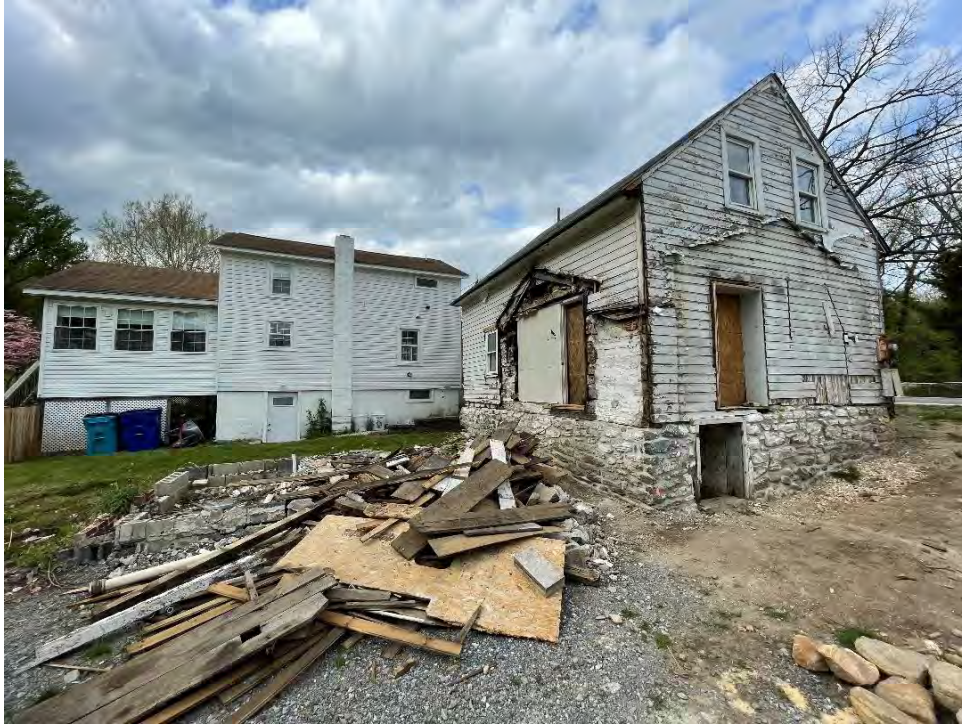
Figure 48: West and south elevations of the dwelling post-excavation. The outlines of both additions are visible on the original dwelling, and much of its original stone foundation has been revealed. The large divot in the ground where the patio and additions all were is evident when compared to pre-excavation photographs. (25 April 2024).

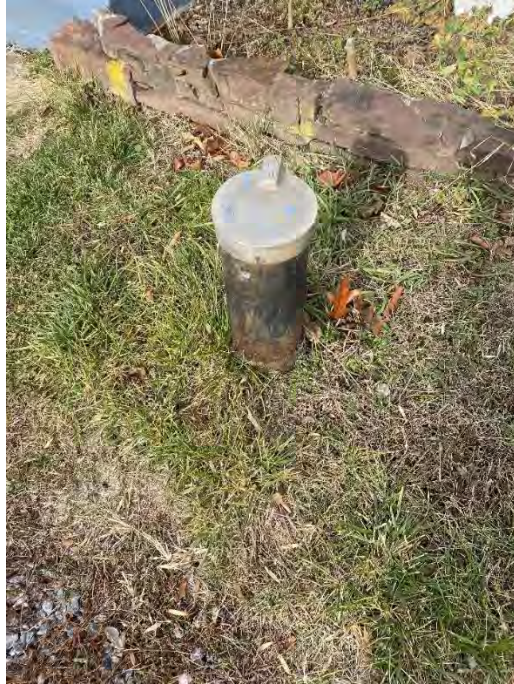
Figure 50: Black well casing between the driveway and south addition.

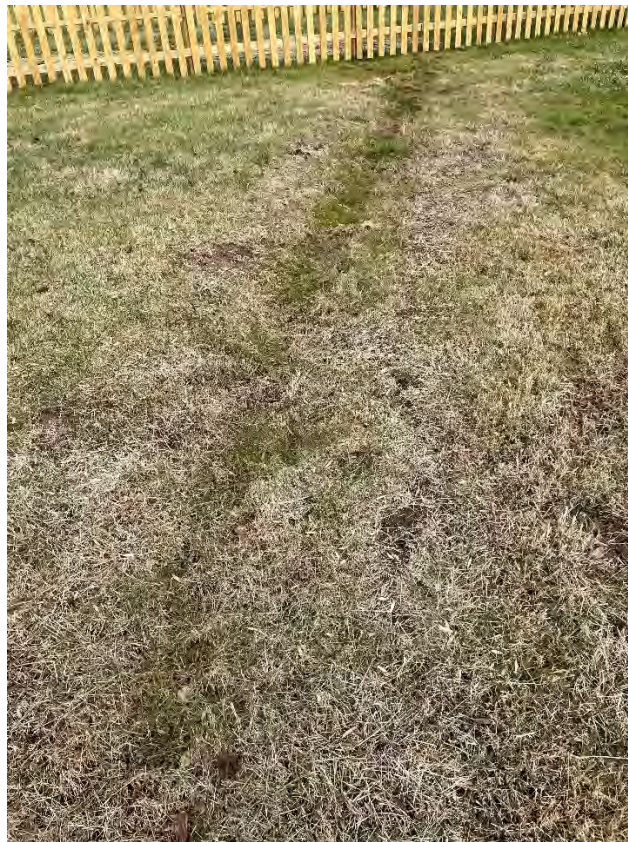
Figure 51: Section of the former ditch stream from the north property line to the middle rear yard.

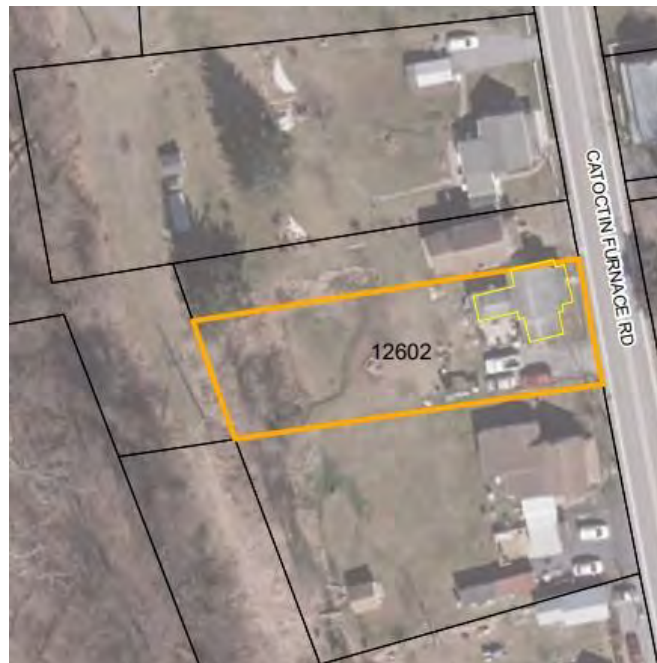
Figure 53: Property lines of the Hoke, Rohwein (north of Hoke), Carty-Miller (north of Rohwein), and Sweeney (south of Hoke) properties. The indented path of the former ditch stream through the Hoke property is more clearly visible here. The thin stretch of land taken out of the Hoke property in 1942 can also be seen in proportion to what the property area was before 1942. Image courtesy of Elizabeth Comer.

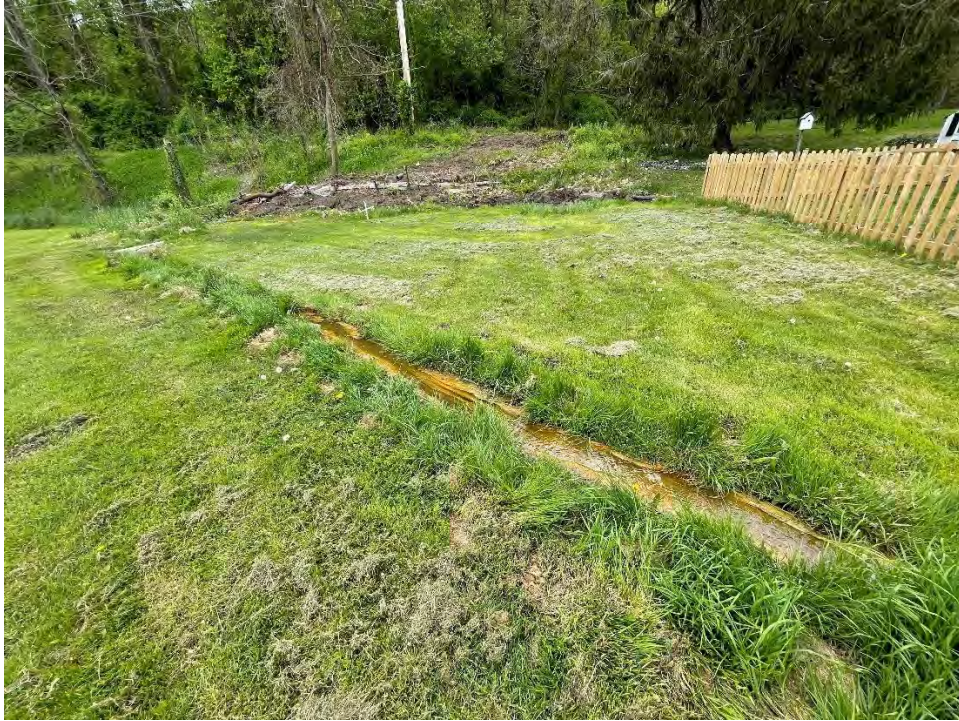
Figure 54: Ditch stream while it was temporarily active in spring 2024. (25 April 2024).

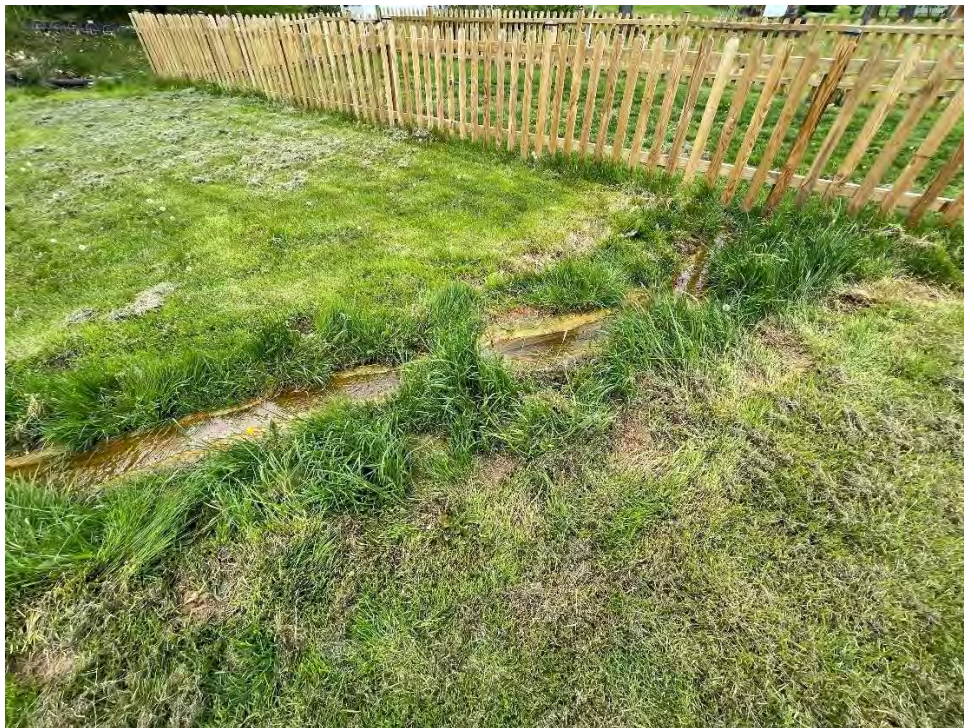
Figure 55: Active ditch stream where it emerged from beneath the fence in the Rohwein rear yard.

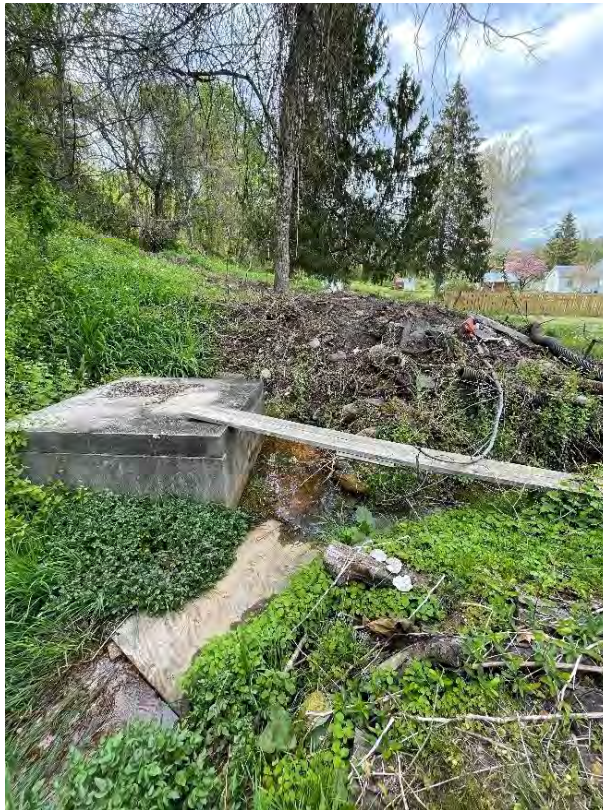
Located in the southwest corner of the Hoke property and northwest corner of the Sweeney property, there is a large concrete water intake structure, which is situated in the aforementioned channel and measures roughly five feet wide on all sides and protrudes about four feet from the bottom of the channel (*Figure 59*). The structure collects rain and subsurface water flowing down from Route 15 and the mountains west of Catoctin Furnace. According to a right-of-way and construction project issued by the Maryland State Highway Administration (MDSHA) on 29 October 1990, the structure was installed by MDSHA around summer or fall 1991 to improve water drainage from US Route 15 to Little Hunting Creek around Route 806A, likely as a means of reducing the amount of excess water flowing into the properties of Catoctin Furnace. For this project, MDSHA also instituted a temporary easement between the Hoke and Sweeney properties as well as along the channel extending south of the structure for the construction of the structure, a revision that was dated to 6 August 1991. Kenny Sweeney states that MDSHA purchased that corner of the two properties from him and Beverly Hoke for the project. He further attests that MDSHA also purchased the channel flowing south of the intake structure and the land immediately surrounding it from him and the other residents south of him. Water from the now underground ditch stream and the rusted grate both daylight around this structure and then flow south through the channel along the trolley bed hill. The stream continues south through this channel for roughly 450 feet before turning east, passing underneath Route 806A, and finally emptying into Little Hunting Creek.

Figure 59: Concrete intake structure just outside the Hoke and Sweeney properties, showing the channel surrounding and flowing south from it. (25 April 2024).

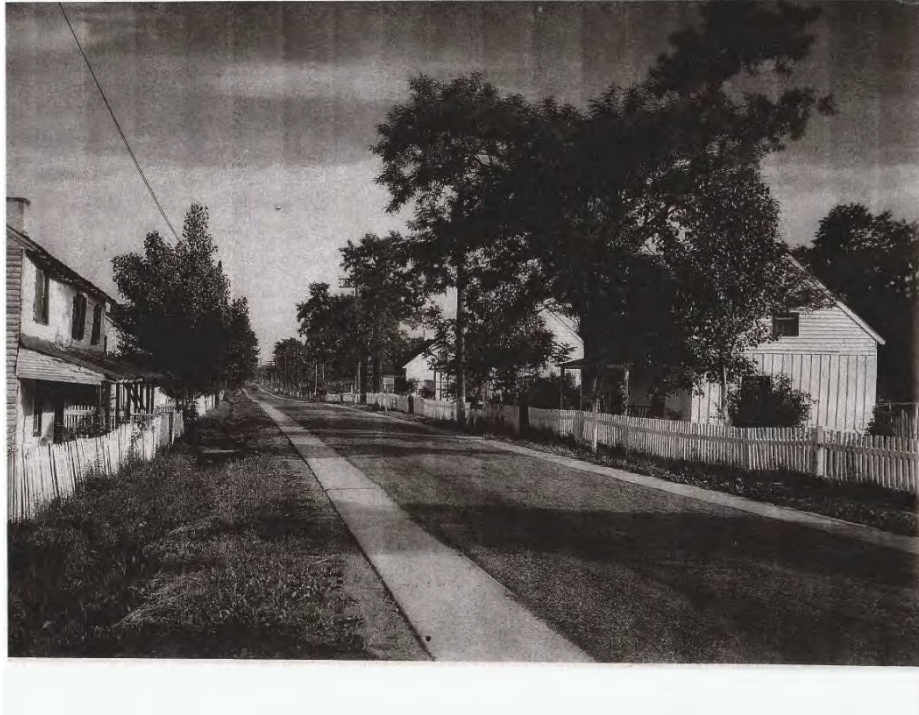
Figure 60: Photograph of Catoctin Furnace Road facing south. While the Hoke dwelling is not clearly visible, note the vertical board and batten siding on the Carty-Miller dwelling (right), which was the original siding configuration. The fence spanning across the front yard is also the earlier, white-painted wood picket fence that existed in front of most of the village houses at the time. (October 30, 1932).

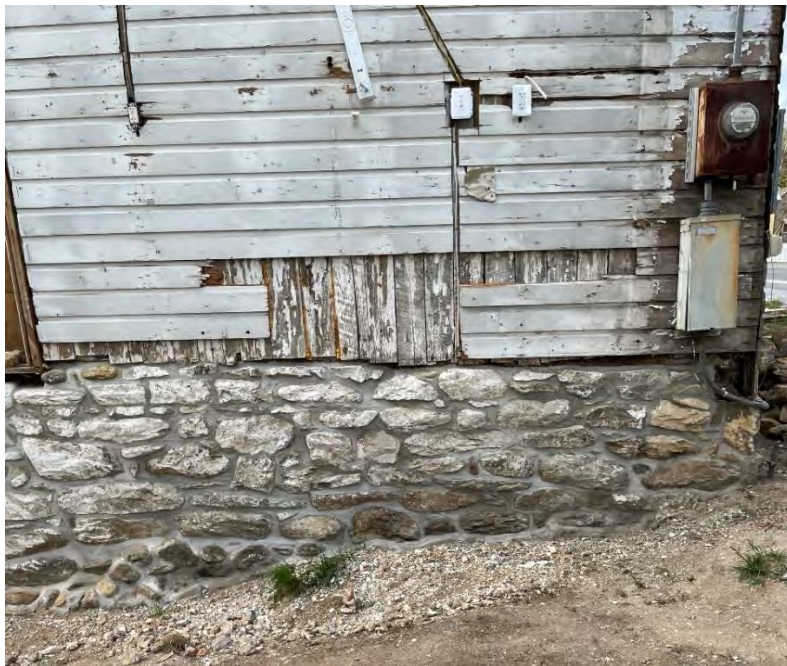
Figure 61: Section of the original vertical board siding revealed by the excavation, as well as the wood Dutch lap siding covering it. (25 April 2024).

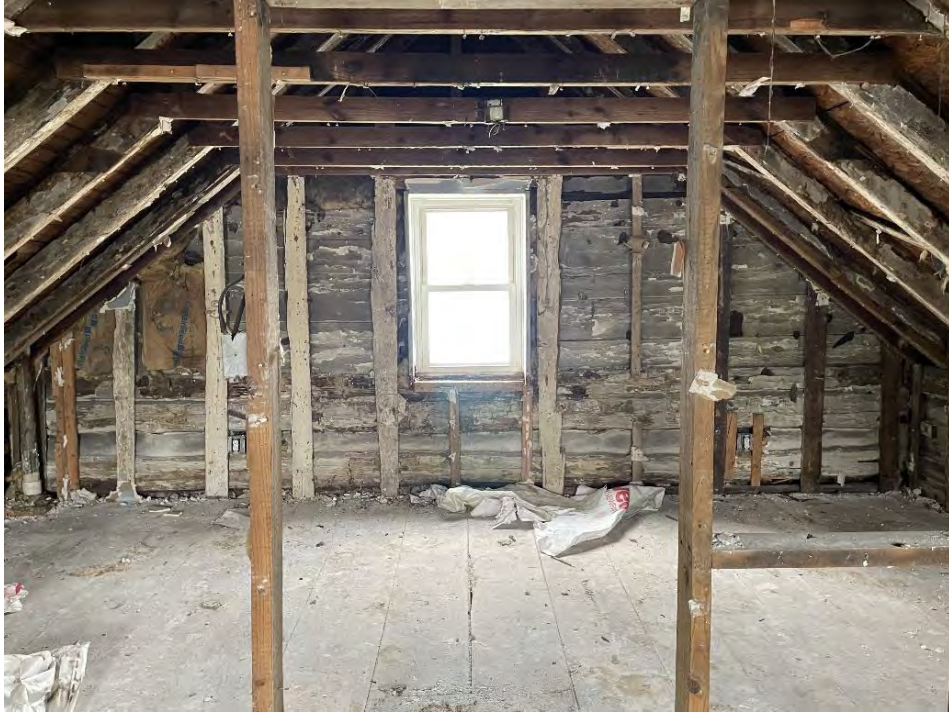
Figure 62: Original second-story horizontal wood board walls seen from within the dwelling. (25 April 2024).

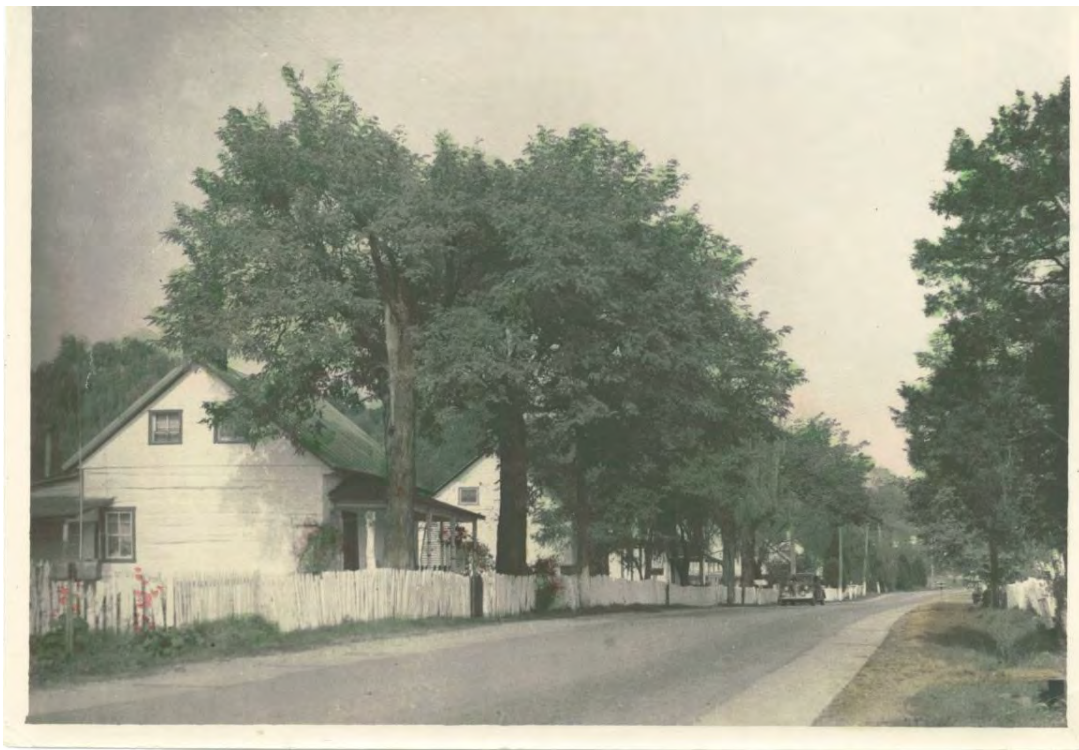
Sometime prior to October 1932, before any of the present-day additions were built, a small frame addition with a shed roof and containing some type of stove or fireplace with a chimney was added to the west elevation of the original dwelling structure (*Figure 63*). It would have acted as a kitchen and/or canning area. All the historic worker dwellings had an addition like this in that period. Attached to the south elevation of this addition was a covered side porch that extended slightly onto the exterior of the original structure (*Figure 63*). Meanwhile, the south elevation of the original dwelling at this time included a single window positioned where the cased opening to the kitchen is now located (*Figure 63*).

Figure 63: Hand-colored photograph of Catoclin Furnace Road facing north. The Hoke house is in the left foreground, and can be seen with its small frame shed roof west addition and without its south addition. The earlier front porch installed by Phil Miller, the white-painted wood picket fence, and two large trees that were in the front yard are also visible. Furthermore, the original placement of the front door is present in this image (October 30, 1932).

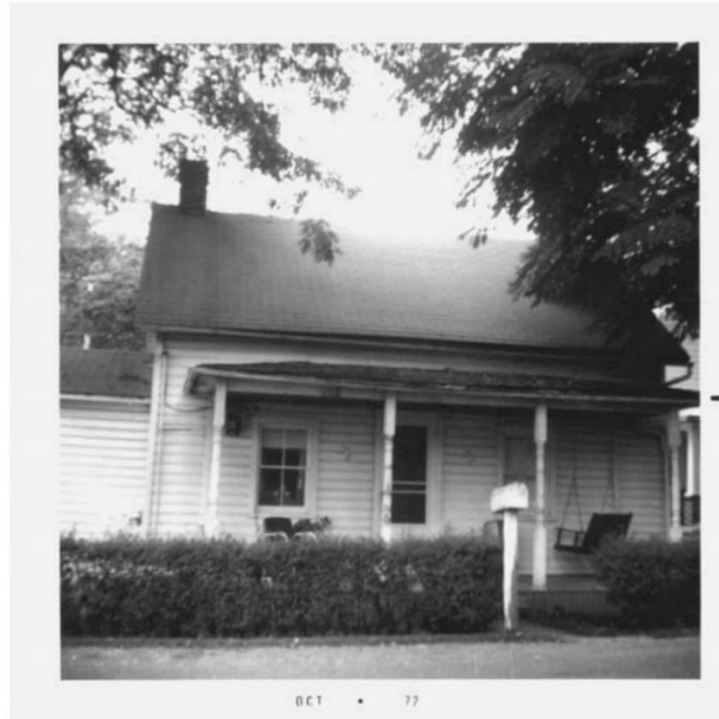
Figure 64: East elevation of the Hoke dwelling, with its earlier all-wood front porch, boxwood shrub front yard hedges, and top portion of the original stone chimney stack all still present, although the chimney was not connected to a fireplace by that time. (October 1972). Image courtesy of Catocctin Furnace Historical Society, Inc.

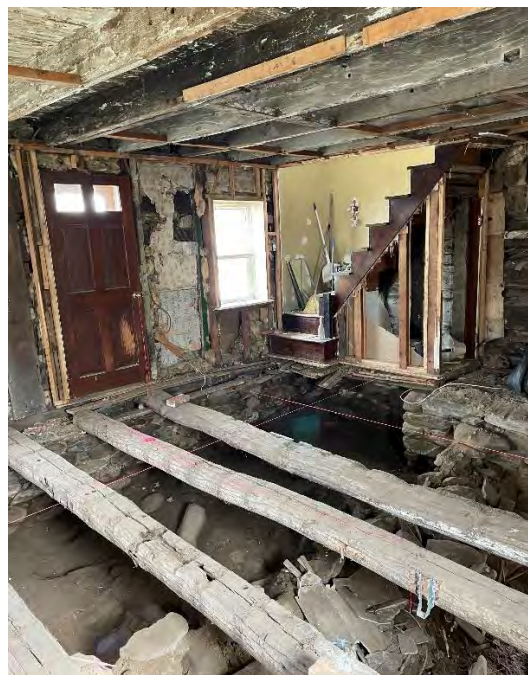
Figure 65: Southeast elevation of the living room post-excavation, depicting the original log floor joists and stone foundation, as well as the frame surrounding the front window, which once housed the front door. The bottom step of the staircase is directly against the old doorframe, indicating why the front door was moved. The original stone foundation along the east and southeast sides of the dwelling can also be seen. (25 April 2024).

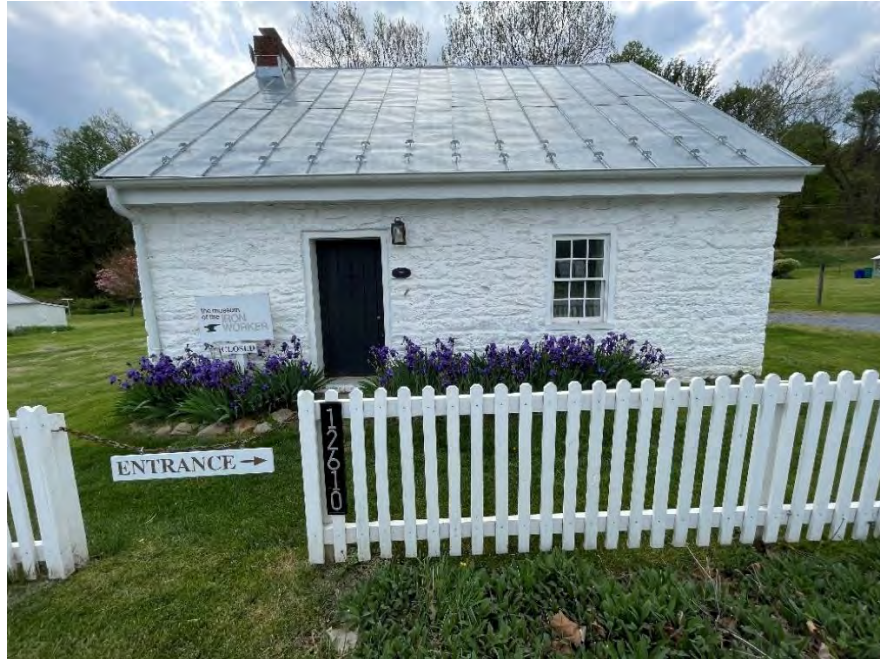
Figure 66: The Museum of the Ironworker at 12610 Catoctin Furnace Road, another historic worker home in the village that shows the original placement of the front door, as well as the original hand-crimped standing seam tin roof. (25 April 2024).

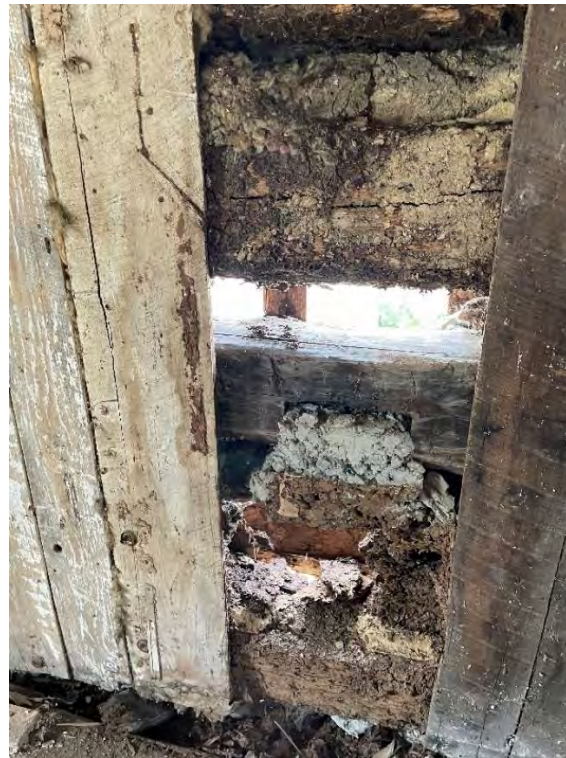
Figure 67: Interior view of the section of wall where the Smith family installed the gas heating system in 1979. The dwelling's original vertical board over log construction can be seen via the hole in the wall. (25 April 2024).

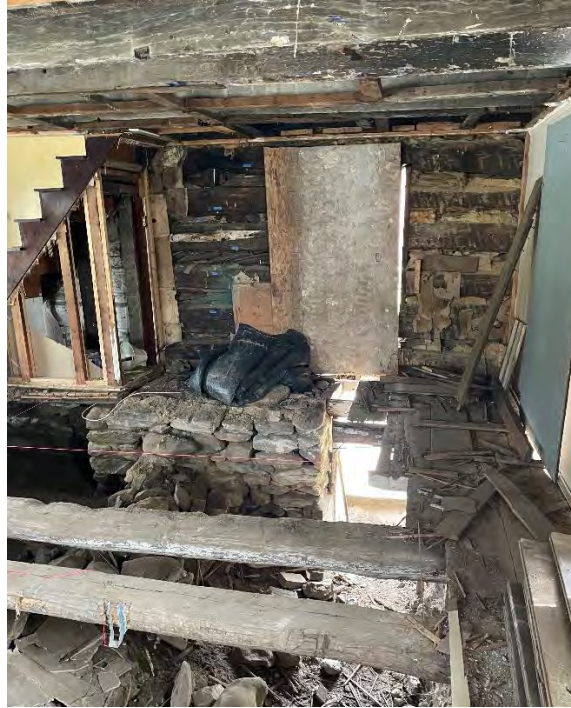
Figure 72: Southwest elevation of the original dwelling interior post-excavation from what was once the restroom. Image provides a full view of the stone base of the dwelling's original hearth and chimney, along with the original log and wood board wall and the former cased opening on the south elevation of the dwelling. Also in view are the crawl space entrance and original wood floor joists. (25 April 2024).

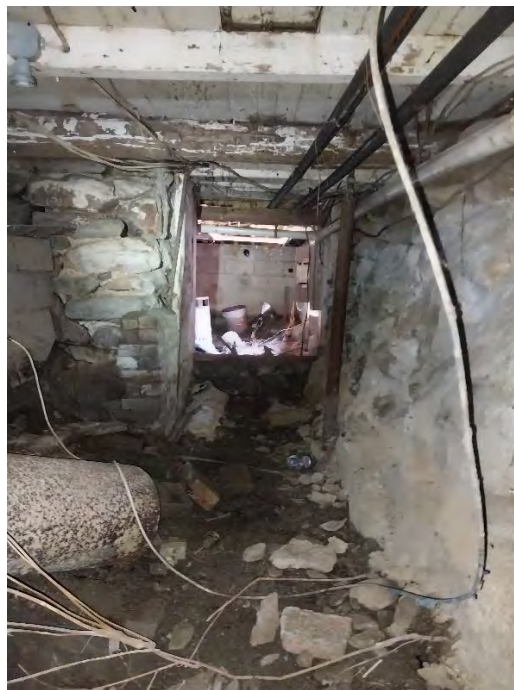
Figure 73: Crawl space entrance from within the crawl space, looking into the cellar area. As can be seen, it was difficult to distinguish the stone hearth base (left) from the rest of the stone foundation before excavation. (11 August 2023). Image courtesy of David Bittle.

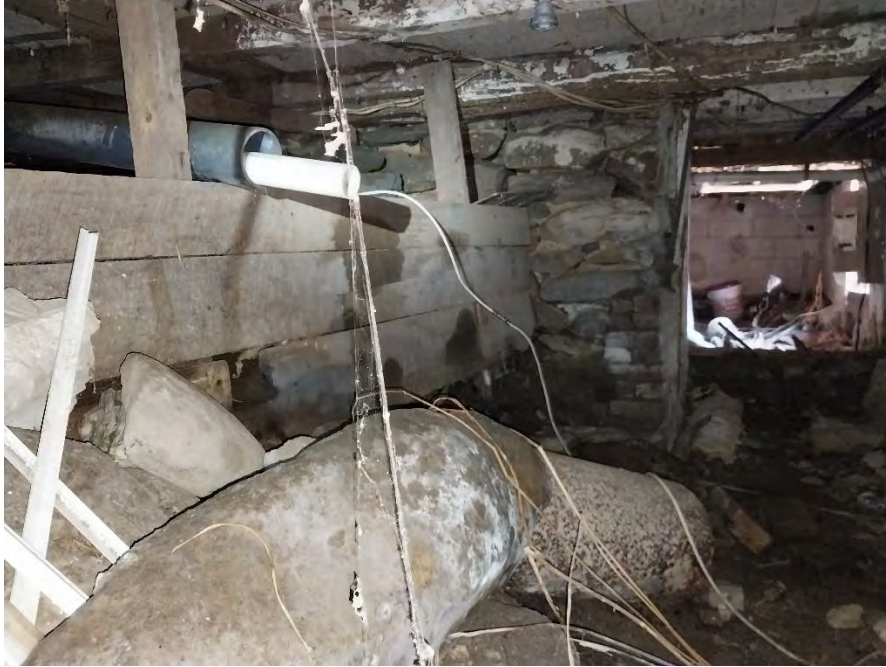
Figure 74: South elevation of the crawl space, providing a much more direct view of the stone hearth base before excavation. Without being able to look at it from above or the eastern portion of the crawl space, there was little to suggest it was anything other than part of the original foundation. There are also nonoriginal floor supports made of wood boards. (11 August 2023). Image courtesy of David Bittle.

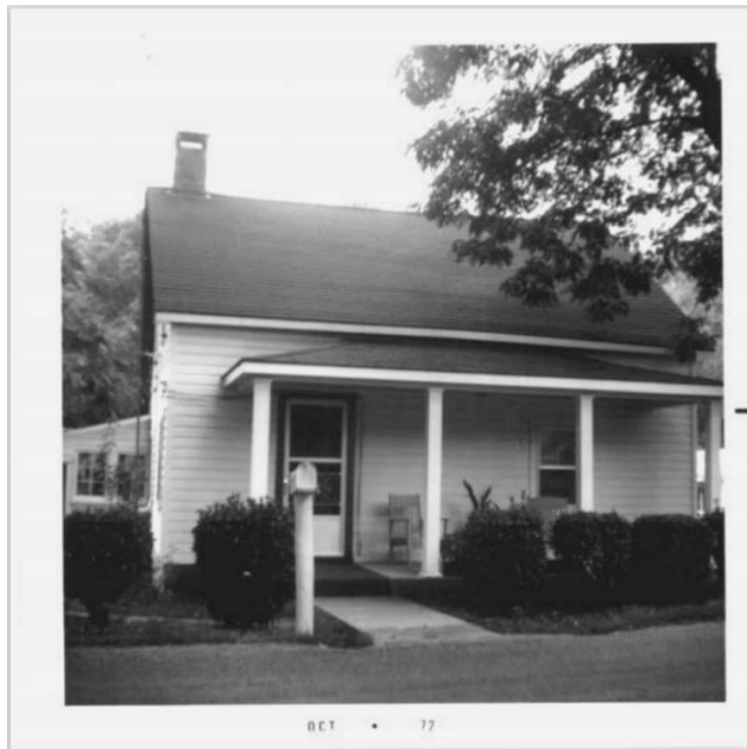
Figure 75: The Carty-Miller dwelling and front yard, showing the boxwood shrub hedges planted in the front yards of many other properties in Catoclin Furnace at the time. (October 1972). Image courtesy of Catoclin Furnace Historical Society, Inc.

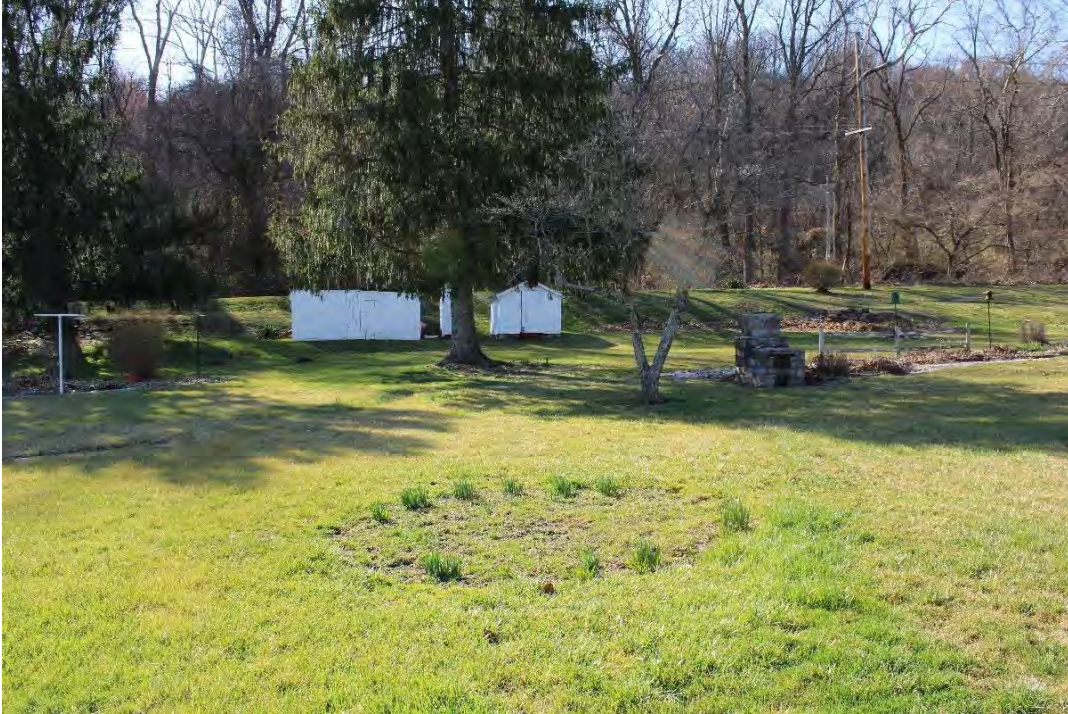
Figure 76: The smaller of the two extant pine trees given to the Smith children, planted next to the fireplace in the Carty-Miller rear yard. (5 March 2023).

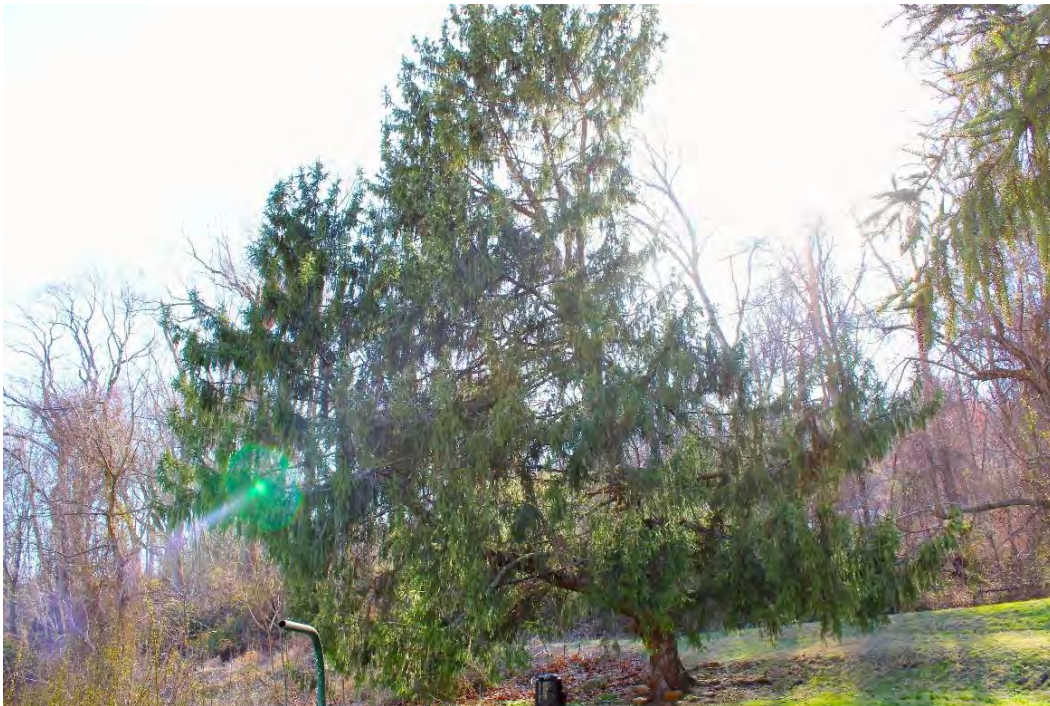
Figure 77: The larger of the two extant pine trees given to the Smith children, planted on the slope of the trolley bed hill in the corner boundary between the Rohwein and Carty-Miller properties. The tree's dramatic lean is clearly visible. (5 March 2023).

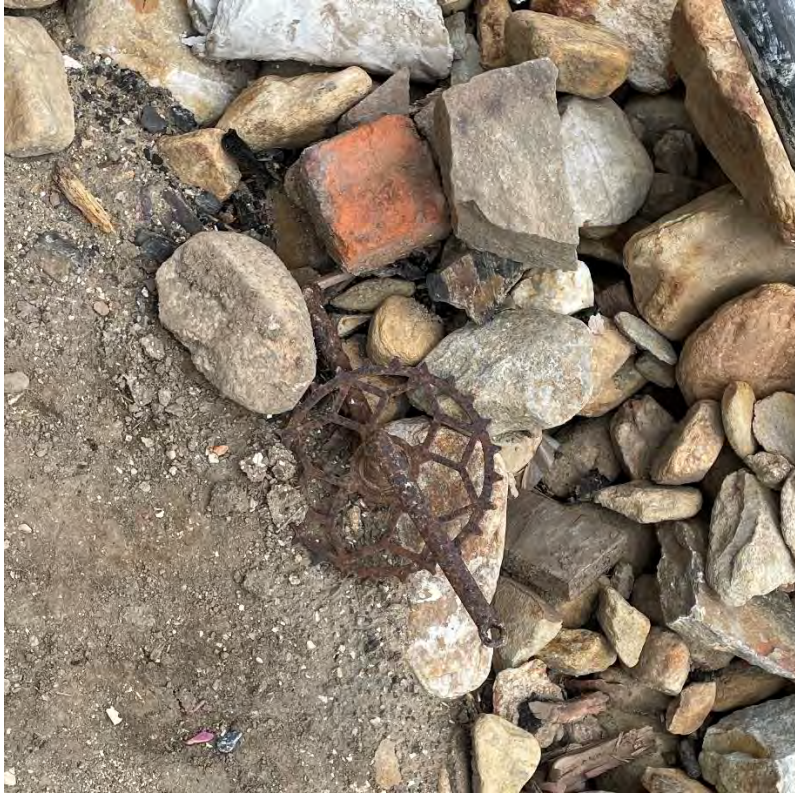
Figure 78: What appears to be an antique crank and sprocket, possibly for a bicycle, found beside a pile of debris south of the dwelling post-excavation. (25 April 2024).

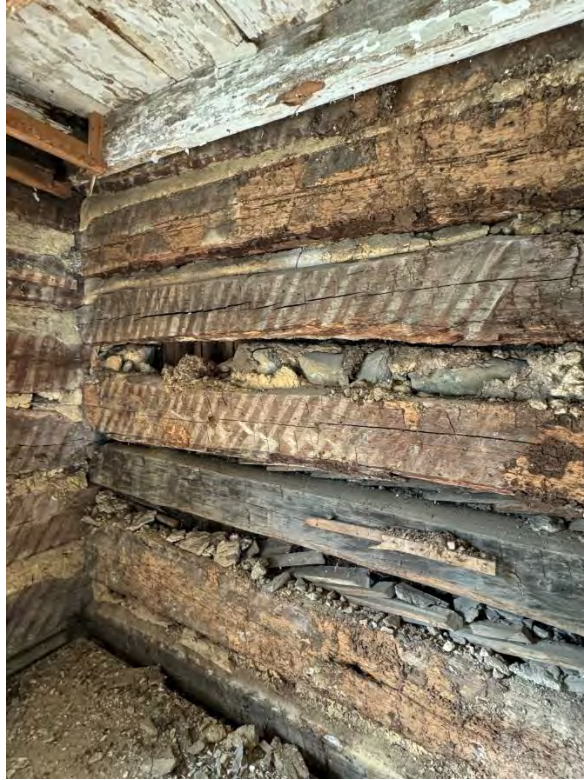
Figure 80: West corner of the original structure's north elevation wall after the vertical wood plank wall (see Figure 27) had been removed, showing the original horizontal log construction and part of the original wood ceiling. The chinking between the logs and the various materials it is composed of are clearly visible. (10 September 2024). Image courtesy of Elizabeth Comer.

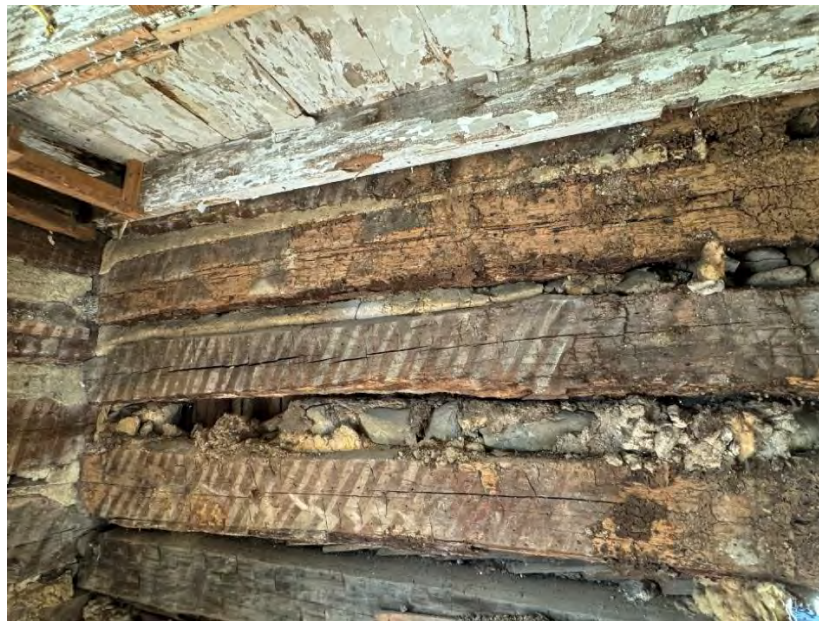
Figure 81: Close-up of the interior north wall post-excavation, with a more detailed view of the original horizontal logs and the chinking between them. (10 September 2024). Image courtesy of Elizabeth Comer.

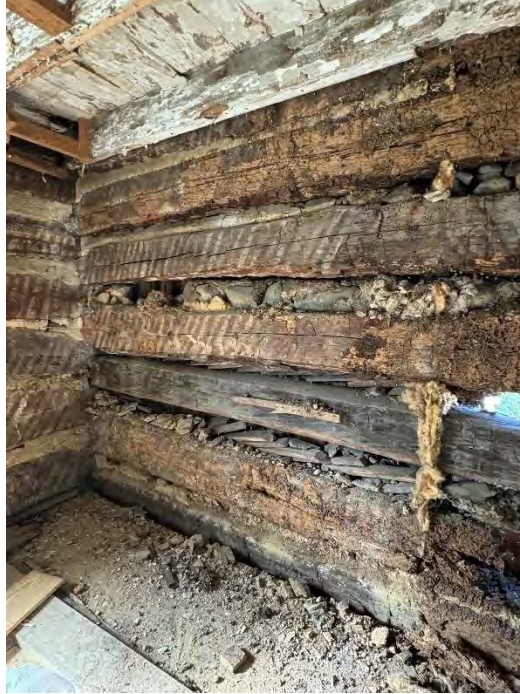
Figure 82: Wider view of the northwest portion of the original structure, showing more of the floor as well as the horizontal log walls, chinking, and some of the hole in the wall where the gas heating system was installed by the Smith family. (10 September 2024). Image courtesy of Elizabeth Comer.

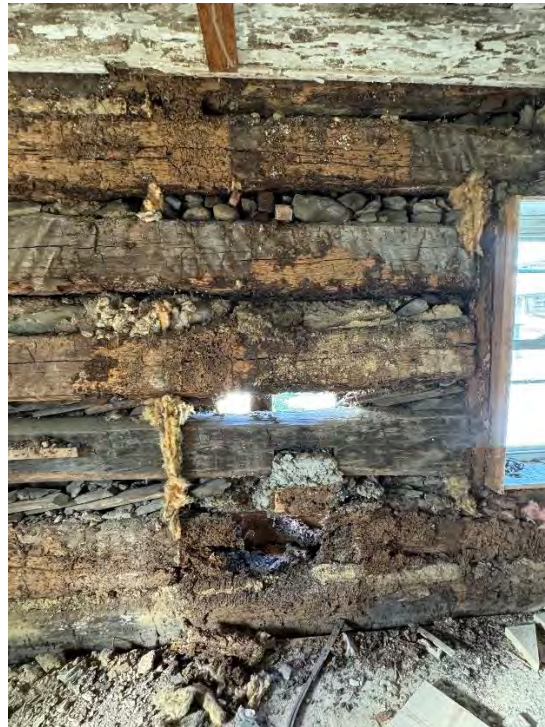
Figure 83: Gap in the horizontal log wall where the gas heating system was installed around the center of the original structure's north elevation. More of the chinking between the logs is also visible, much of which appears to be composed of wood and stones. The north elevation window is also in view to the right. (10 September 2024). Image courtesy of Elizabeth Comer.
