Historic Structures/Cultural Landscape Report: The Hoke House

12602 Catoctin Furnace Rd, Thurmont, MD

Tyler Wilson

December 2024

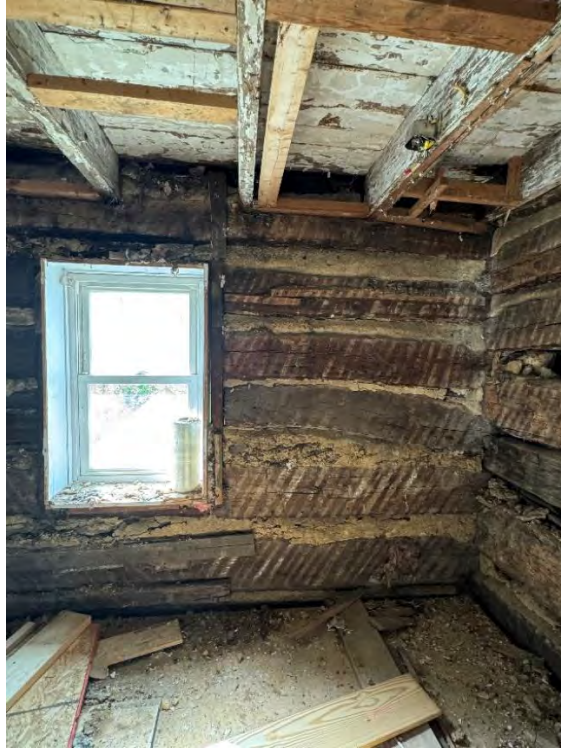
Figure 84: Northern section of the west elevation interior wall post-excavation, showing the west elevation window, the wooden ceiling and floors, and the horizontal log walls. The chinking in this area of the wall appears to be made from a much more uniform composition of materials than on the north elevation. (10 September 2024). Image courtesy of Elizabeth Comer.

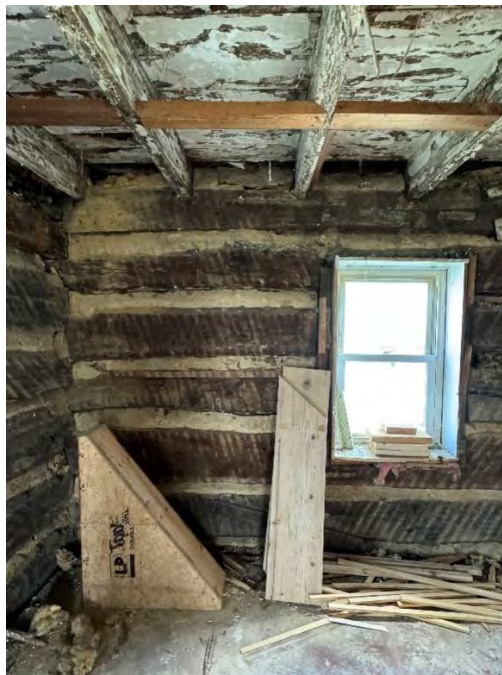
Figure 85: Northern section of the east elevation interior wall post-excavation showing the northernmost east elevation window and more of the wooden ceiling, floors, log walls. Like the northern west elevation, the chinking in this area of the wall appears to be made from a more uniform composition of materials. (10 September 2024). Image courtesy of Elizabeth Comer.

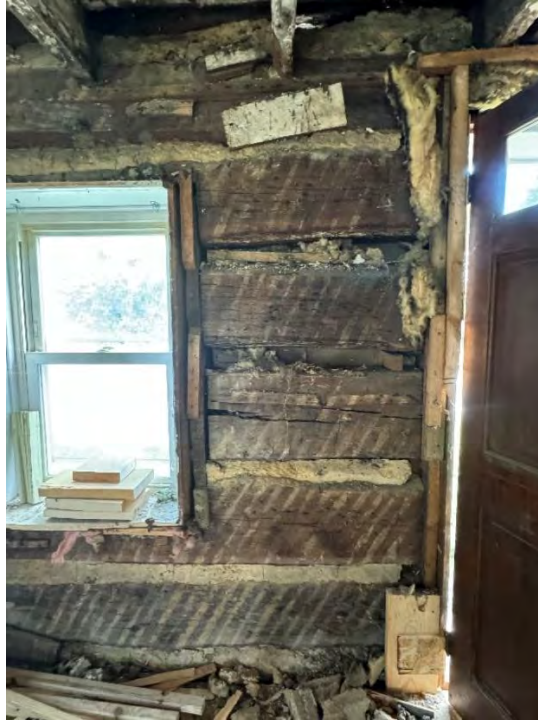
Figure 86: East elevation interior wall between the northernmost front window and the front door post-excavation. Small planks and blocks of wood can be seen intermittently attached to the original log wall. The chinking around the third highest log appears to have deteriorated or otherwise been stripped away, leaving gaps between the logs above and below it. (10 September 2024). Image courtesy of Elizabeth Comer.

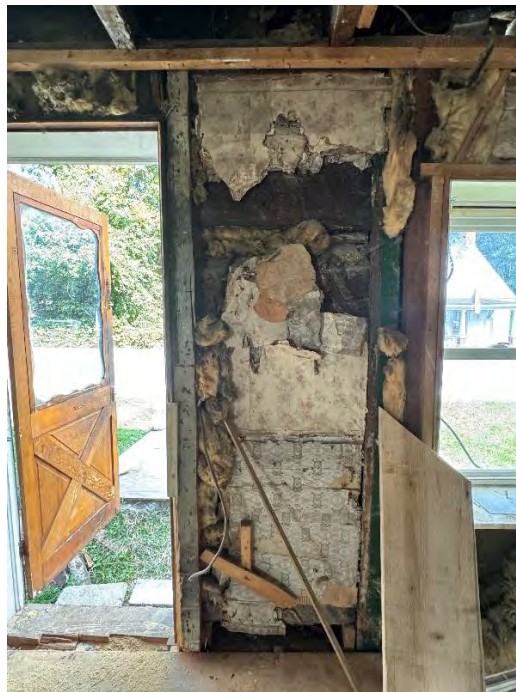
Figure 87: East elevation interior wall between the front door and the southernmost front window post-excavation. Much of the original horizontal log construction is obscured by wallpaper. (10 September 2024). Image courtesy of Elizabeth Comer.

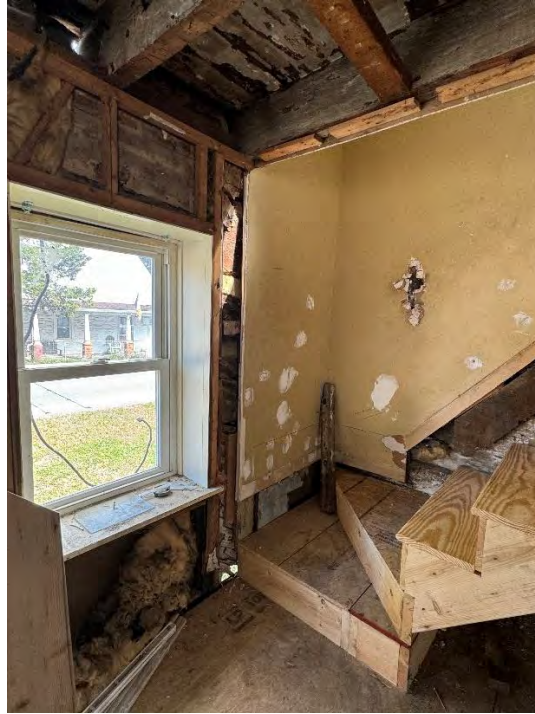
Figure 88: Southeast corner of the original structure post-excavation, showing the southern front window and newly rebuilt staircase, as well as the plywood covering the original log wall. The original wood in the ceiling is also visible at the top. (10 September 2024). Image courtesy of Elizabeth Comer.

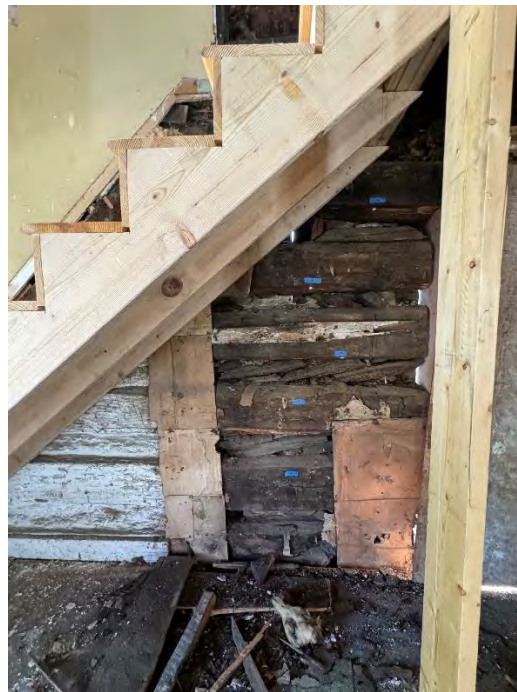
Figure 89: View of the spandrel space beneath the staircase, showing more of the new wood making up the rebuilt staircase. Part of the original horizontal log siding can also be seen through the spandrel. (10 September 2024). Image courtesy of Elizabeth Comer.

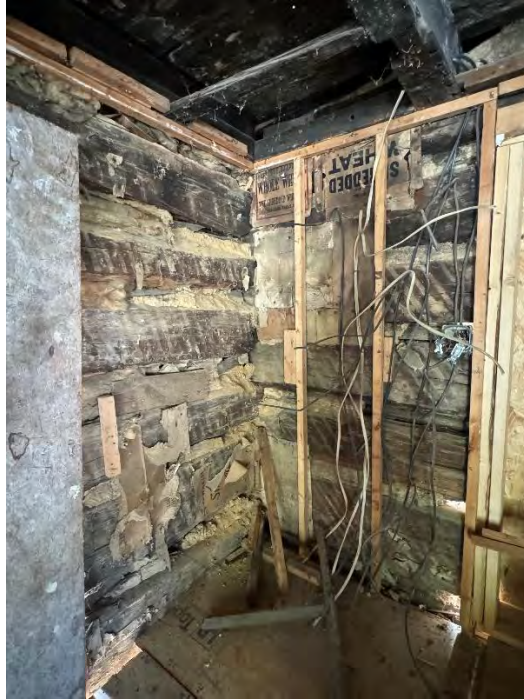
Figure 90: Southwest corner of the original dwelling post-excavation, displaying the covered entrances to the since removed south (left) and west (right) additions, along with the original log walls between them. Once again, the chinking between the logs in this part of the dwelling is much more uniform than that on the north elevation. The wood ceiling can be seen noticeably blackened at the top of the image, quite likely due to charring from the large house fire on 15 December 1979. (10 September 2024). Image courtesy of Elizabeth Comer.

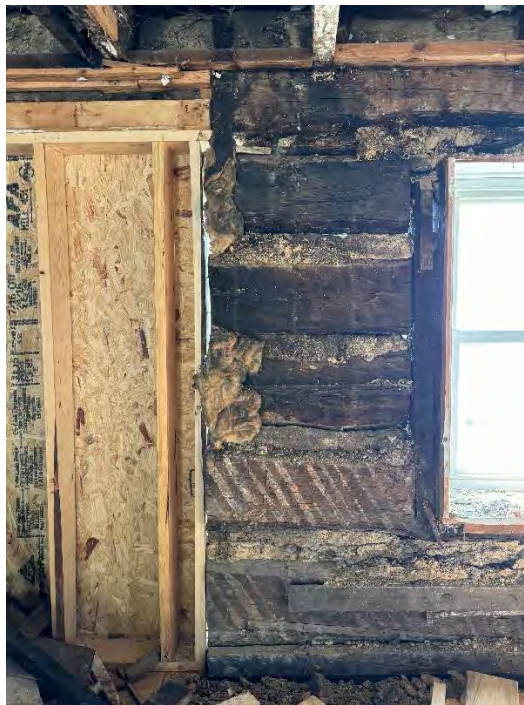
Figure 91: Post-excavation view of the west elevation interior log wall between the entrance to the since removed west elevation and the former bathroom window. (10 September 2024). Image courtesy of Elizabeth Comer.
