Historic Paint Finishes Study:

The F. W. Fraley Store, Exterior Surfaces

14 October 2022

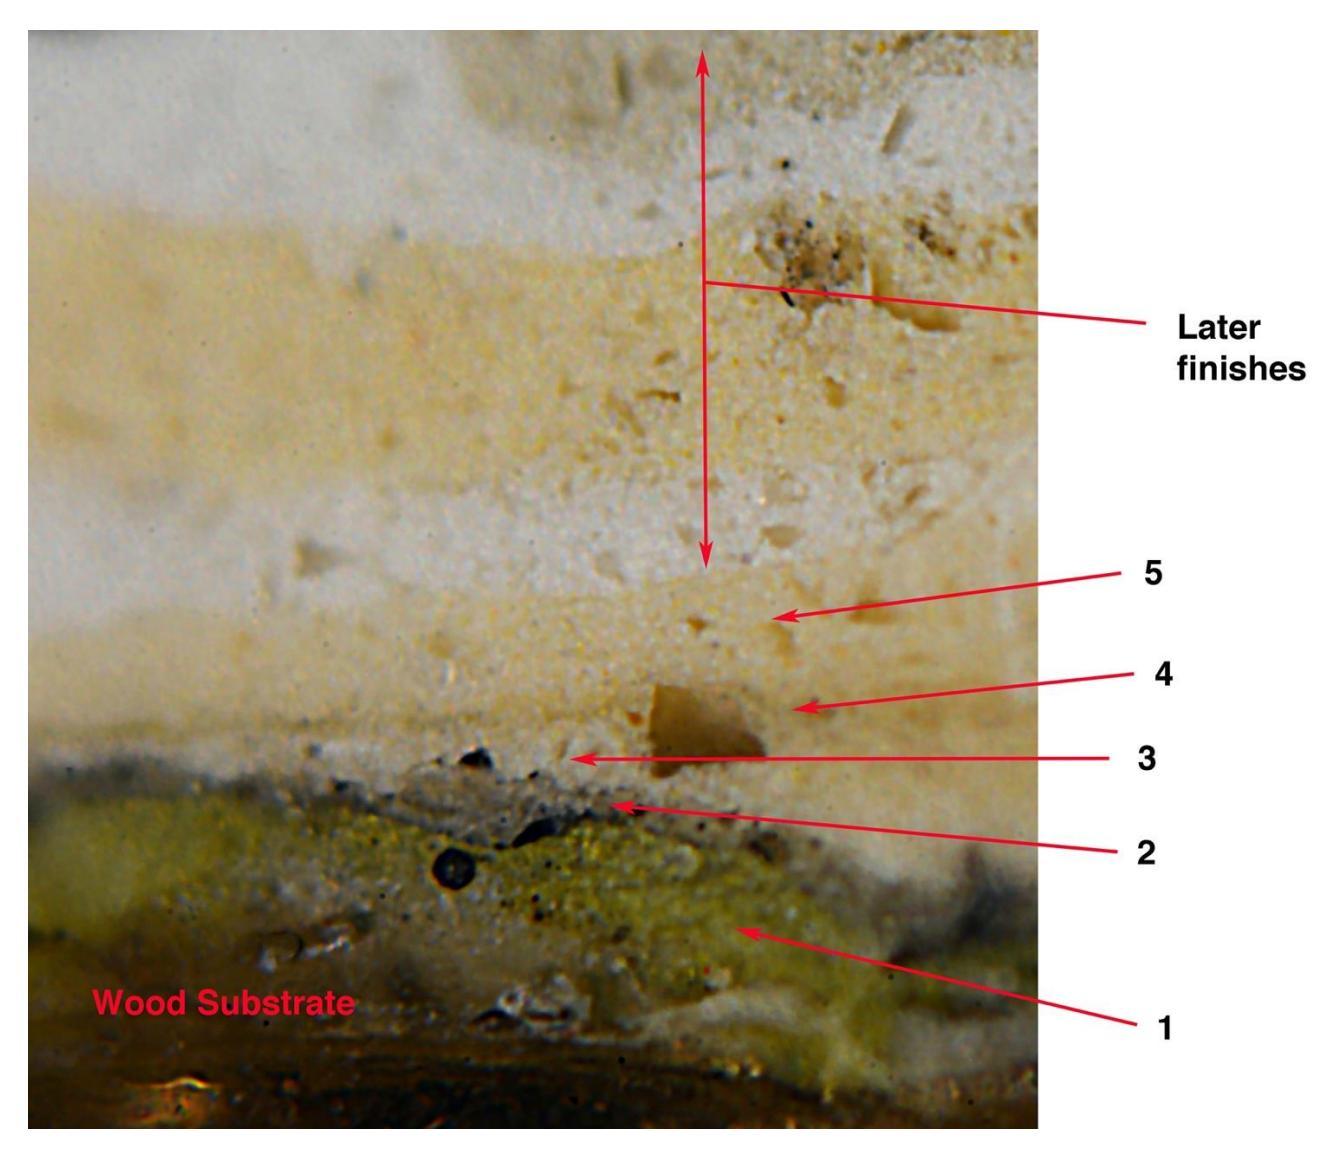
The 1906 Section: Siding finish Photomicrograph: South elevation, ca. 1906 section siding

Note: The sample has been mounted in polymer resin, cut and polished to 8000 micron grit polishing cloth for additional examination. A fragment of the original wood substrate is seen at the lower left of the photomicrograph. The first finish is clearly seen [1]: this is a yellowish green, prepared with chrome green and other pigments. The second finish is a moderate bluish gray [2], which is worn due to a long term exposure. The third finish [3] probably indicates the

ca. 1928 finish: the first finish on the 1928 section was a lead white also. The fourth finish may be ca. 1940 [?] and the fifth finish [5] is the restoration finish period ca. 1945-1950. The fifth finish above corresponds to the third finish on the 1928 section.

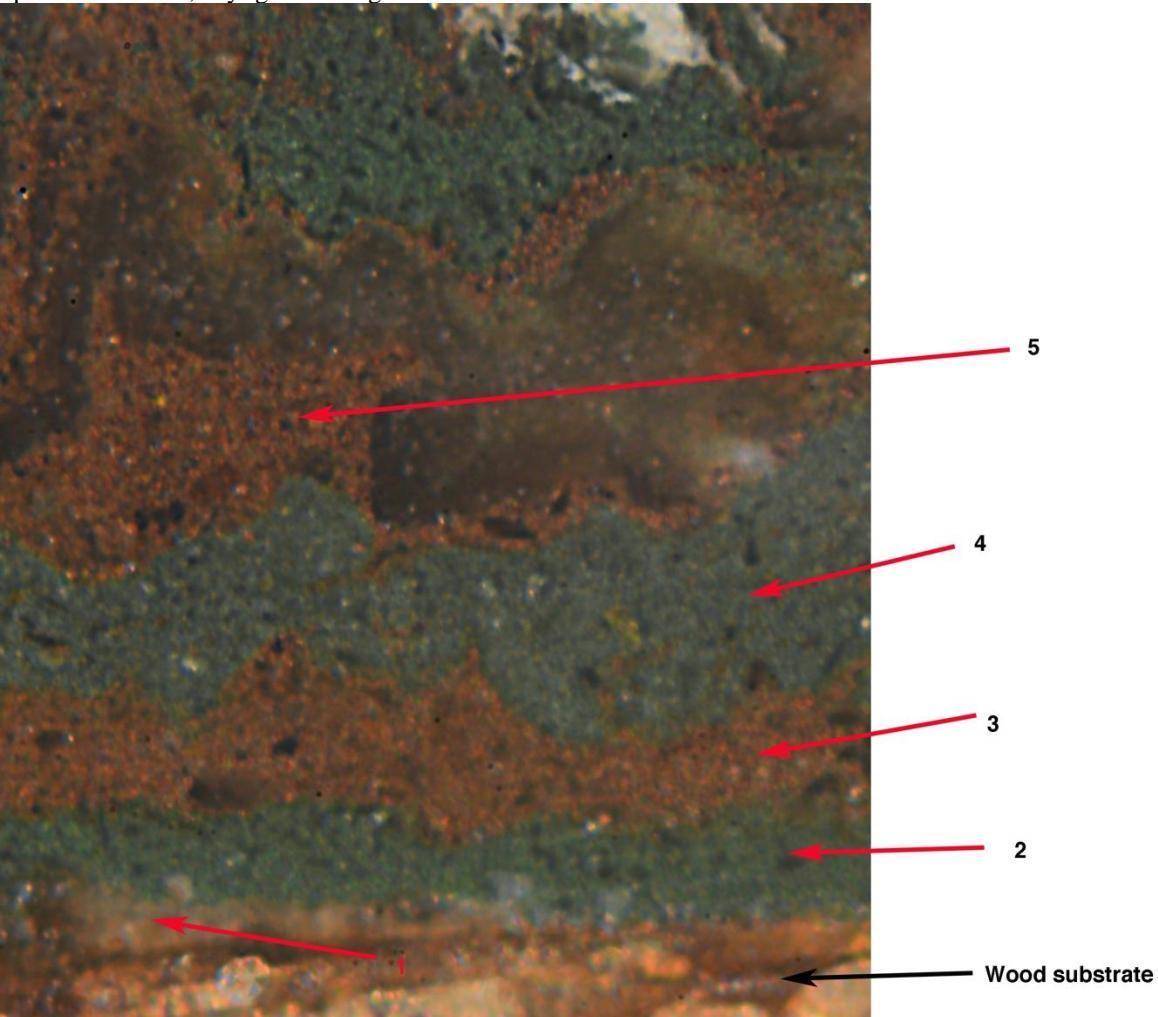
Photomicrograph: South elevation, ca. 1906 section Soffit/Trim

Note: The sample has been mounted in polymer resin, cut and polished to 8000 micron grit polishing cloth for additional examination. The original wood substrate is seen at the base of the sample as indicated. The first finish is extremely deteriorated [1]: lead white. The second finish [2] is a dark green that was used repeatedly. Note that the brown finish is also repeated, and it is likely that the fifth finish [5] is the finish of ca. 1945-1950.

All of the layers are very deteriorated due to the heat and sun from the south elevation location.

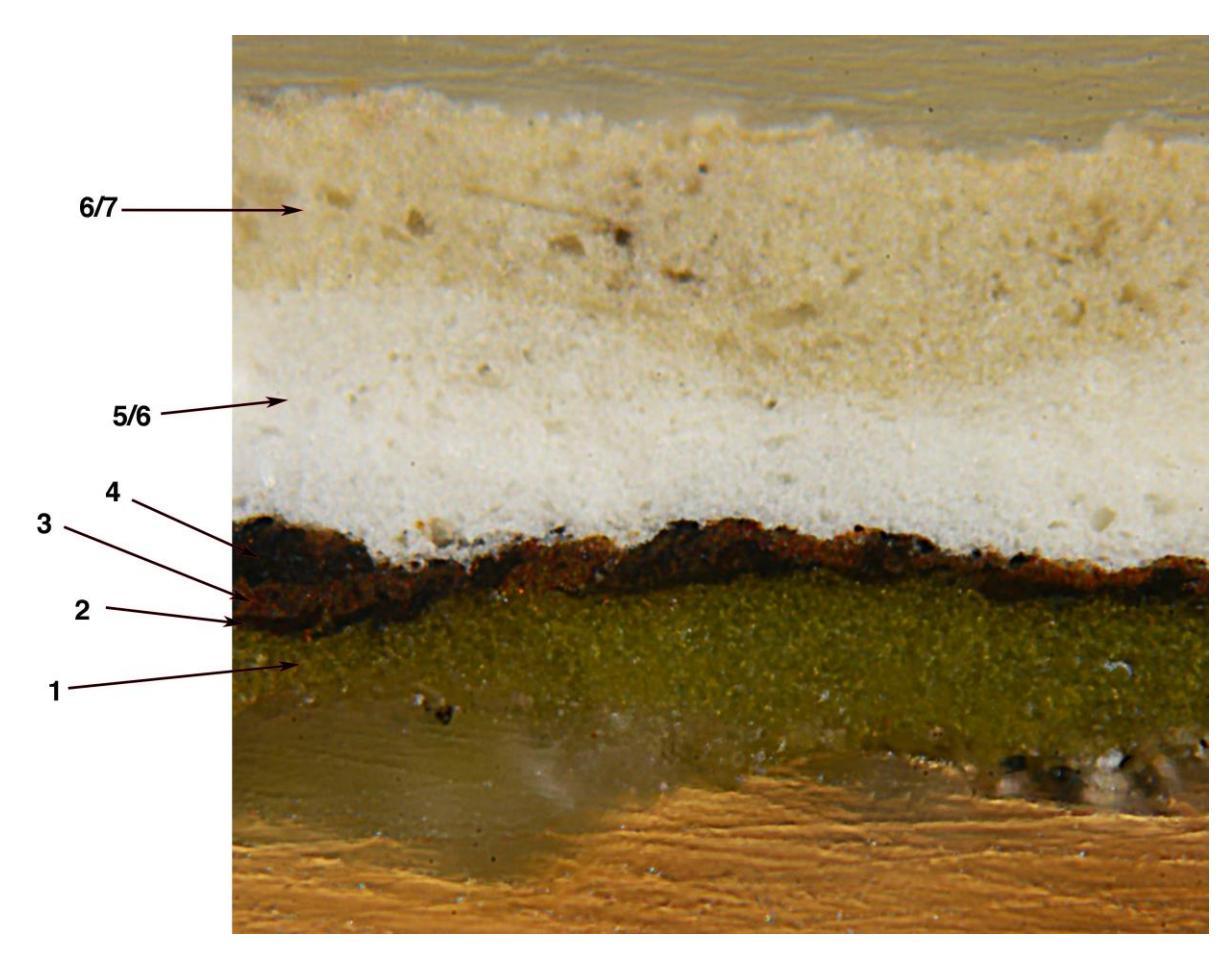
1906 section: Gable end, East elevation: Board and Batten Door

Note: The sample has been mounted in polymer resin, cut and polished to 8000 micron grit polishing cloth for additional examination. The paint layering has delaminated from the wood sample, due to deterioration. The first finish is a moderate yellowish green [1] that is discolored. The second finish is a near-black dark gray finish [2]. The third finish, ca. 1945-1950 is the dark brown seen on other locations. Later the near-black finish paint is used again. The later finishes are also seen: this door appears to have not been painted as frequently as some of the other surfaces.

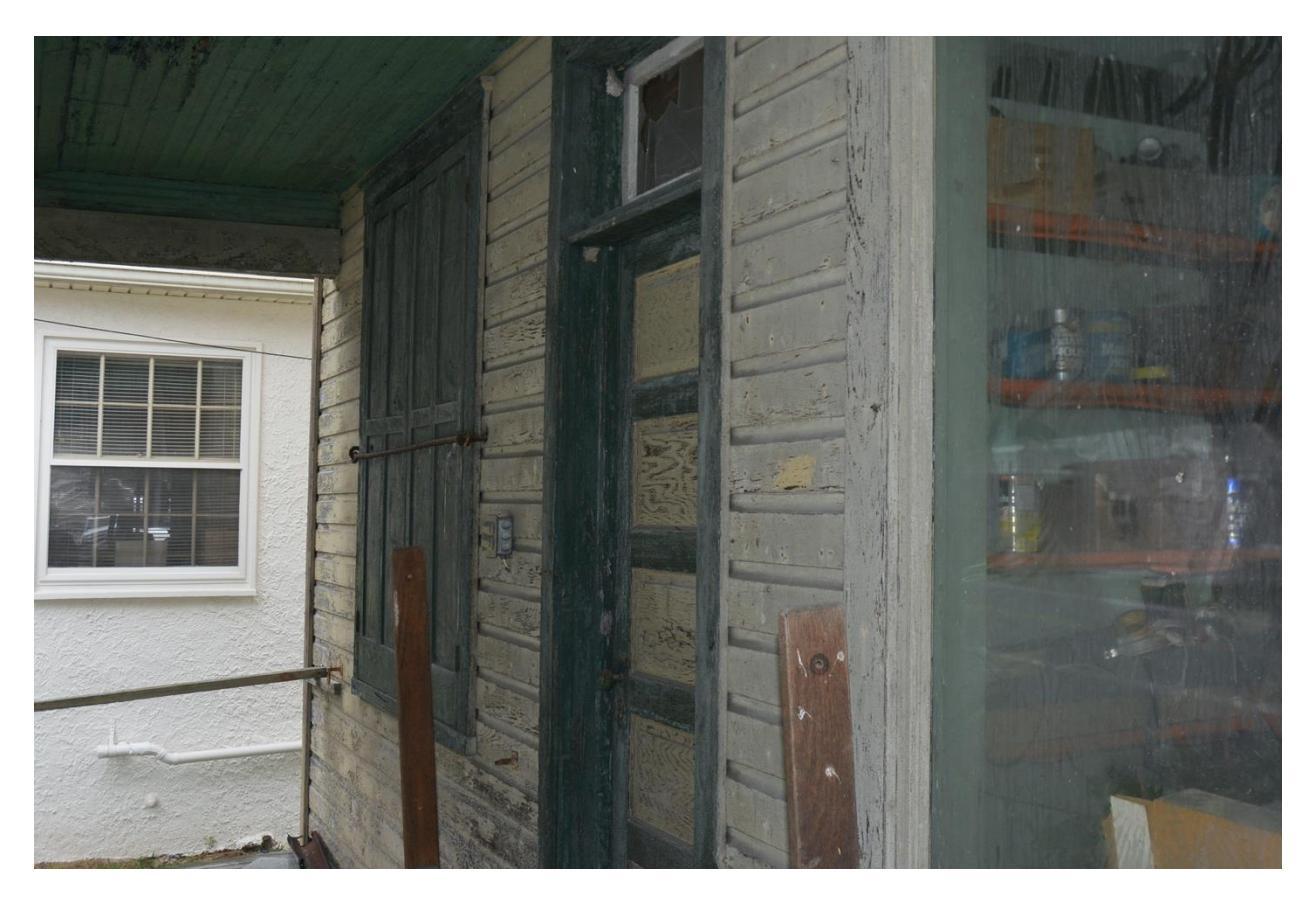
The west elevation has been protected from the sunlight by the porch. The principal samples were taken from under the porch.

- 1. Siding [German Siding]
- 2. Five panel door
- 3. Store front enframement [partial view]
- 4. Shutters

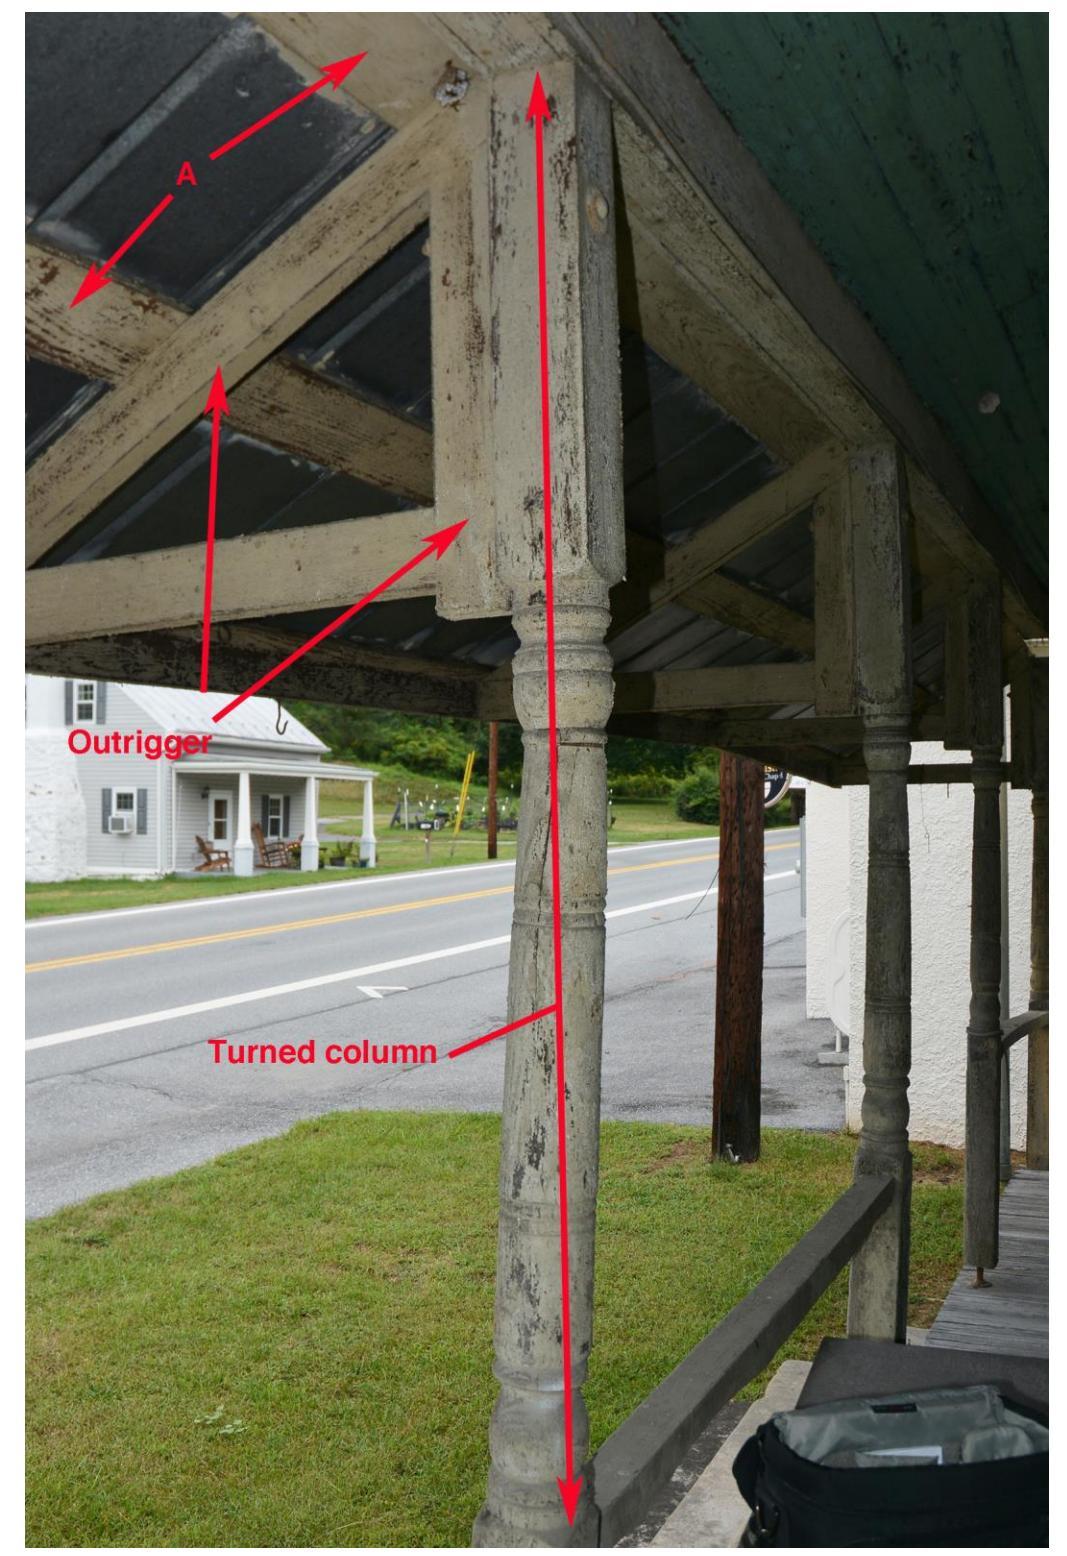
Sample locations from the West Elevation, under the porch

Columns [turned] Outriggers, Nailer boards [A]

Note: Samples were taken from various turnings of the columns: all of the surfaces showed the same sequences, thus the columns were painted with one finish during the ca. 1945-1950 period.

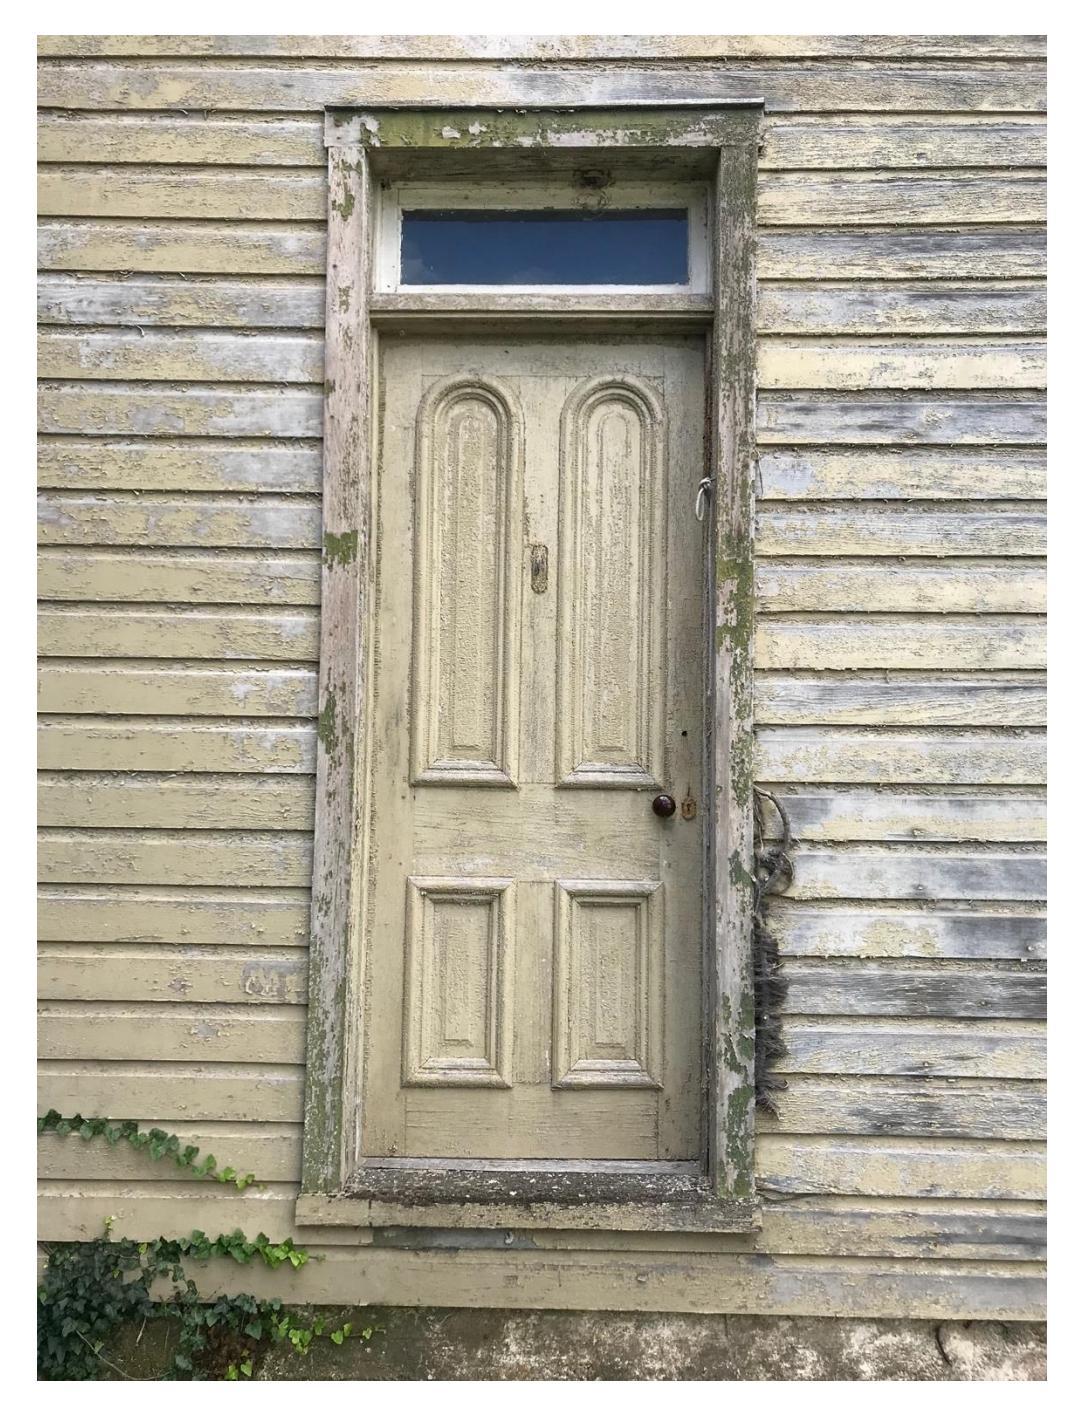
1928: East elevation, with re-used door

Note: The north extension of the 1928 front addition has a late nineteenth century Italianate door re-used in this location. It was originally finished in an expert walnut graining, with a high gloss varnish finish. It is entirely possible that this is an interior door from a long-demolished residence from ca. 1850-1880. The molding profiles indicate an Italianate style.

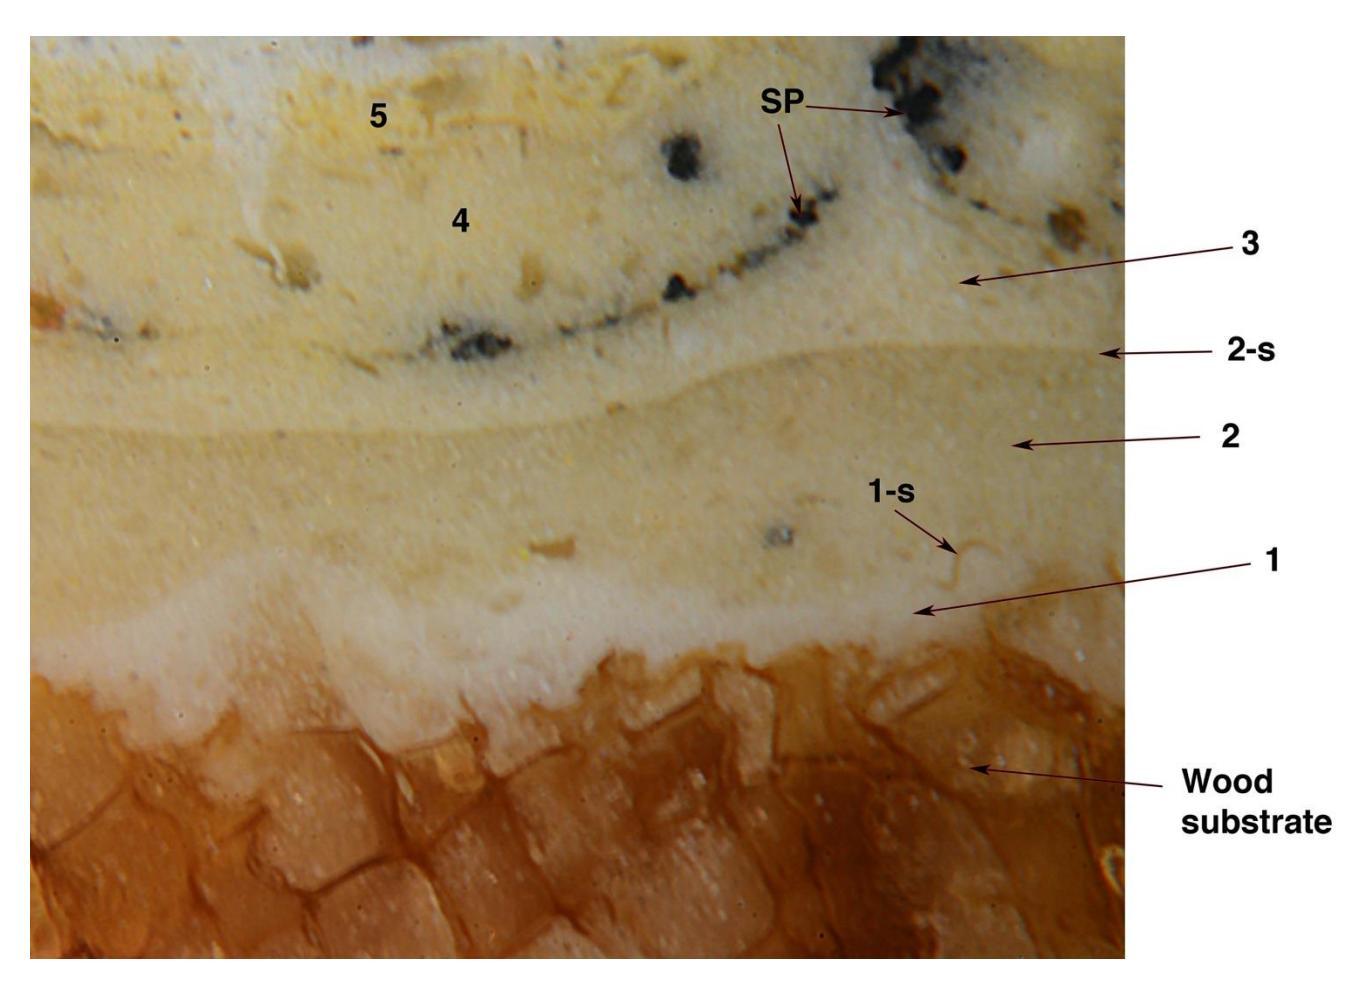
Sample: 1928 West Elevation: Siding

Note: The sample has been mounted in polymer resin, cut and polished to 8000 micron grit polishing cloth for additional examination. The wood substrate is seen at the base of the sample. The first finish, a lead white is clearly seen [1]. This was followed by the second finish, a light yellow [2]; note the surface particulate and exposure condition at the surface of finish 2 [2-s]. Finish 2 is the first in a series of yellow finishes. Finish 3 is estimated to be the ca. 1945-1950 period light yellow finish. Note the heavy surface particulate [SP: soot] at the surface. Two later light yellow layers are also seen [4,5]

- 1. All Siding: Light yellow: Benjamin Moore CW-395 ["Governor' Gold" *Colonial Williamsburg line*] Gloss level: Semi-Gloss
- 2. All Window and Door Frames: Dark Brown: Benjamin Moore HC-71 ["Hasbrouck Brown *Historical Colors line*] Gloss level: Semi-Gloss

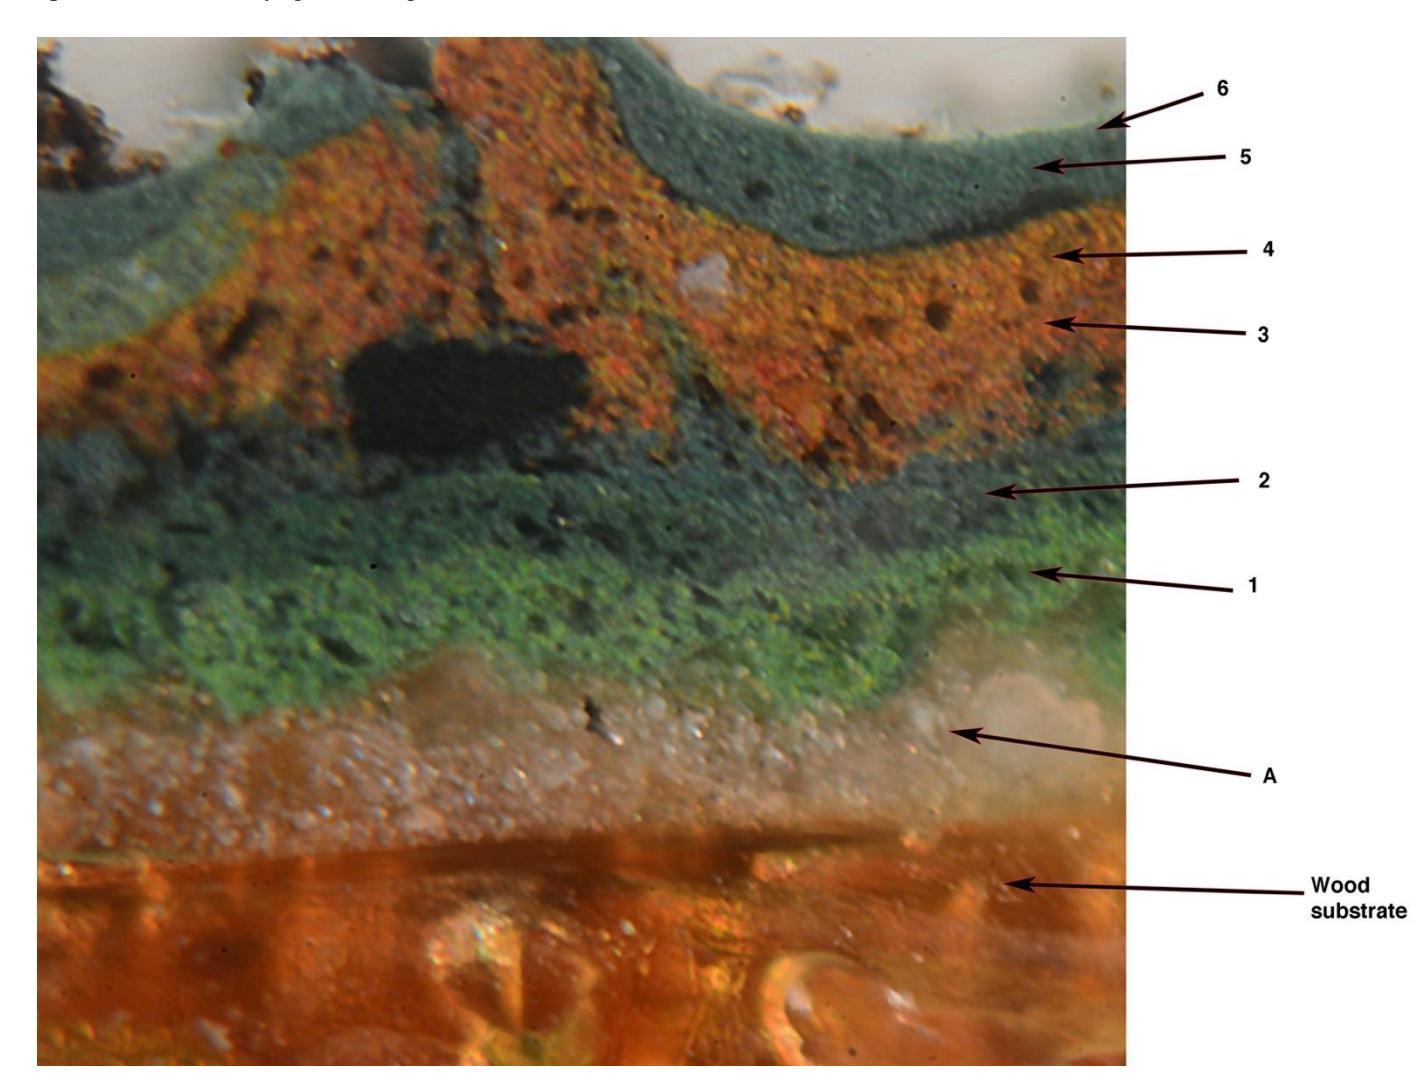
Sample: 1928 West Elevation: Shutters

Note: The sample has been mounted in polymer resin, cut and polished to 8000 micron grit polishing cloth for additional examination. The wood substrate is seen at the base of the sample. The first layer [A] may be a thin lead white primer. The first finish is a chrome green an inexpensive and very popular color for shutters since 1830 [1]. The second finish a bluish green is also prepared with chrome green and other pigments [2]. The third finish [3] is the first brown finish on the shutters, and relates to the Sinclair painting. There is a second brown finish [4]. Finish 5 is the same color as Finish 2; the last finish is a thin chrome green finish [6].

Note: Five panel door Rails and Stiles: were painted the same brown as finish 3 of the Shutters during the restoration period.

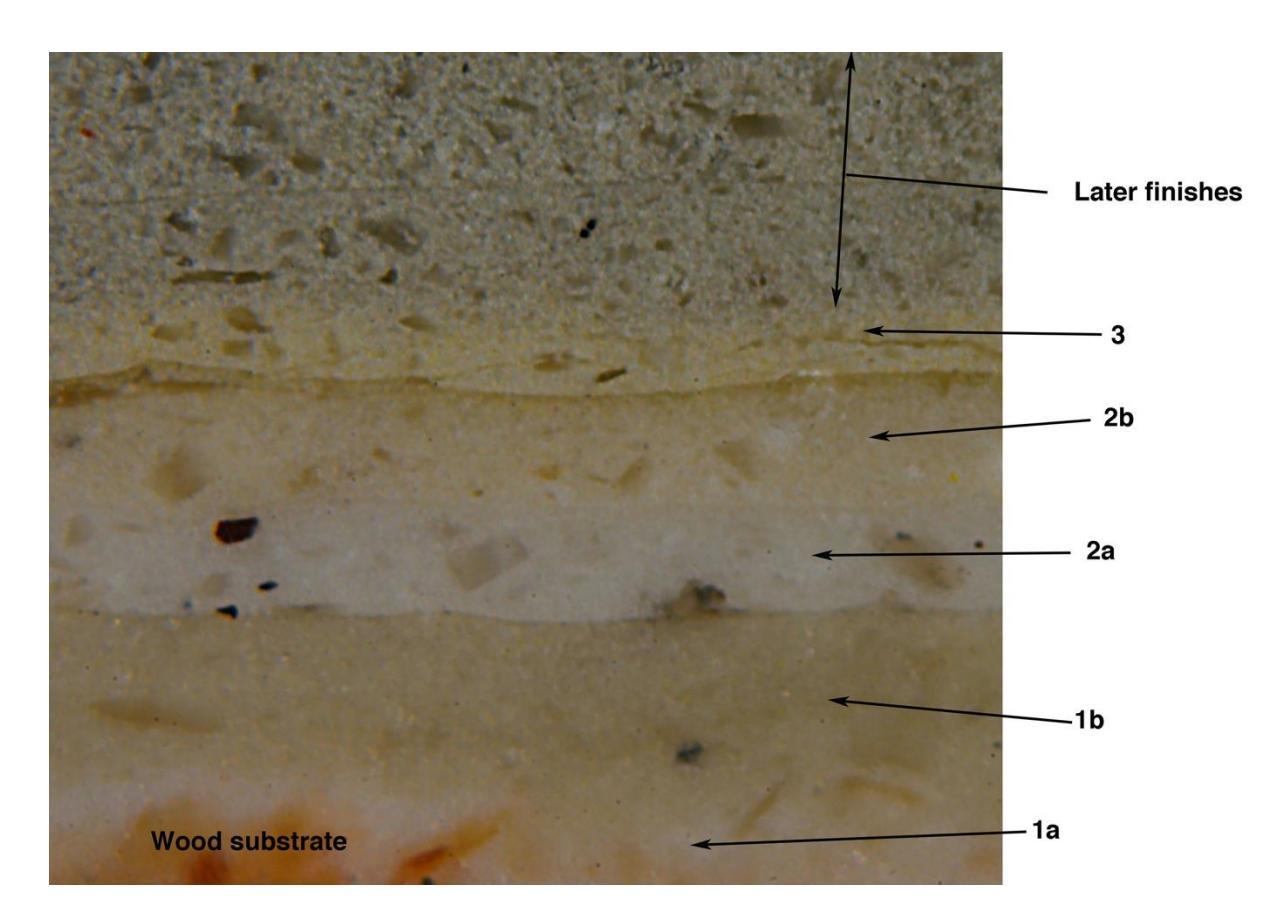
Sample: 1928 West Elevation: Five Panel Door: Panel

Note: The sample has been mounted in polymer resin, cut and polished to 8000 micron grit polishing cloth for additional examination. The wood substrate is seen at the base of the sample. The first finish is a light yellow applied over a white prime [1a, prime, 1b finish]. The sequence is repeated for the second finish [2a, 2b] but it is possible that the heavy white layer 2a was exposed for a period of time. The restoration period finish is the same light yellow as seen on the siding [3]. The later finishes are also indicated.

Rails and Stiles: Dark Brown: Benjamin Moore HC-71 ["Hasbrouck Brown Historical Colors line] Gloss level: Semi-Gloss Panels: Light yellow: Benjamin Moore CW-395 ["Governor' Gold" Colonial Williamsburg line] Gloss level: Semi-Gloss

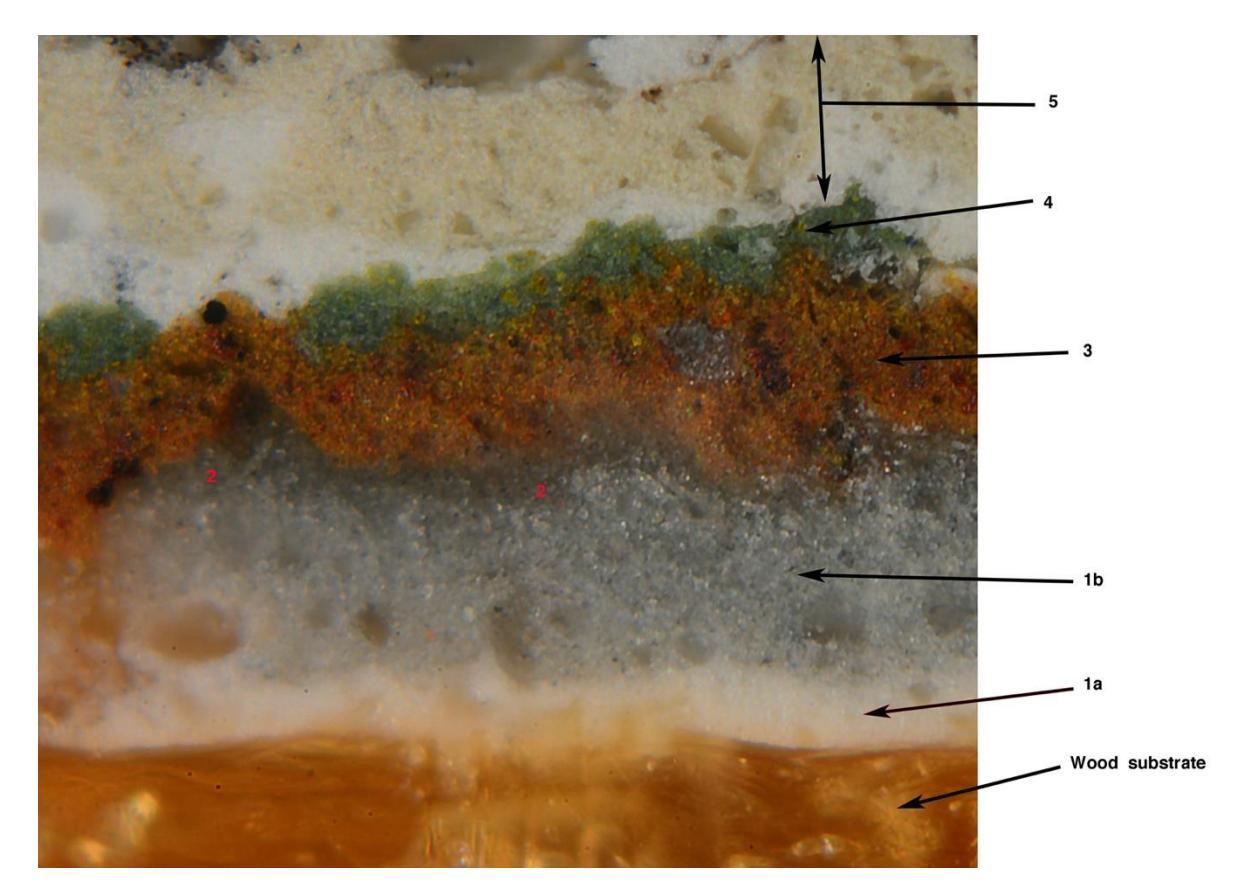
Sample: 1928 West Elevation: Store front enframement

Note: The sample has been mounted in polymer resin, cut and polished to 8000 micron grit polishing cloth for additional examination. The store enframement has somewhat unusual paint sequence.

The wood substrate is seen at the base of the sample as is indicated. The first finish is comprised of a lead white primer [1a] and a moderate bluish gray finish [1b]. There is a second darker gray finish [2]. Either gray may be a possible reusing of a gray paint from the second finish on the 1906 section.

The third finish, estimated to be ca. 1945-1950 is the brown finish seen on other trimwork, and relating to the Sinclair watercolor. The fourth finish is a later green finish. The later finishes [5] are also indicated.

- West Elevation: Store front enframement: All surfaces, except panels: Dark Brown: Benjamin Moore HC-71 ["Hasbrouck Brown *Historical Colors line*] Gloss level: Semi-Gloss

- 8. Store front enframement: Panels below shop windows: Light yellow: Benjamin Moore CW-395 ["Governor' Gold" *Colonial Williamsburg line*] Gloss level: Semi-Gloss

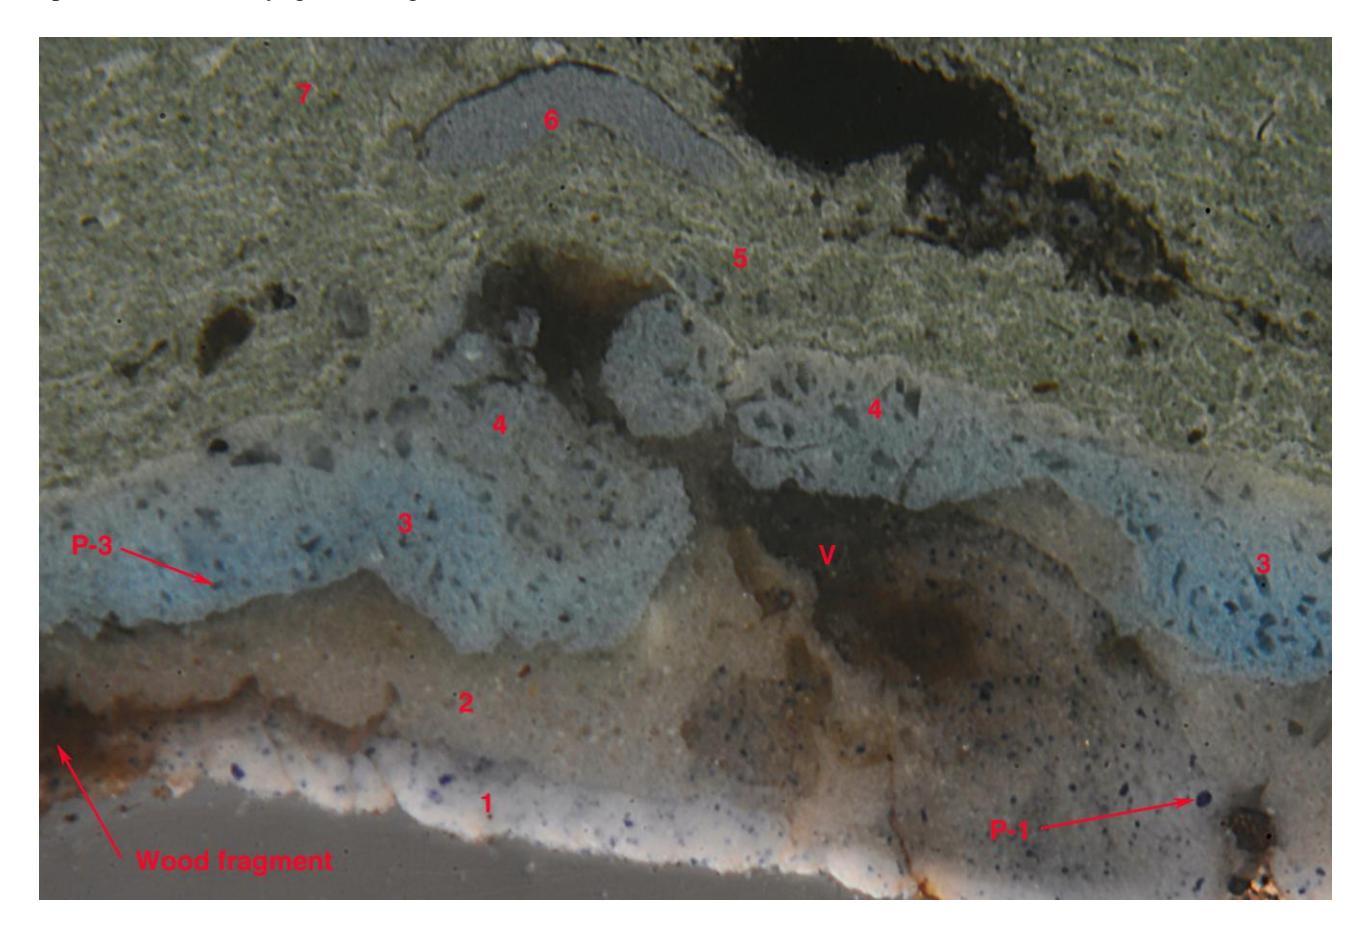
Sample: 1928 West Elevation: Porch Bead Board Ceiling

Note: The sample has been mounted in polymer resin, cut and polished to 8000 micron grit polishing cloth for additional examination. The wood substrate is seen at the base of the sample. This is a remarkable sample for the indication of the pigments used in the preparation of the earlier finishes.

The first finish is a fine moderate purplish blue [1] prepared with lead white and distinctly seen artificial ultramarine blue [note pigment particle P-1]. The same combination of pigments is used for the second finish [2]. The third finish, which is estimated to date to the restoration period 1945-1950 is clearly seen: the blue pigment is Prussian blue [note particle P-3]. Note the later finishes [5, 6, 7] are all variations on *sky blue* though they show discoloration.

- **9.** Porch Board and Batten Ceiling: Moderate blue: Benjamin Moore CW-605 ["Palace Blue" *Colonial Williamsburg line*] Gloss level: Semi-gloss
- **10. Lintels of Porch:** Dark Brown: Benjamin Moore HC-71 ["Hasbrouck Brown *Historical Colors line*] Gloss level: Semi-Gloss [refer to illustration below]

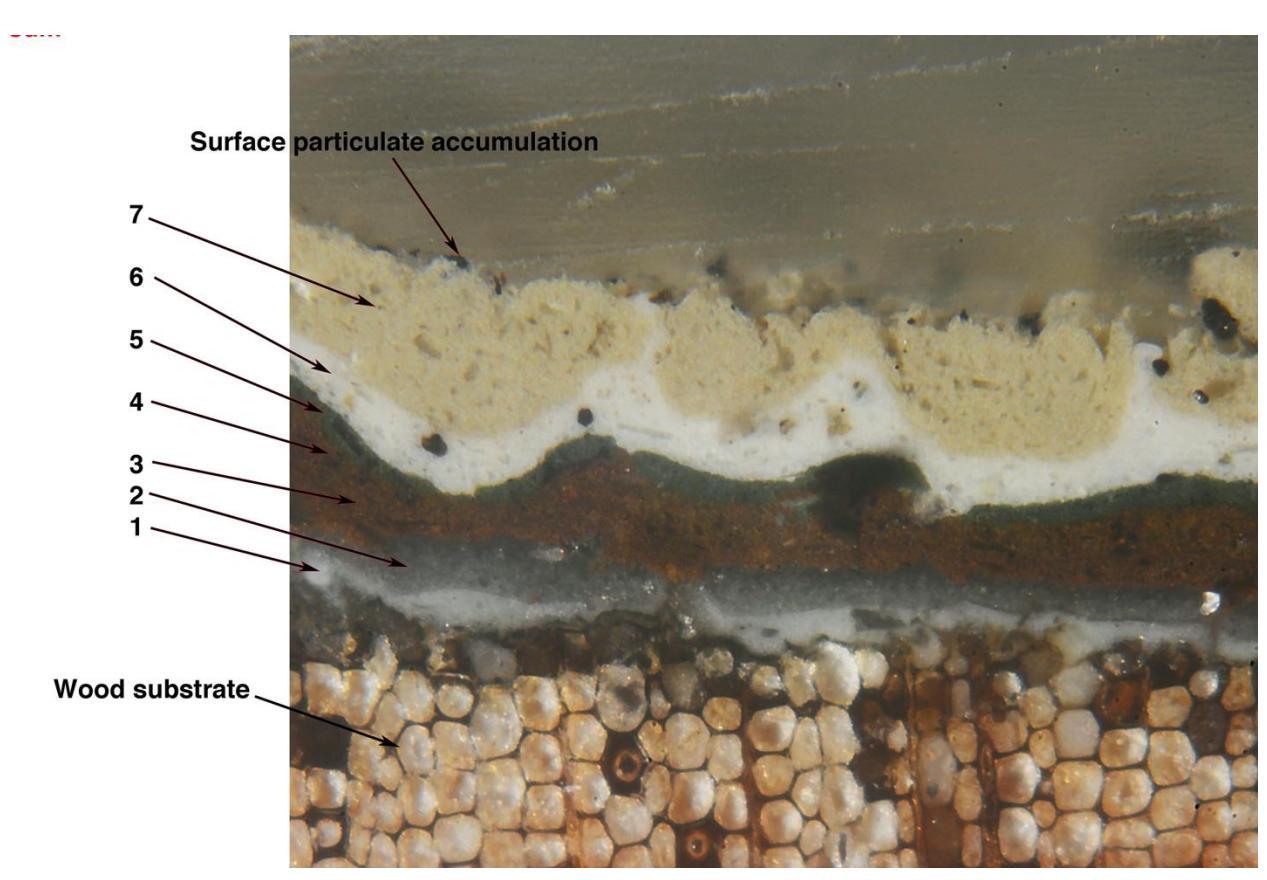
Sample: 1928 West Elevation: Turned columns

Note: The sample has been mounted in polymer resin, cut and polished to 8000 micron grit polishing cloth for additional examination. The wood substrate is clearly seen at the base of the sample. The first white finish [1] and the second gray finish [2] are from the period between 1928-ca. 1945-1950. The third finish is the dark brown [3] that relates to the Sinclair watercolor. The later finishes are also recorded and indicated.

- **11. Turned columns: :** Dark Brown: Benjamin Moore HC-71 ["Hasbrouck Brown *Historical Colors line*] Gloss level: Semi-Gloss [**refer to illustration below**]

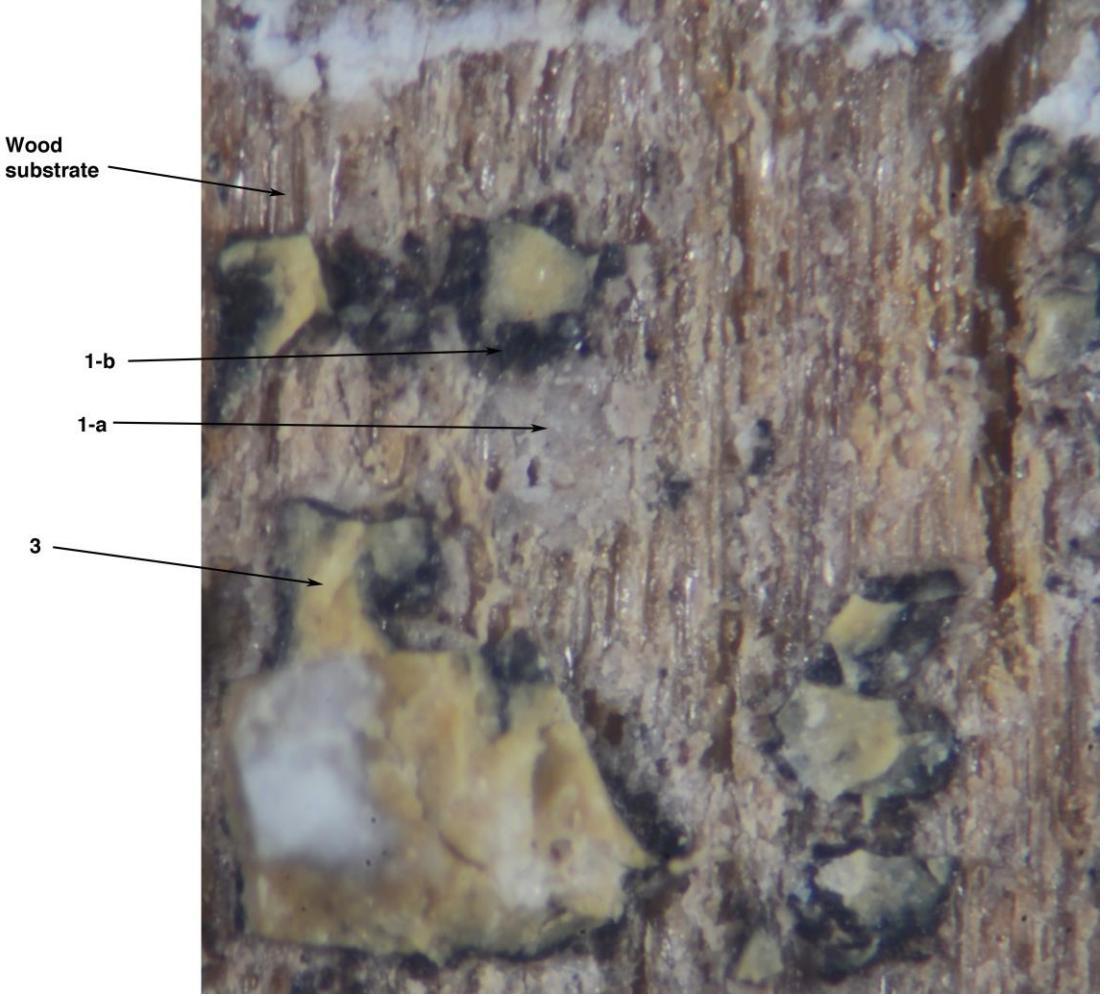
Sample: 1928 addition, East elevation Re-used door, 19th Century Italianate style

Note: The view of this sample is looking down onto the finish surface; the sample has been subject to delamination of some of the later paint layers in order to afford this view. The wood substrate is clearly seen and is indicated. The first layer is a primer and ground coat: layer 1-a, that is prepared with lead white and earth pigments: this is the ground for a <u>walnut graining finish</u>. The graining and varnish glaze layer [1-b] is clearly seen: this layer is prepared with burnt umber, raw umber and black pigments. The figuration of the wood that is emulated is seen within this layer. 1-b also shows the varnish coatings that were used to preserve and finish the emulation of the dark walnut. The yellow finish that is clearly seen appears to be from the third finish period [3] estimated to be ca. 1945-1950.

It is entirely possible that this door is from a demolished house of the mid-late 19th century. Doors from early houses have always been salvaged from demolition and reused. This is one such example.

- 14. 1928 East Elevation: Re-used 19th century door Light yellow: Benjamin Moore CW-395 ["Governor' Gold" Colonial Williamsburg line] Gloss level: Semi-Gloss [refer to illustration below]

- **15. Re-used 19th century door frame:** Dark Brown: Benjamin Moore HC-71 ["Hasbrouck Brown *Historical Colors line*] Gloss level: Semi-Gloss
